**LAPORAN ON THE JOB TRAINING
DI GMF AEROASIA - HANGAR TANGERANG
05 MEI 2025 – 25 JULI 2025**

**PROGRAM STUDI DIPLOMA 3 TEKNIK PESAWAT UDARA
POLITEKNIK PENERBANGAN SURABAYA
2025**

Pesawat Airbus A320 dengan registrasi VT – IFP harus dilakukan perbaikan dengan alur bagan 4. 1 karena terjadi permasalahan *Failure of Overpressure Valve*.

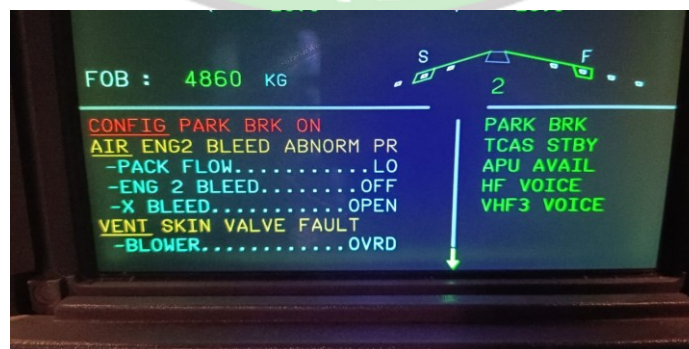
Gambar 4. 3 AIR ENG2 BLEED ABNORM PR

Troubleshooting Overpressure Valve #2 terjadi ketika dalam tahap Run Up yang mana pada ECAM muncul alert AIR ENG2 BLEED ABNORM PR. Troubleshoot ini terjadi pada pesawat Airbus A320 dengan aircraft registration VT-IFP yang menunjukkan AIR ENG2 BLEED ABNORM PR yang ditunjukkan pada gambar 4. 3.

Untuk mengetahui penyebab terjadinya *fault AIR ENG2 BLEED ABNORM PR*, maka *engineer* melakukan pengecekan *continuity* antara *output BMC#2* hingga *input OPV#2*. Dari pengecekan *continuity* dinyatakan bahwa *wiring* antara *output BMC#2* dan *input OPV#2* dalam kondisi baik. Berdasarkan dari pengecekan tersebut *engineer* menyatakan bahwa kemungkinan terjadinya *fault* adalah kerusakan pada *OPV#2*.

Setelah mengetahui pasti penyebab *trouble* selanjutnya *engineer* dan mekanik melakukan *replacement Overpressure Valve #2* berdasarkan *reference AMM Removal TASK 36-11-53-000-001-A* dan *AMM Installation TASK 36-11-53-400-001-A*. Sesuai dengan TSM langkah selanjutnya yaitu melakukan *replacement OPV #2*. Sebelum melakukan AMM removal *TASK 36-11-53-000-001-A* dibutuhkan *tools* yaitu *ACCESS PLATFORM 1M (3 FT)*, *CAP-BLANKING*, *COVER-PROTECTION* dan *WARNING NOTICE(S)*.

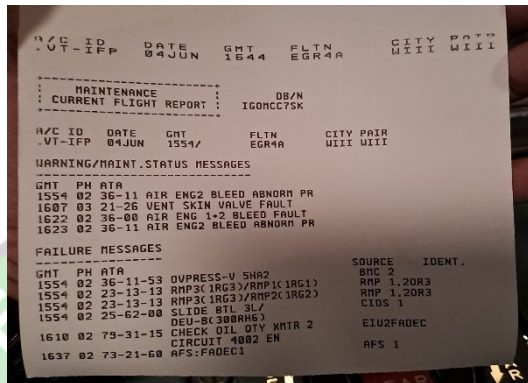
Gambar 4. 6 AIR ENG 2 BLEED ABNORM PR massage OVPRESS-V 5HA2

Berdasarkan TSM (*Troubleshooting manual*) Ref. TSM TASK 36-11-00-810-844-A menunjukkan beberapa penyebab dari adanya *AIR ENG2 BLEED ABNORM PR* diantaranya adalah *VALVE-OVERPRESSURE, ENG 2*. Hal ini diperkuat oleh adanya hasil tes yang menunjukkan *massage (OVPRESS-V 5HA2)*.

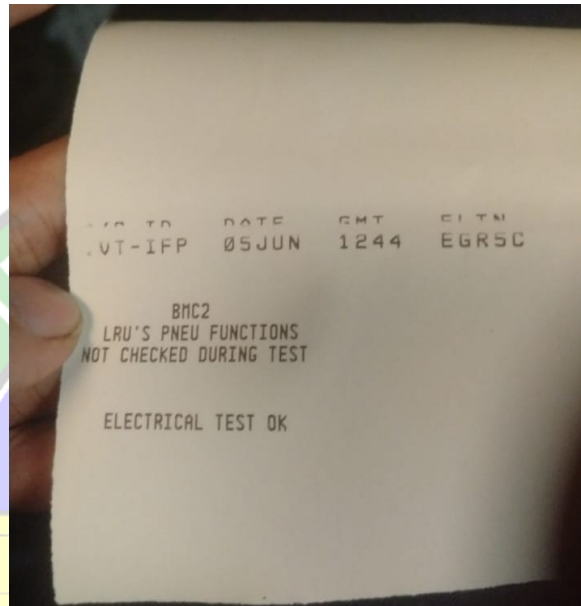
Gambar 4. 11 Result of Functional Test Overpressure Valve

Setelah melewati tahap *replacement Overpressure Valve#2* maka selanjutnya akan dilakukan *BITE TEST of Overpressure Valve #2* dengan Ref. AMM TASK 36-11-00-740-001. Hasil *BITE TEST of Overpressure Valve #2* menunjukkan “*ELECTRICAL TEST OK*”.

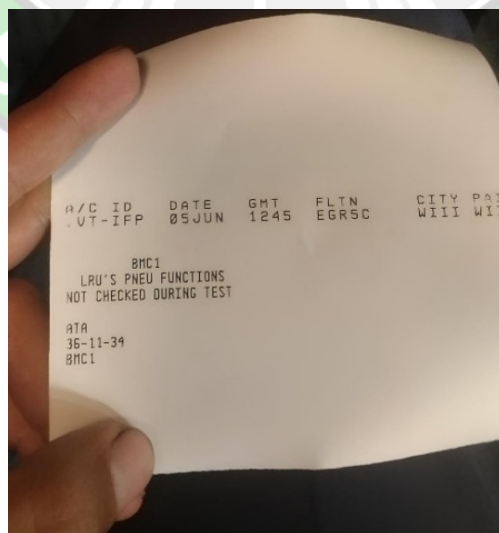
Gambar 4. 15 Message BMC 1 fail

Ref. TSM TASK 36-11-00-810-801-A. Sesuai dengan *reference information* untuk mengkonfirmasi penyebab munculnya *fault*, maka *engineer* melakukan *BITE TEST* Ref. AMM TASK 36-11-00-740-001, yang menunjukkan BMC1 *FAULT* ditunjukkan pada gambar 4. 15.

Setelah mengetahui pasti penyebab *trouble* selanjutnya *engineer* dan mekanik melakukan *replacement* BMC #1 berdasarkan *reference* AMM Removal TASK 36-11-34-000-001-A dan AMM Installation TASK 36-11-34-400-001-A. Sesuai dengan TSM langkah selanjutnya yaitu melakukan *replacement* BMC #1. Sebelum melakukan AMM removal TASK 36-11-34-000-001-A dibutuhkan *tools* yaitu ACCESS PLATFORM 2M (6 FT), CAP-BLANKING, dan SAFETY CLIP-CIRCUIT BREAKER.

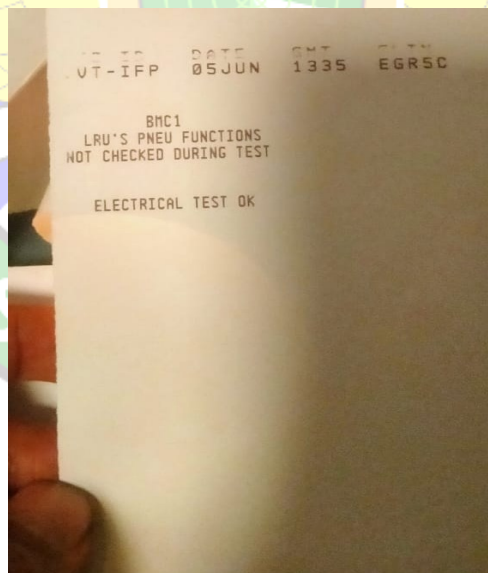
Gambar 4. 21 Result BITE TEST of BMC 1

Setelah mengganti BMC 1, lakukan *BITE TEST* sesuai dengan AMM TASK 36-11-00-740-001-A dapat dilihat pada gambar bahwa hasil dari *BITE TEST* adalah “*ELECTRICAL TEST OK*”.
