**LAPORAN *ON THE JOB TRAINING***  
**DI FL TECHNICS INDONESIA – HANGGAR CENGKARENG**  
**PADA AIRBUS 320 PK-AZE**  
05 Mei 2025 – 25 Juli 2025

**LAPORAN *ON THE JOB TRAINING***  
**DI FL TECHNICS INDONESIA – HANGGAR CENGKARENG PADA**  
**AIRBUS 320 PK-AZE**

1. *Replacement Static Discharge At L/H Horstab Tip and Elevator*
2. *Replacement Bonding Cable At Fuel Tank*

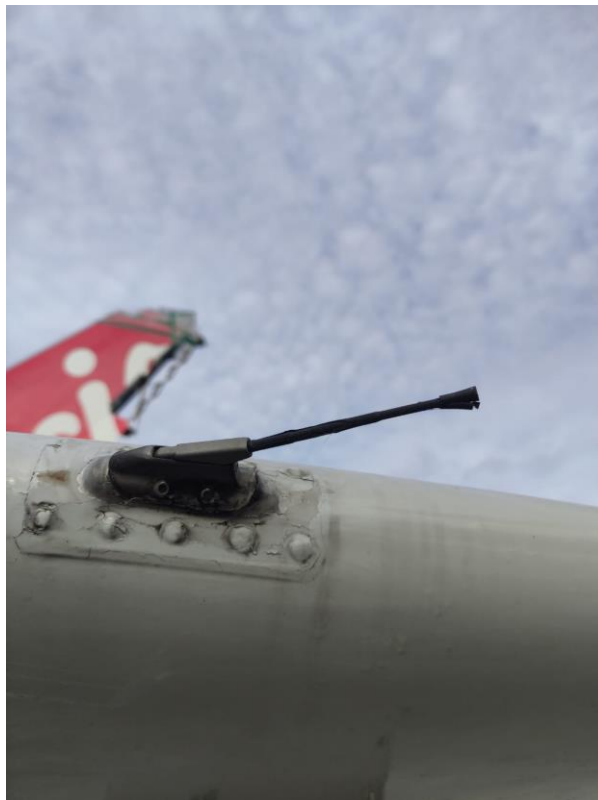
Gambar 4.5 Broken Static Discharge

Hasil *visual inspection & Check for A/C General Condition* berdasarkan ATD Form F111 ditemukannya *bad condition* pada *static discharge* yang ditampilkan pada gambar 4.5.

Dinyatakan *bad condition* karena nilai *resistance static discharge* tidak memenuhi standar yaitu berada dibawah 6 megaohm. Maka dilakukanlah *Replacement* dan pengukuran *resistance* sesuai dengan standar Ref AMM. 23-61-00-210-050-A

setelah melakukan *visual inspection* pada *static discharge*, jika ditemukannya *broken* pada *static discharge* maka tahap selanjutnya melakukan *replacement* dengan mengikuti tiga standard AMM yang ditampilkan pada halaman 21 sampai 38 dan ditampilkan juga pada lampiran di halaman 44 hingga 67.

Melalui proses inspeksi dan pengujian resistansi menggunakan megohmmeter, diketahui bahwa nilai resistansi komponen tersebut berada di luar batas toleransi, yaitu di bawah atau melebihi rentang 6–120 MΩ sebagaimana tercantum dalam *Aircraft Maintenance Manual* (AMM). Oleh karena itu, dilakukan penggantian (*replacement*) sesuai prosedur yang berlaku.

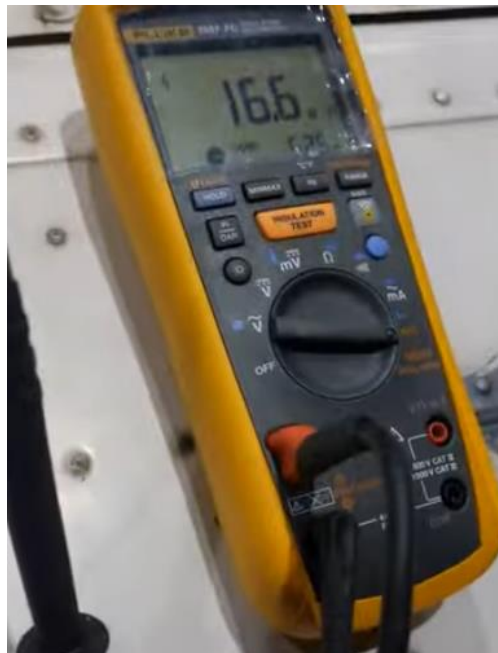
Gambar 4.6 Hasil pengukuran resistansi

1. Pastikan *bonding resistance* antara *static discharge retainer* dan struktur pesawat sesuai Ref AMM. 20-28-00-869-002.
2. Dalam pengukuran *resistance* antara *bonding resistance tip* dan *static discharge retainer* dengan menggunakan megger (megaohm meter).
3. Tahap selanjutnya *connect* salah satu *probe* megohm meter pada *static discharge retainer*.
4. Setelah itu tempel *probe* megger dengan menggunakan *spons* basah pada salah satu *lead/tip static discharge*
5. Kemudian test megohm meter dan pastikan nilai resistannya antara 6-120 megohm meter
6. Pada saat pengukuran, hasil nilai dari megaohm meter sebesar 16,6 megohms.
7. Setelah pengukuran selesai, pastikan area kerja bersih.
