**LAPORAN HASIL PELAKSANAAN *ON THE JOB TRAINING***  
**BATAM *AERO TECHNIC***

**PROGRAM STUDI DIPLOMA 3 TEKNIK PESAWAT UDARA**  
**POLITEKNIK PENERBANGAN SURABAYA**

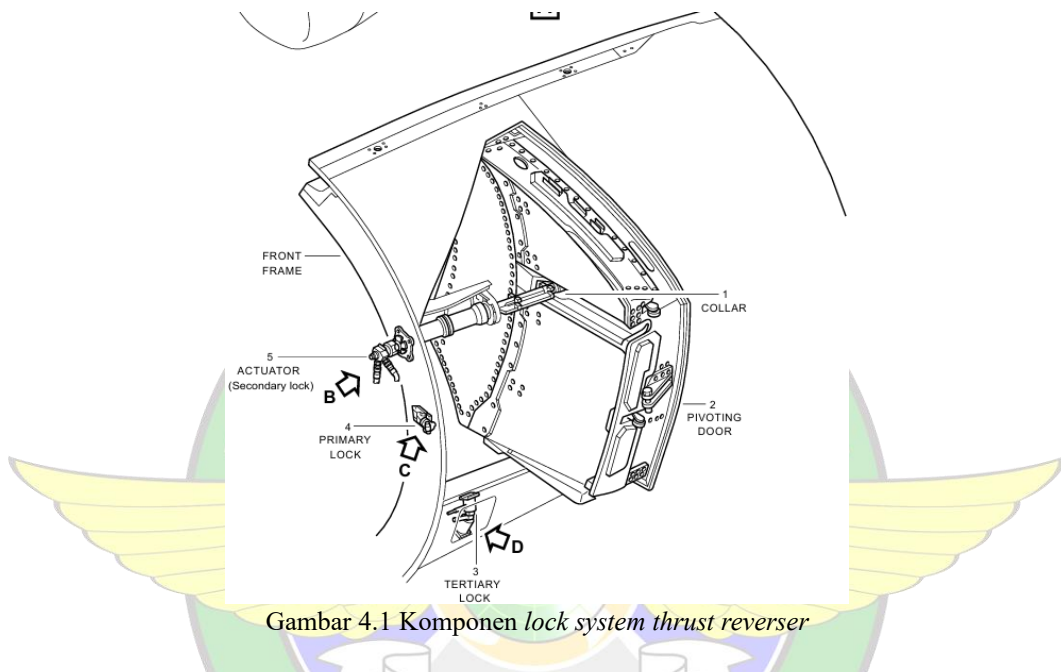
Gambar 4.1 Komponen lock system thrust reverser

- a) *At the front of the beam, use a standard WRENCH 5-16 IN. – SQUARE SPANNER or WRENCH 5-16 IN. – OPEN ENDED SPANNER to turn the primary release lock on the primary lock.*
- 2) *To test the secondary lock, use your hands and try to open the pivoting door (2). Make sure the pivoting door (2) does not open.*
- 3) *Disengage the secondary lock release on the actuator.*
  - a) *If the pivoting door (2) does not move as the secondary lock is disengaged, replace the pivoting door actuator.*
- 4) *To test the tertiary lock (3), use your hands and try to open the pivoting door. Make sure the pivoting door (2) does not open.*
- 5) *If you can open the pivoting door (2), do an inspection of the tertiary lock.*

- 1) *Remove the inhibition bolt from its stowage and install it between the front frame and the pivoting door.*
  - 2) *Tighten the inhibition bolt until the primary lock (4) and the secondary lock of the actuator are engaged.*
  - 3) *Remove the inhibition bolt and install it in its stowage.*
- b) *Activate the thrust reverser.*

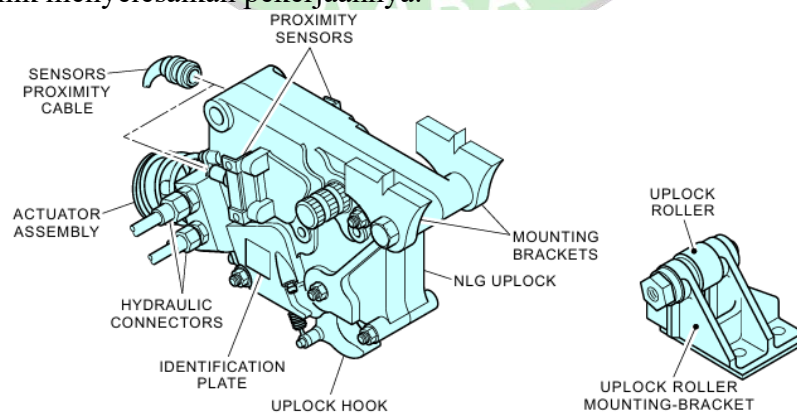
Gambar 4.4 komponen *uplock unit* dan *uplock roller*

Tujuan dari inspeksi ini adalah untuk mengecek komponen apakah terjadi kerusakan, *crack*, maupun korosi. Komponen yang diperiksa dari inspeksi ini diantaranya: *landing gear uplock*, *landing gear door uplock*, *landing gear uplock roller*, *landing gear door uplock roller*. Komponen tersebut ada pada *nose landing gear* dan *main landing gear*. Mekanik akan melakukan *detailed inspection* sesuai 22 langkah-langkah pada task card nomor A330-323000-20-1-IDN.

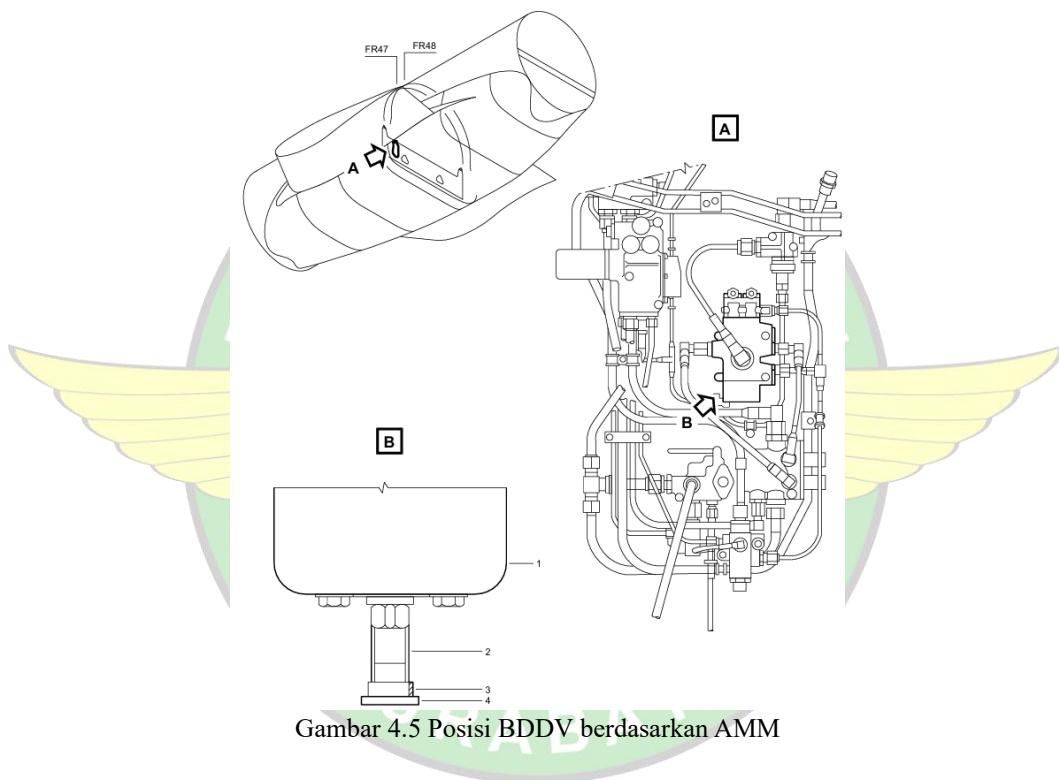
Gambar 4.5 Posisi BDDV berdasarkan AMM

- A. *Put a container in position below the alternate-brake dual valve (1).*
- B. *Remove the collar (3) of the drain tube (2).*
- C. *Remove the cap (4) to drain the drain tube (2).*
- D. *If water is found in the drain tube, do the detailed visual inspection of the alternate-brake dual valve (5403GG) for corrosion [Ref. AMM TASK 32-43-14-200-802](#).*
- E. *If hydraulic fluid is found in the drain tube (five drops or less):*
  - 1) *Do the operational test of the alternate braking system [Ref. AMM TASK 32-43-00-710-801](#).*

- 2) Replace the alternate-brake dual valve (5403GG) within seven days or ten flight cycles (the one that occurs first) [Ref. AMM TASK 32-43-14-000-801](#) and [Ref. AMM TASK 32-43-14-400-801](#).
- 3) If you find more than five drops, replace the alternate-brake dual valve (5403GG) before the next flight [Ref. AMM TASK 32-43-14-000-801](#) and [Ref. AMM TASK 32-43-14-400-801](#).

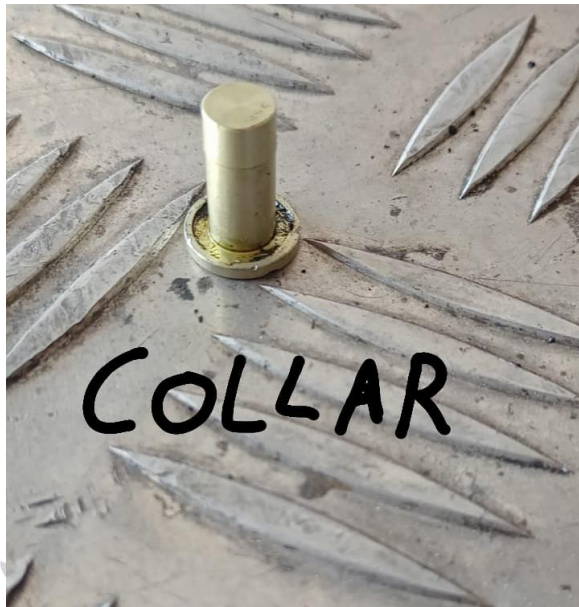
Gambar 4.6 collar drain tube

Setelah dilakukan *visual check* sesuai prosedur diatas, maka *mechanic* tidak menemukan adanya air, maupun cairan *hydraulic* di dalam *drain tube*, sehingga hanya dilakukan *cleaning* di area *drain tube*, ditunjukkan pada gambar 4.7 yang dilingkari.

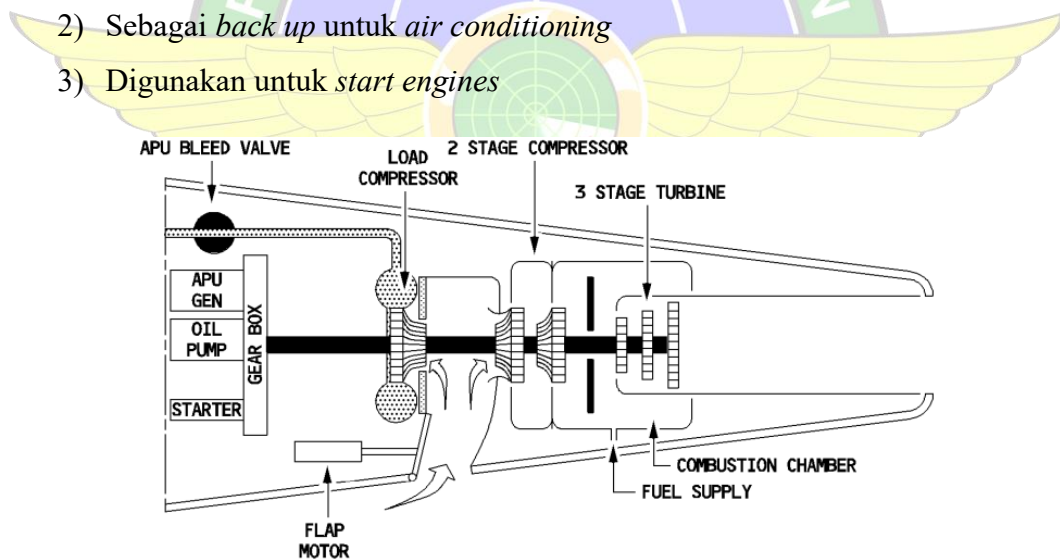
Gambar 4.8 Komponen utama APU

Pada saat *on ground*, APU menyuplai *bleed air* untuk *start engines* dan untuk *air conditioning system*. Serta dapat menyuplai *electrical power* untuk keperluan *electrical system*.

Selama *take off*, APU juga menyuplai *bleed air* yang digunakan untuk *air conditioning*, sehingga dapat menghindari penurunan *engine thrust* yang disebabkan oleh penggunaan *engine bleed air* untuk keperluan *air conditioning*.

- 1) Sebagai *back up* untuk *electrical system*
- 2) Sebagai *back up* untuk *air conditioning*
- 3) Digunakan untuk *start engines*

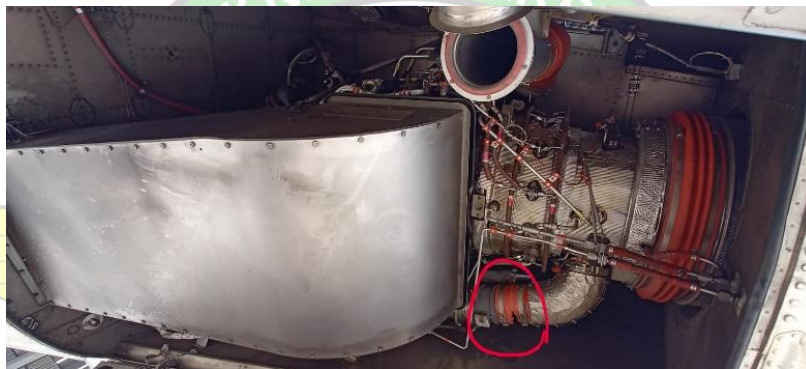
Gambar 4.9 Penemuan kerusakan pada komponen APU

Pada sub bab ini dilakukan *maintenance C-Check 04* pada pesawat A330 dengan registrasi PK-LEF dengan dilakukan pekerjaan *General visual inspection of tail cone APU air intake area (EWIS)*. Dalam pengerjaan *maintenance* ini, *mechanic* mengikuti 27 langkah-langkah yang ada pada *taskcard*, namun ditemukan permasalahan pada salah satu komponen dari APU, yaitu *broken duct air surge*.

Pada pesawat Airbus A330 dengan registrasi PK-LEF dilakukan pengerjaan *general visual inspection* pada APU *air intake area* (EWIS). Pekerjaan ini merupakan bagian *maintenance* dari *C-Check* 04 pada pesawat Airbus A330 (PK-LEF) dengan mengikuti 28 langkah-langkah yang ada pada referensi *taskcard* no. A330-ZL-313-01-1-IDN. Pada saat inspeksi ditemukan permasalahan yaitu terdapat suatu komponen APU yang rusak (berlubang) seperti pada gambar 4.9 yang dilingkari. Dalam *maintenance* ini diperlukan *articulating boom* untuk mencapai tempat yang tinggi. Pekerjaan ini dilakukan pada tanggal 8 Mei 2024.

Selanjutnya dibuat dokumen MDRR (*Maintenance Defect & Rectification Report*) No. 111544 ditunjukan pada gambar 4.11, kemudian terbit dokumen N/R (non-rutin) dengan N/R-00027 yang dikeluarkan oleh PPC di hangar A, ditunjukan pada gambar 4.12. untuk penggantian komponen tersebut, maka *mechanic* menggunakan referensi dari AMM 49-51-52-000-801-A – *Removal of the Surge Control Valve* dan referensi AMM 49-51-52-400-801-A – *Installation of the Surge Control Valve*.

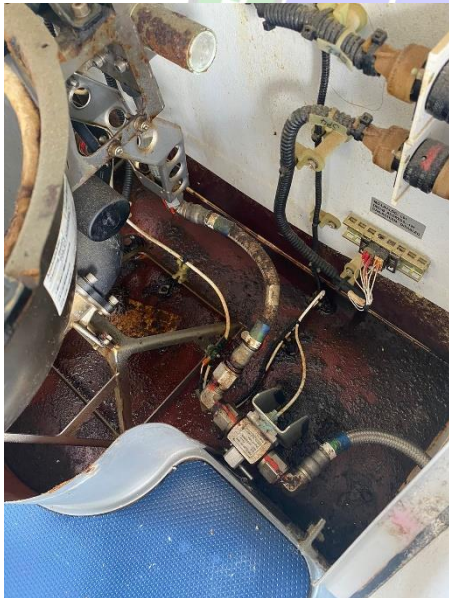
Gambar 4.17 Before cleaning

Pada langkah ini mekanik membuka *toilet shroud*, maka ditemukan terdapat genangan air yang berbau tidak sedap di dalamnya, seperti yang ditunjukkan pada gambar 4.16. Kemudian mekanik melakukan *cleaning* pada bagian dalam *toilet shroud* untuk mencari sumber bau dan kebocoran.

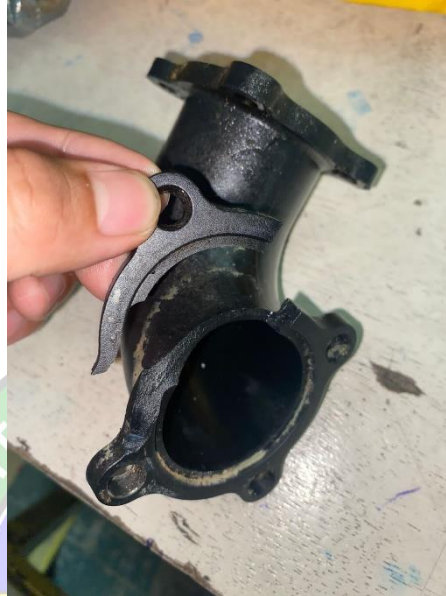
Gambar 4.19 Broken elbow pipe

Setelah dilakukan *cleaning*, selanjutnya mekanik mencari sumber dari kebocoran yang ada, dan ditemukan bahwa sumber kebocoran terdapat pada *elbow pipe*. Setelah dilakukan *remove elbow pipe*, ditemukan adanya patahan pada *elbow pipe*, seperti yang ditunjukkan pada gambar 4.18.

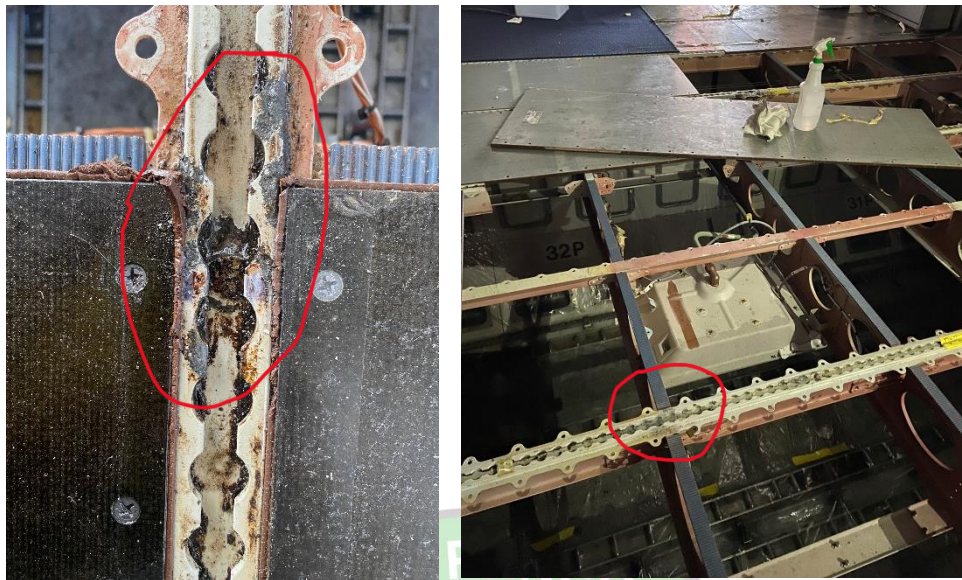
Gambar 4.20 korosi pada *seat track*

Pada saat dilakukan identifikasi pada *structure* setelah *removal lavatory block*, dan melepas *floor panel* di sekitar *lavatory*. Maka ditemukan terdapat banyak korosi pada *seat track*, seperti pada gambar 4.19. Selanjutnya mekanik membuat dokumen MDRR untuk selanjutnya pekerjaan diserahkan kepada divisi repair.

Setelah dilakukan inspeksi oleh divisi *repair*, dan ditemukan ada banyak korosi di beberapa bagian *seat track*, maka disimpulkan untuk dilakukan penggantian *seat track* yang dikerjakan oleh divisi *repair*. Penggantian ini dilakukan dengan melepas masing-masing *seat track* yang korosi pada setiap zona seperti yang ditampilkan pada gambar 4.20.

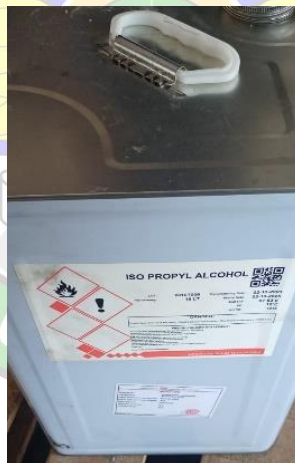
Gambar 4.23 Kaleng cairan *alcohol*

Setelah *bogie pivot pin* terlepas, selanjutnya dilakukan *cleaning* menggunakan cairan *iso propyl alcohol* untuk membersihkan *grease* dan *visual inspection* untuk mencari adanya *crack*, *scratch*, maupun kerusakan lainnya.

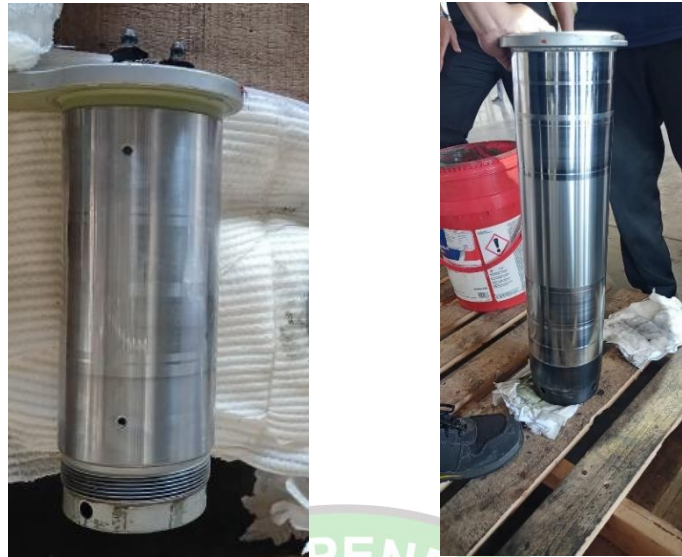
Gambar 4.24 *Inspection* komponen *pivot pin*

Setelah dilakukan *cleaning*, maka *engineer* akan memeriksa *pivot pin*, untuk mencari adanya, kerusakan, *scratch*, maupun *crack*. Namun tidak ditemukan adanya beberapa kerusakan diatas pada komponen *pivot pin*, sehingga hanya dilakukan *lubrikasi* pada komponen *pivot pin* dengan memberikan olesan *grease 33* seperti pada gambar 4.24 dibawah ini.

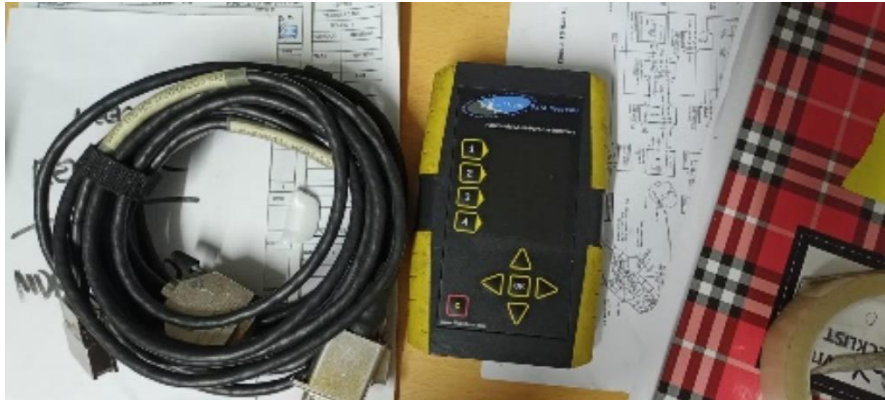
Gambar 4.26 HHMPI CVR/FDR readout

Untuk mengerjakan *taskcard* tersebut diperlukan beberapa *tools* diantaranya: *HHMPI CVR/FDR readout*, *Interface cable (SSFDR) FA2100*, *USB key (1-2G)*. pada gambar 4.25 dibawah ini merupakan gambar alat yang digunakan.

Namun pada saat pengerjaan, ditemukan kendala pada *tool* yang digunakan, yaitu *tool HHMPI CVR/FDR readout* tidak dapat menyala. *Engineer* mencoba untuk melakukan *charging* terlebih dahulu pada alat tersebut sekitar 30 menit dan mencoba untuk menyalakan lagi. Namun alat tersebut tetap tidak dapat digunakan sesuai seharusnya.

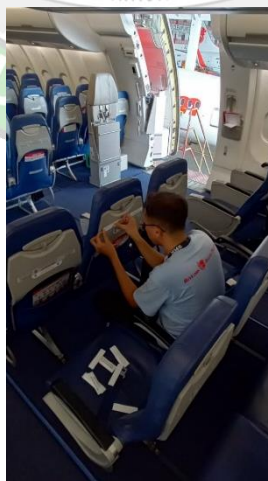
Gambar 4.31 Proses instalasi placards

Pada pekerjaan ini tidak diperlukan *tool* apapun, mekanik hanya menggunakan kanebo untuk membersihkan bidang yang akan dipasangkan *placards*. Kemudian menempelkan *placard* dalam tulisan bahasa arab pada bagian belakang seluruh *passenger seat* dan beberapa bagian lainnya seperti *lavatory*. Seperti ditunjukan pada gambar 4.30 dan 4.31 dibawah ini.

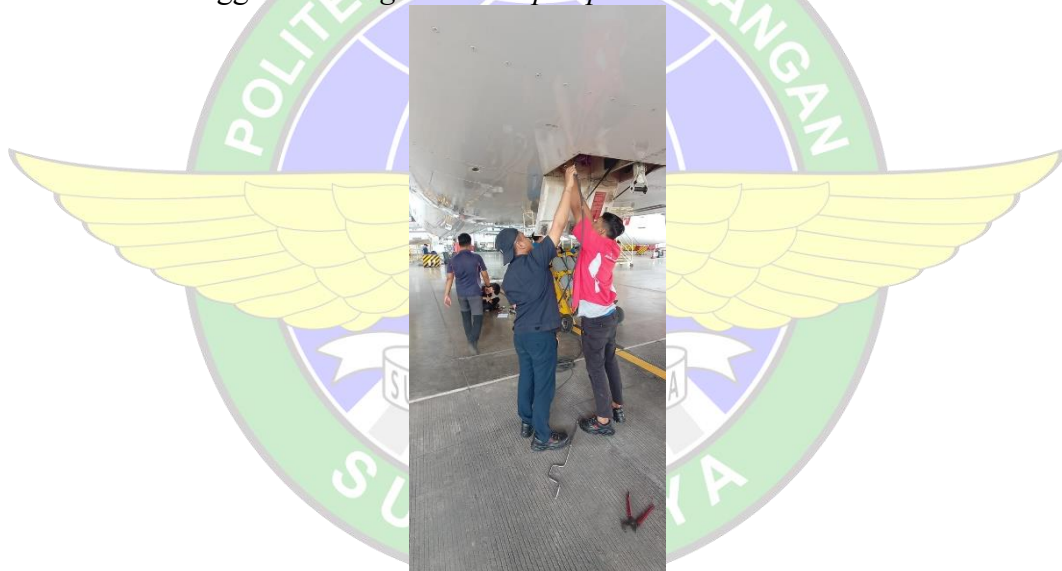
Gambar 4.33 Pengerjaan *pressurization hydraulic reservoirs*

Pada *yellow system*, mendapatkan *pressure* dari *pump engine 2*. *System* ini punya tambahan *electric pump* yang dapat dikontrol secara manual dan otomatis, yang memungkinkan *hydraulic* untuk *ground operations* ketika *engine off*. Saat terjadi *engine 2 failure* ketika *takeoff*, *electric pump* otomatis menyala jika *green electric pump* tidak bekerja untuk *landing gear retraction*.

Pada setiap *system*, *electric pump flow* dibatasi hanya 18% dari kapasitas aliran *engine driven pump*. Ini dapat digunakan untuk *retract flight control surfaces*, tidak untuk menggantikan *engine driven pumps*.

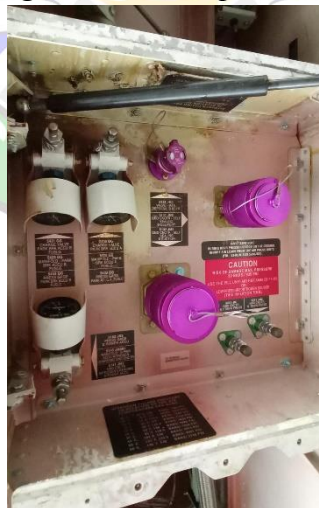
Gambar 4.34 Hydraulic pressurizaation ground service panel

- 1) *Open the left Main Landing Gear (MLG) door.*
- 2) *Put a ACCESS PLATFORM 3M (10 FT) - ADJUSTABLE in position at the zone 147.*
- 3) *Put a ACCESS PLATFORM 3M (10 FT) - ADJUSTABLE in position at the access door 195BB.*
- 4) *Open the Blue ground-service panel 195BB.*

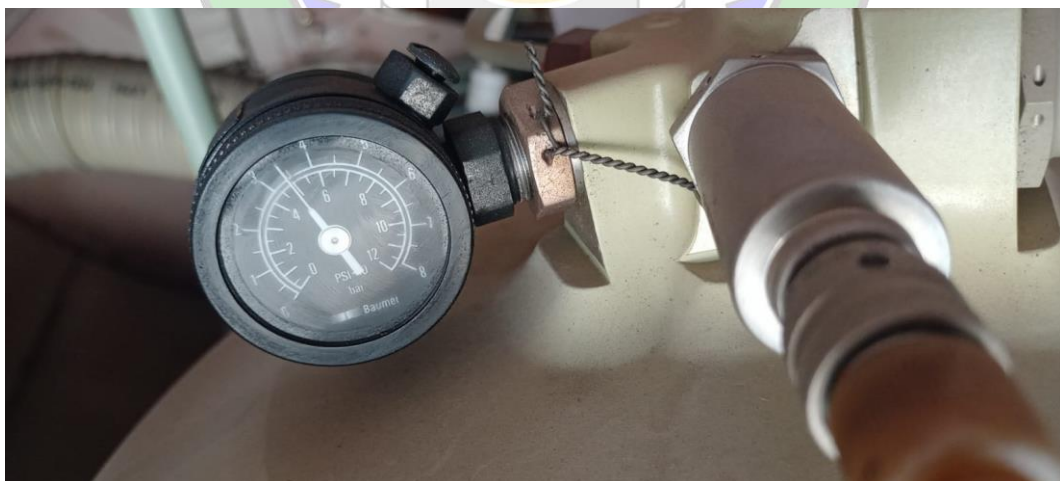
Gambar 4.36 pengecekan tekanan reservoir pada pressure gauge

Mekanik melakukan *double check* yaitu dengan memeriksa kembali pekerjaan yang telah dilakukan, baik memeriksa torsi pada *ground connector nut*, memeriksa *pressure gauge reservoir* dengan memastikan tekanan sesuai dengan anjuran AMM dan tidak terjadi kebocoran tekanan, seperti yang ada pada gambar 4.23.

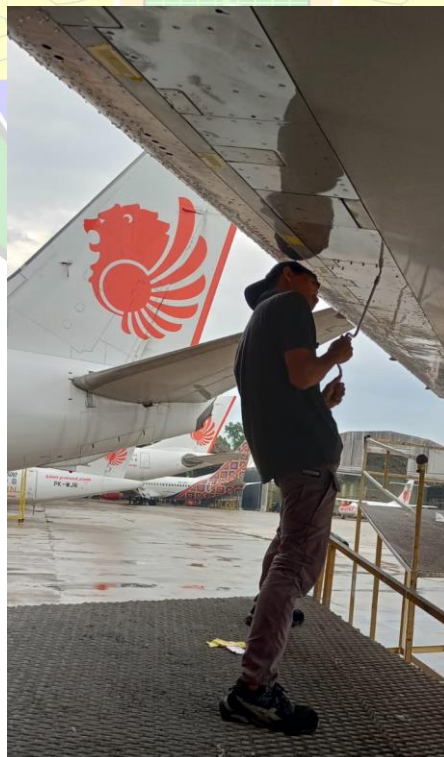
Gambar 4.42 Proses *removal panel*

Pada Langkah ini diperlukan beberapa *tools*, diantaranya: *speed handle, bit*, plastik *screw bag*, *part holding tag*. Setelah *tools* siap, selanjutnya dilakukan *remove panel* menggunakan *speed handle*, terdapat beberapa panel yang harus dilepas mengikuti prosedur dari *taskcard*. Setelah panel terlepas, kemudian diberikan *part holding tag* sesuai nama dari panel tersebut agar tidak tertukar dengan panel lainnya.

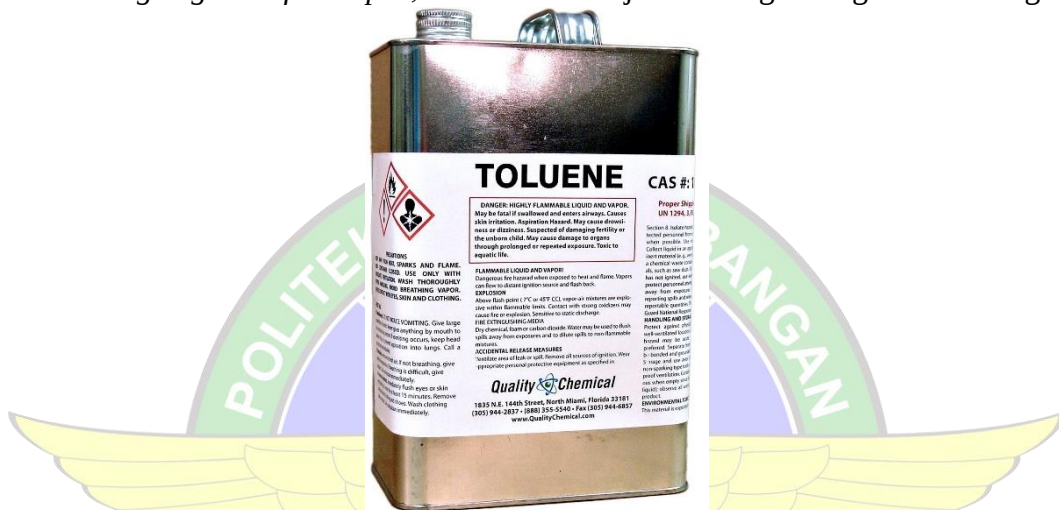
Gambar 4.43 Cairan toluene

Selanjutnya *mechanic* melakukan *cleaning* pada area yang akan di inspeksi dengan menggunakan majun, kuas, dan cairan toluene. Setelah *cleaning* selesai, maka *mechanic* mulai inspeksi pada area *leading edge* dan *front spar* untuk memeriksa adanya *crack*, maupun korosi.

Pada saat inspeksi tidak ditemukan adanya korosi maupun *crack* pada area *leading edge* dan *front spar*, kemudian dilanjutkan dengan langkah servicing.

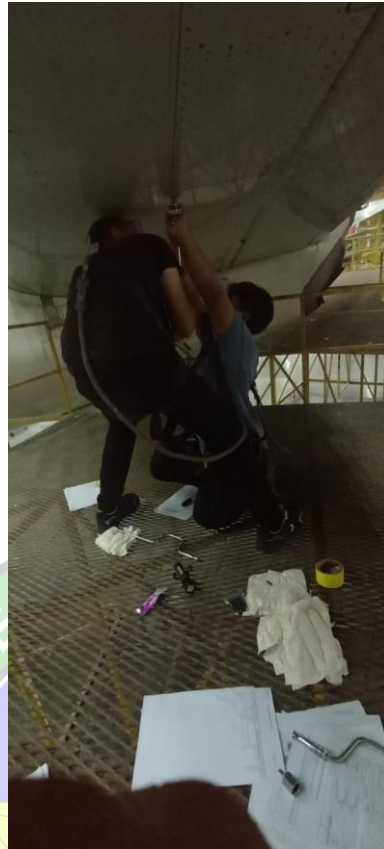
Gambar 4.44 Proses pengerjaan

Setelah proses *servicing* dilakukan dan cairan *AV* yang dioleskan sudah kering, dilanjutkan dengan proses *install panel* dengan memperhatikan pada *part holding tag* yang dipasang sebelumnya.

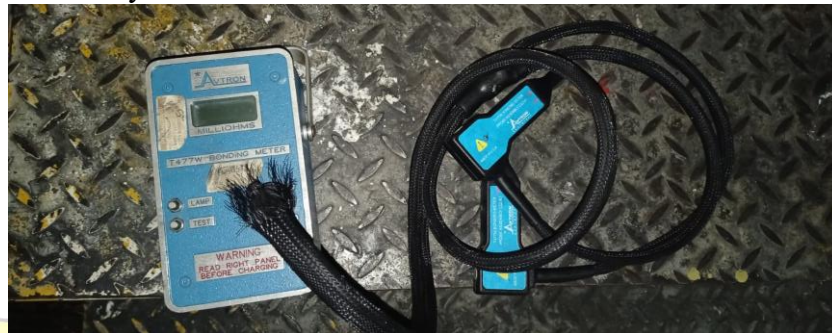
Gambar 4.45 Alat *bonding meter*

Untuk melakukan *test* ini diperlukan *tool* yaitu *bonding meter* sebagai alat ukur. Selanjutnya *mechanic* memulai pengukuran dengan mengikuti prosedur pada *taskcard.* *Mechanic* mengukur *resistance* yang ditampilkan pada *bonding meter* kemudian membandingkan dengan nilai yang tercantum pada *taskcard* dan mencatatnya.

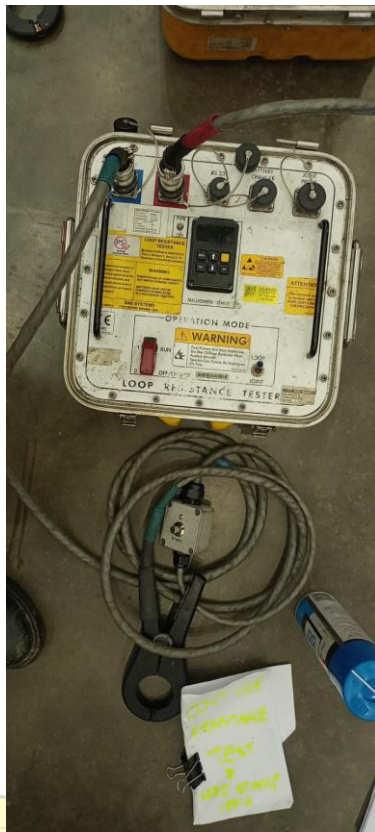
Gambar 4.47 Alat LRT

Untuk melakukan *test* ini diperlukan *tool* yaitu LRT (*Loop Resistance Tester*) sebagai alat ukur. Selanjutnya *mechanic* memulai pengukuran dengan mengikuti prosedur pada *taskcard*. *Mechanic* mengukur *resistance* yang ditampilkan pada LRT kemudian membandingkan dengan nilai yang tercantum pada *taskcard* dan mencatatnya.

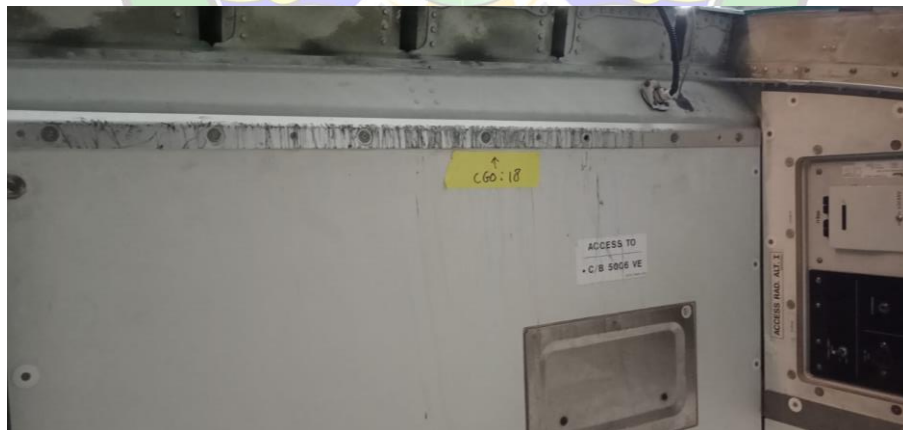
Gambar 4.49 *Scratch* pada *aft cargo ceiling metal lining strip*

Pada *lining panel*, terdapat beberapa pengecekan, yaitu memeriksa adanya *crack* atau kerusakan lain, memastikan *lining panel* terpasang dengan baik (memeriksa adanya *loose fasteners*, memeriksa adanya *fasteners* yang hilang). Pada *floor panels*, dilakukan pengecekan apakah ada *crack* atau kerusakan lain, dan memastikan *seal* dari setiap *floor panel* pada posisi yang seharusnya.

Untuk *replacement*, mekanik menggunakan referensi dari AMM 25-53-00. Untuk *tools* yang diperlukan yaitu *bit four wing* dan *speeder*. Langkah pertama yaitu mekanik melepas *screw* pada *metal lining strip*, kemudian melepas *metal lining strip* dan menggantinya dengan yang baru, setelah itu memasangkan kembali *screw* menggunakan *speeder*, dan memastikan semua *screw* telah terpasang dengan kencang.

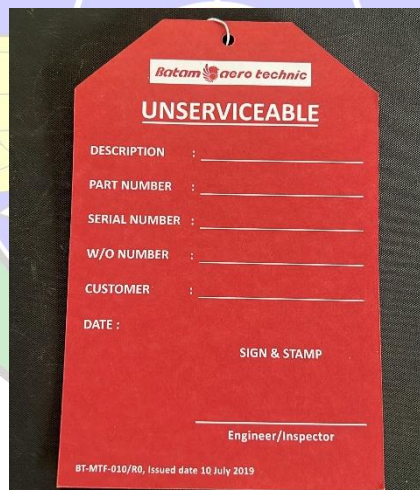
Gambar 4.52 *Unserviceable tag*

Selanjutnya untuk komponen *ceiling metal lining strip* yang dilepas (*scratch*) diberikan *unserviceable tag* untuk memberikan tanda bahwa komponen tersebut tidak untuk digunakan kembali. Setelah pemberian *unserviceable tag*, komponen tersebut dikirim ke *unserviceable storage* yang ada di *hangar A*.
