**LAPORAN *ON THE JOB TRAINING***  
**DI FL TECHNICS INDONESIA – HANGGAR BALI**  
**01 April 2024 – 30 Juni 2024**

**PROGRAM STUDI DIPLOMA 3 TEKNIK PESAWAT UDARA**  
**POLITEKNIK PENERBANGAN SURABAYA**  
**2024**

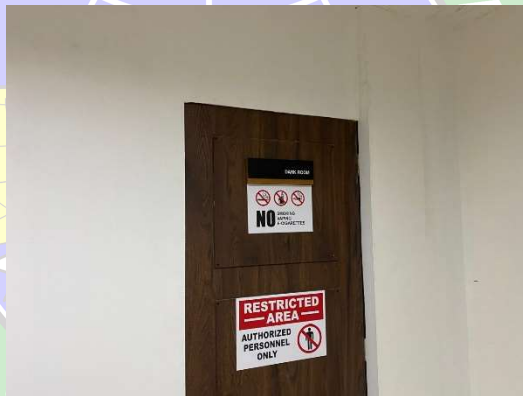
Gambar 2. 10 Dark Room

sebagai ruangan untuk melihat *leak* dan *crack* suatu benda dengan menggunakan bantuan sinar *ultraviolet* yang dapat dilihat pada gambar 2.10

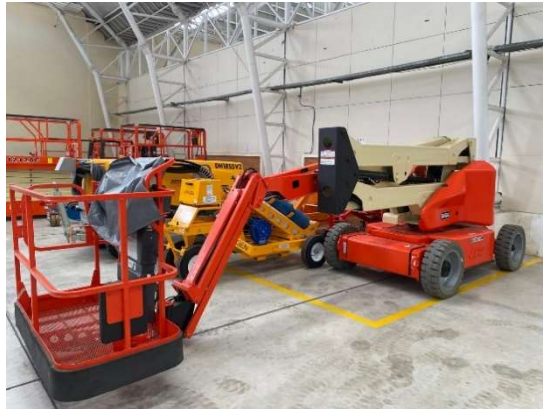
Gambar 2. 15 Ground Support Equipment

sebagai alat untuk membantu dalam pergerakan selama di hangar, yaitu seperti *Towing*, *Boom Lift*, dan *Scissors* dapat dilihat pada gambar 2.15

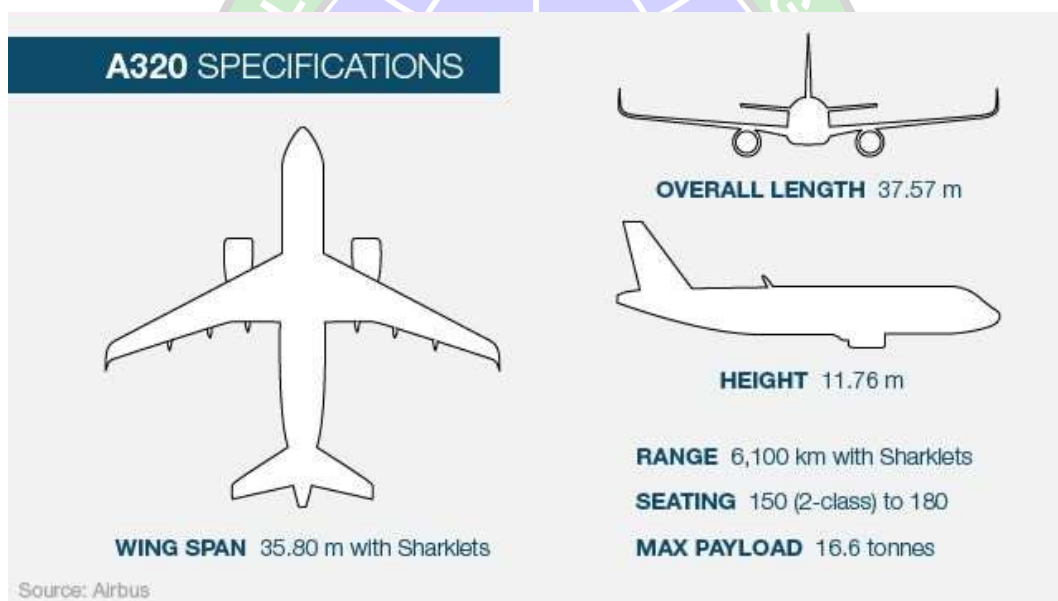
Gambar 3. 2 Airbus A320 Spesifikasi

| <i>Design Weights</i> | | |
|---|---|---|
| <i>Typical operating weight empty</i> | 42.4 tonnes | 93.5 lbs. x 1000 |
| <i>Typical volumetric payload</i> | 16.6 tonnes | 36.59 lbs. x 1000 |

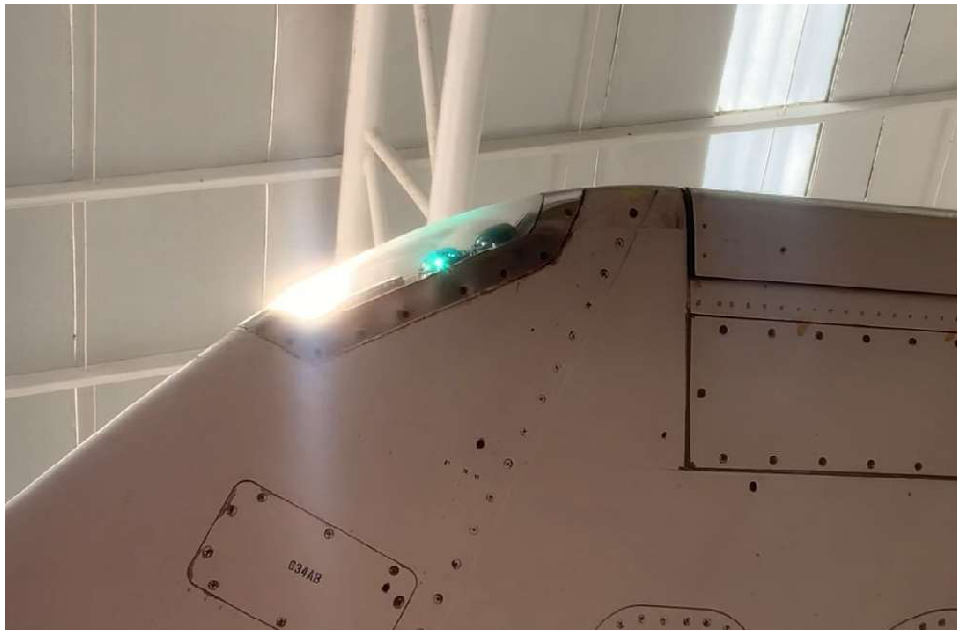
Gambar 3. 5 *Strobe Light*

*Strobe position light* adalah lampu kilat yang memancarkan cahaya kurang lebih 60 kali setiap menitnya yang berguna untuk mengetahui posisi pesawat terbang pada saat di udara. *Strobe position light* terpasang di setiap wing tip dan pada *fuselage tail cone*. *Strobe position light* adalah LED wing strobe light yang berwarna putih dan ketika dipancarkan seperti kilat. Letak posisi LED wing strobe light terletak di ujung wing. Berguna untuk mengetahui posisi pesawat terbang ketika di udara. Mempunyai flash rate 60 +5 per menitnya. Strobe Light sendiri terletak di dua tempat, yang pertama pada bagian Wings kiri kanan dan yang ke dua terletak di bagian Tail. Strobe Light berfungsi sebagai isyarat aktivitas pesawat agar terlihat oleh Air Traffic Control (ATC). Strobe Light mempunyai switch untuk menyalakan lampu yang terdapat pada Cockpit pada bagian Overhead Panel. Strobe Light mempunyai switch untuk menyalakan lampu yang terdapat pada Cockpit pada bagian Overhead Panel.

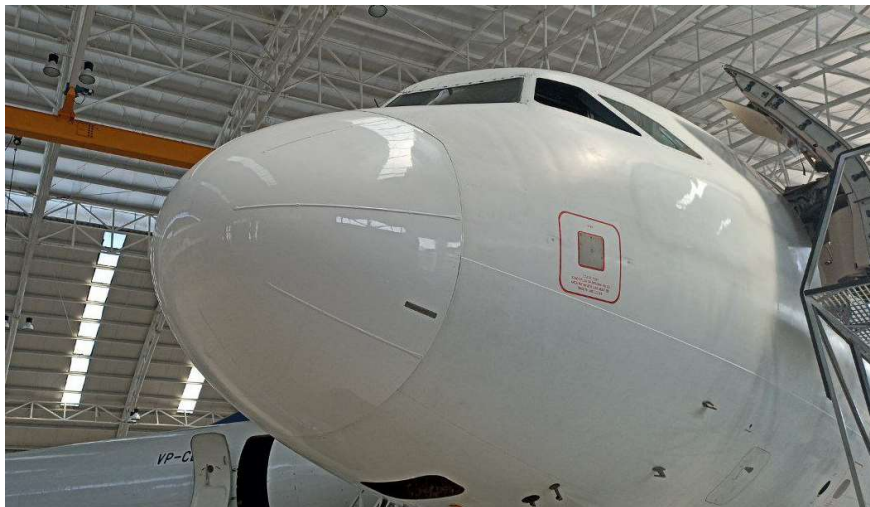
Gambar 3. 6 Nose Airbus A320 tempat Weather Radar berada

*Weather Radar* adalah untuk mendeteksi dan menghindari dari cuaca yang dapat merusak pesawat. Display akan menampilkan informasi cuaca dengan warna yang membedakan tingkat ketebalan awan, deras atau tidaknya hujan. *Weather radar* terletak pada nose dapat dilihat pada gambar 3.6

Cara kerja *Weather Radar* akan menunjukkan kepada pilot dengan menguraikan beberapa tempat yang digambarkan pada display termasuk gambar waktu menembus hujan lebat atau gambar sungai – sungai, pinggir laut, pegunungan, atau kota untuk posisi yang tetap. *Weather Radar Display* akan menunjukkan kepada pilot untuk menghindari hujan disertai angin dan petir dan termasuk turbulensi. *Basic Weather Radar* terdiri dari *receiver* dan *transmitter unit*, *antenna assembly* serta *wave guide* dan *control panel*.

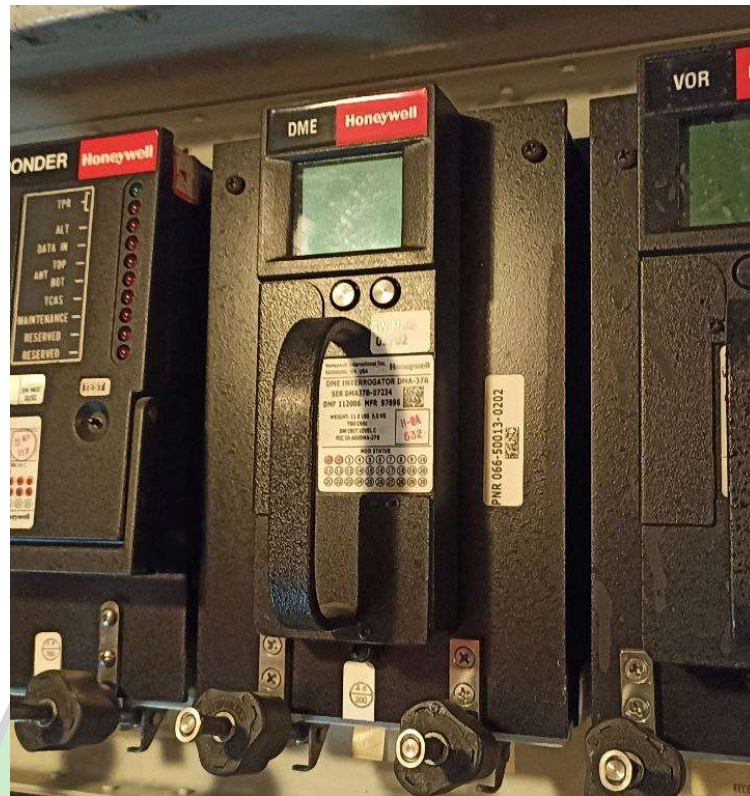
Gambar 3. 8 DME Interrogator

Interrogator merupakan sebuah pemancar radar yang mengirimkan pasangan pulsa dan memicu sebuah transponder. Interrogator DME terletak pada *EE Compartment* dapat dilihat pada gambar 3.8. Sistem ini biasanya dikombinasikan dalam satu unit dengan alat penjawab, yang menerima sinyal balasan dari transponder dan menghasilkan output yang sesuai. Hal ini disebut juga dengan *interrogator-transmitter*.

DME terdiri dari Interrogator yang berada pada pesawat sedangkan DME Station berada di on ground. Interrogator pada pesawat memancarkan pulse pada DME Station yang on ground. Pulse yang diterima memicu DME Station untuk membalas pulse tersebut. Balasan tersebut diterima oleh DME Interrogator yang berada pada pesawat. Perbedaan waktu antara transmisi dan penerima digunakan untuk menghitung jarak dari pesawat ke DME Station. Karena Interrogasi itu berulang, informasi yang didapatkan juga digunakan untuk menghitung kecepatan di darat.

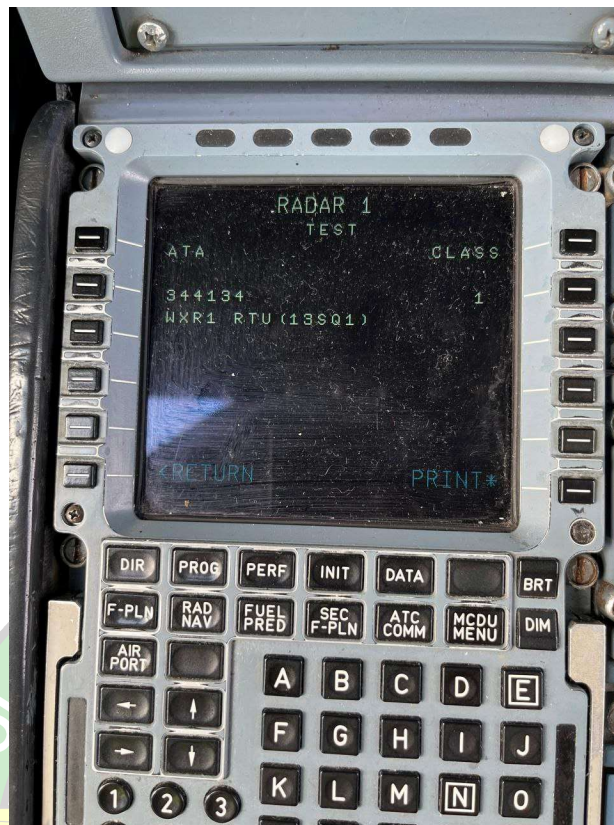
Gambar 4. 4 Weather Radar Transceiver found message (13SQ1)

Maintenance yang dilakukan sesuai dengan TSM (Troubleshoot Manual) Weather Radar Transceiver 1 Ref. TSM TASK 34-41-00-810-853-A pada gambar 4.2, Hasil BITE TEST ref. AMM 34-41-00-740-002-A menunjukkan message (13SQ1). Setelah melakukan BITE TEST, engineer dan mekanik harus melakukan *replace* XMTR/RCVR-WEATHER RADAR 1 (13SQ1) sesuai pada message MCDU pada gambar 4.4.

Selanjutnya engineer dan mekanik melakukan *replacement Weather Radar Transceiver 1* berdasarkan referensi AMM *Removal TASK 34-41-51-000-001-A* dan AMM *installation TASK 34-41-51-400-001-A*.

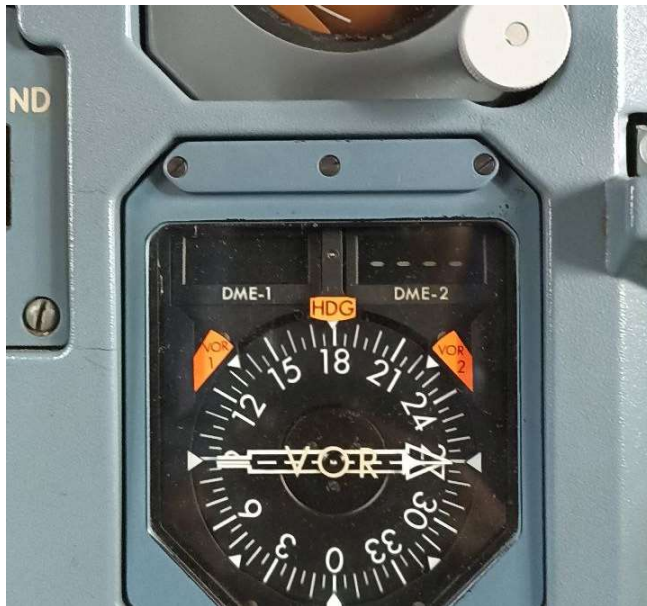
Gambar 4. 10 RMI DME 1 Left Display blanked

*Troubleshooting DME Interrogator* yang dapat dilihat pada gambar 4.9. Ketika pesawat *prolong parking* maka pesawat mendapatkan *Return to Operation Taskcard* sebelum bisa ke *Return to Service* pada pesawat Airbus A320 dengan registrasi LY – NVJ. Ditemukan RMI *left display is blanked* pada gambar 4.10

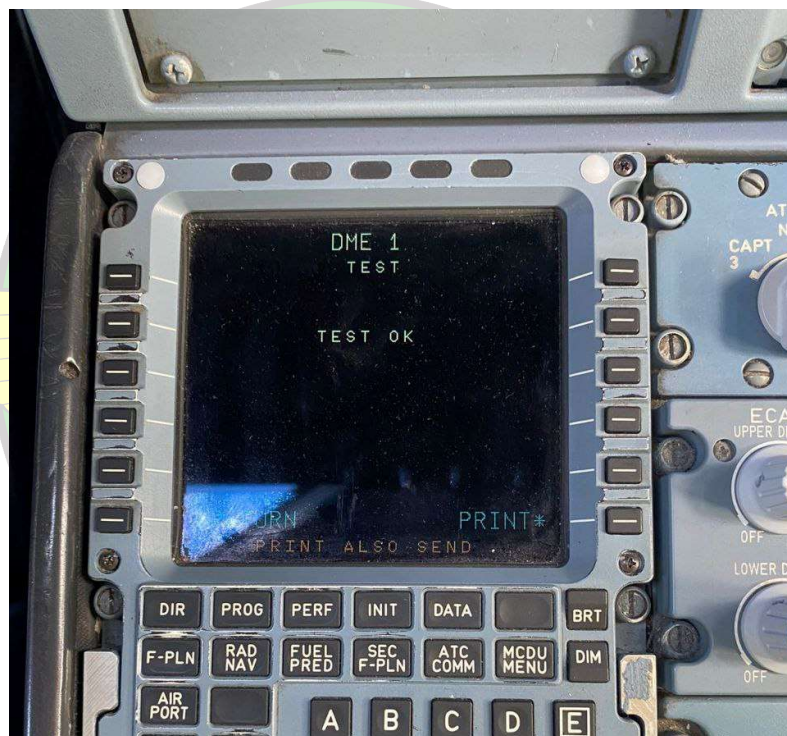
Gambar 4. 17 Hasil BITE TEST DME 1 pada MCDU

Setelah pergantian *DME Interrogator 1*, kembali dilakukan *BITE (Build In-Test Equipment) TEST* sesuai dengan referensi AMM TASK 34-51-00-740-002-A yang dapat dilihat pada gambar 4.17 bahwa hasil yang didapat adalah “Test Ok”.

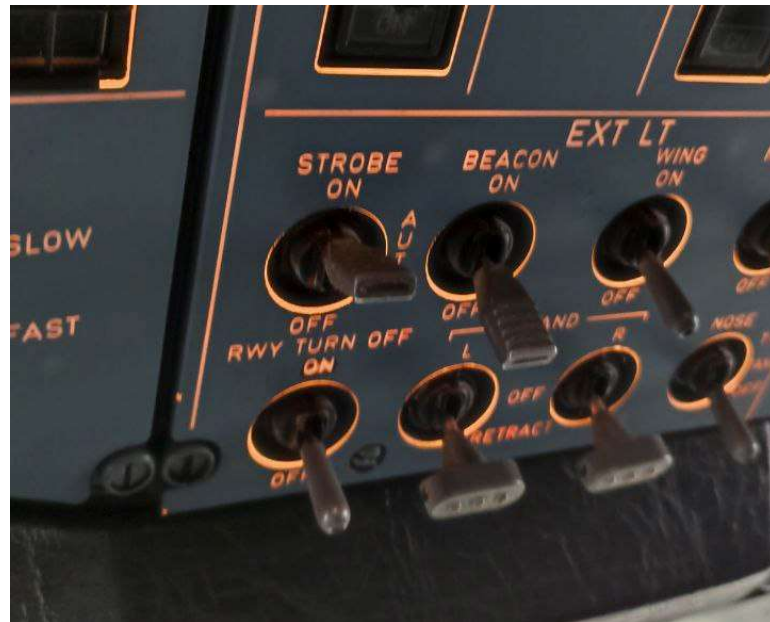
Gambar 4. 22 *Operational Test Strobe Light*

Pada gambar 4.22 sedang melakukan *operational test* pada *strobe light*

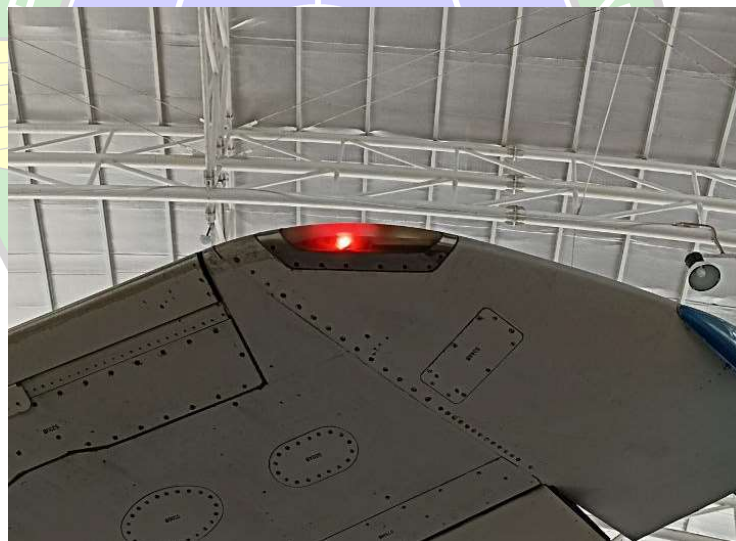
Gambar 4. 23 *strobe light does not flash*

Setelah melakukan identifikasi masalah, maka selanjutnya adalah melihat *Troubleshooting Manual* ref AMM Task 33-48-00-810-802-A pada gambar 4.24. Sehingga engineer dan mekanik harus melakukan *replacement* pada *LIGHT-STROBE, L WING TIP*

- Replace the LIGHT-STROBE, L WING TIP (17LV) Ref. AMM 33-48-14-000-001 and Ref. AMM 33-48-14-400-001.

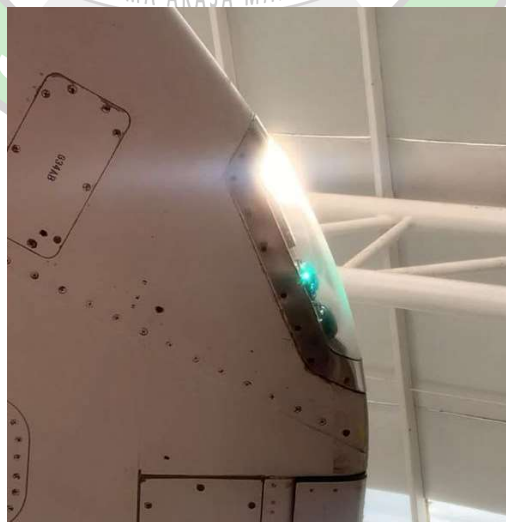
Gambar 4. 28 Strobe light sudah kembali normal

Setelah pergantian strobe light telah dilakukan maka dapat dilakukan *functional test* sesuai pada AMM Task 33-48-00-710-002-A, strobe light kembali menyala secara normal yang dapat dilihat pada gambar 4.19
