**LAPORAN ON THE JOB TRAINING**  
**DI FL TECHNICS INDONESIA – HANGGAR BALI**  
**01 April 2024 – 30 Juni 2024**

**PROGRAM STUDI DIPLOMA 3 TEKNIK PESAWAT UDARA**  
**POLITEKNIK PENERBANGAN SURABAYA**  
**2024**

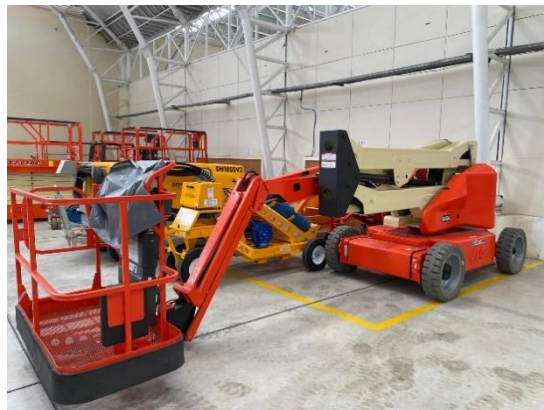
Gambar 2.14 Ground Support Equipment

Sebagai alat untuk membantu dalam pergerakan selama di hangar yaitu seperti *Towing motor*, *Boom Lift*, dan *Scissors* yang dapat dilihat pada gambar 2.14.

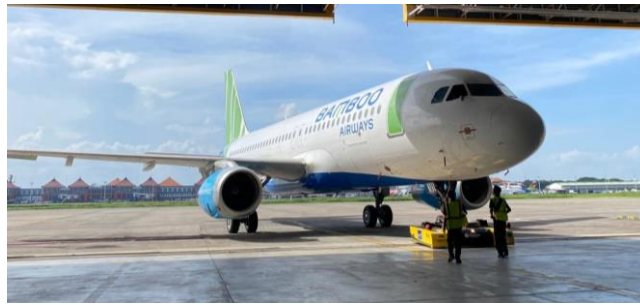
Gambar 3.1 Airbus A320

Airbus A320 adalah pesawat penumpang komersial jarak dekat sampai menengah yang diproduksi oleh Airbus. A320 merupakan pesawat penumpang pertama dengan sebuah sistem kendali *fly-by-wire* digital, di mana pilot mengendalikan penerbangan melalui penggunaan sinyal elektronik dan bukan secara mekanik dengan *handle* dan sistem *hydraulic*. Kelompok pesawat A320 (yang termasuk A318, A319, A320, dan A321, serta pesawat jet bisnis ACJ) adalah satu-satunya kelompok pesawat berbadan sempit (*narrow-body*) yang diproduksi Airbus yang dapat dilihat pada gambar 3.1.

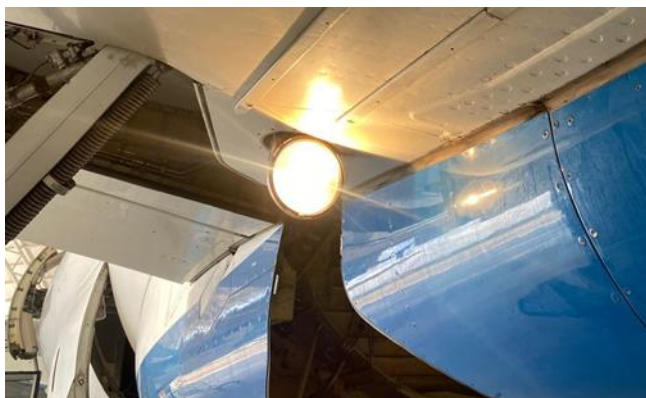
Landing Light adalah lampu yang digunakan untuk mengatur penerangan pesawat pada saat mendarat dan dikontrol oleh *switch* yang berada pada *overhead panel*. Lampu pada pesawat yang berada di *wing* sebelah kanan dan kiri yang terletak pada *leading edge wing* dekat dengan *fuselage* yang dapat dilihat pada gambar 3.5. Lampu bercahaya kearah depan dan kebawah *groundhead* dalam posisi tetap, dengan lebar pancaran 11 derajat. Lampu ini adalah tipe lampu intensitas tinggi dan pemasangan lampu tidak dirancang untuk bekerja terus menerus jika masih diudara. Daya/tegangan untuk lampu ini sebesar 115 V AC dan diperkecil oleh trafo sebesar 28 V DC.

Gambar 3.5 *Landing light*

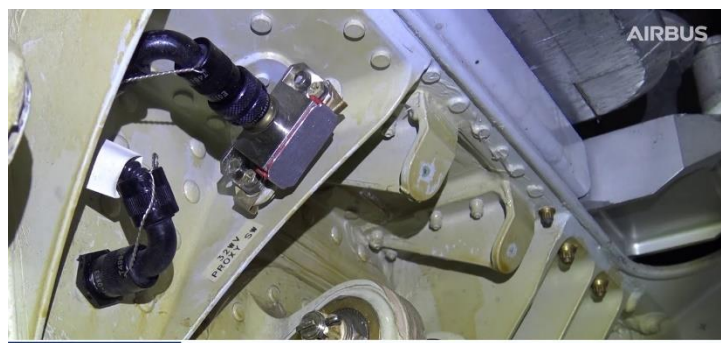
Sensor elektronik yang dapat mendeteksi keberadaan suatu objek tanpa adanya sentuhan fisik. Dapat dikatakan juga bahwa *proximity sensor* adalah sensor yang dapat mengubah informasi tentang Gerakan atau keberadaan objek menjadi sinyal Listrik, seperti pada *cargo door* setiap pergerakan *cargo door* akan terdeteksi oleh *proximity sensor* lalu *ECAM* akan memunculkan *indicator cargo door* yang dapat dilihat pada gambar 3.7.

Gambar 3.7 *Cargo Door Proximity Sensor*

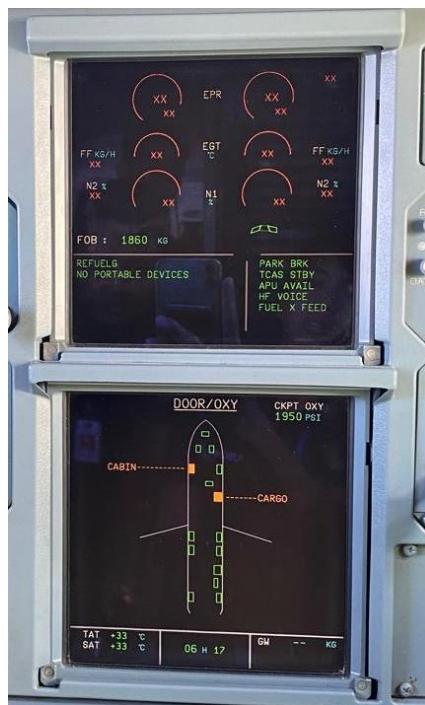
Gambar 3.9 Electronic Centralized Aircraft Monitor (ECAM)

Sistem ECAM terdiri dari dua tampilan penerbangan utama yang dikenal sebagai *Engine Warning Display (E/WD)* dan *System Display (SD)*. E/WD terutama berfokus pada sistem propulsi dan menampilkan parameter mesin yang penting, sedangkan SD memberikan gambaran umum tentang sistem sekunder pesawat. Selain itu, ECAM juga dilengkapi panel kontrol, yang memungkinkan pilot berinteraksi dengan sistem dan mengakses berbagai fungsi dan menu yang dapat dilihat pada gambar 3.9.

Salah satu keunggulan utama ECAM adalah desainnya yang intuitif dan *interface* yang mudah digunakan. Layar diberi kode warna dan menggunakan representasi simbolis untuk menyampaikan informasi dengan cepat dan efisien kepada kru pesawat. Jika terjadi situasi abnormal atau kegagalan sistem, ECAM menampilkan daftar periksa dan prosedur yang relevan, sehingga pilot dapat segera mengambil tindakan yang tepat.

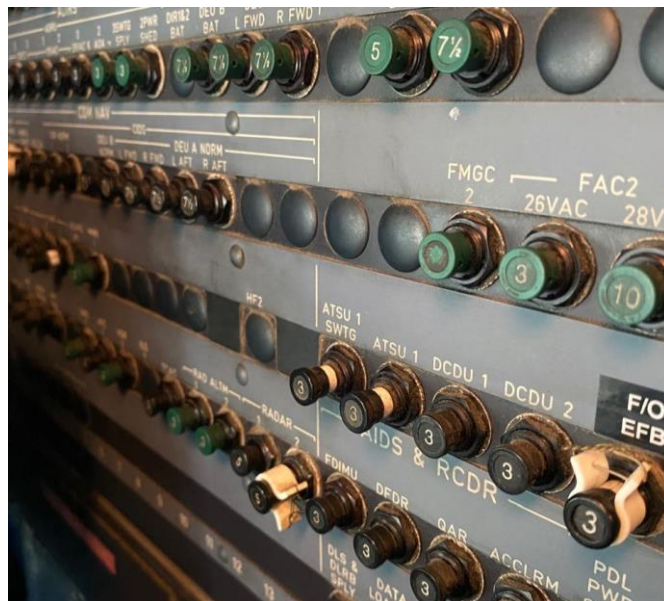
*Circuit breaker* adalah sebuah saklar elektrik yang beroperasi secara otomatis untuk memutus jalur arus listrik dari sirkuit ketika ada kondisi abnormal (tidak normal). Sehingga dapat mencegah kerusakan pada sirkuit listrik dikarenakan adanya hubungan arus pendek (korsleting) yang dapat dilihat pada gambar 3.10.

Gambar 3.10 Circuit Breaker

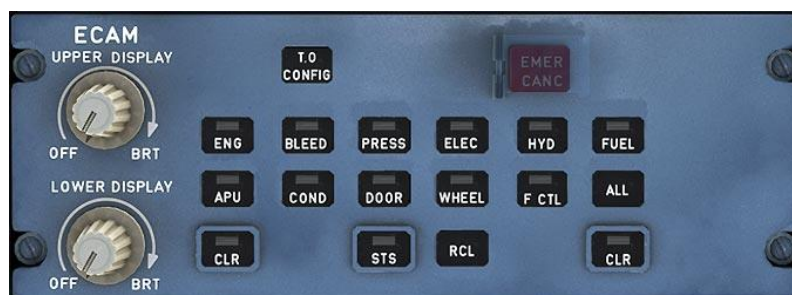
Gambar 3.11 ECAM Control Panel

Suatu alat yang digunakan untuk mengatur *display* ECAM dengan menggunakan knob yang dapat mengatur kecerahan kedua tampilan ECAM yang dapat dilihat pada gambar 3.11.

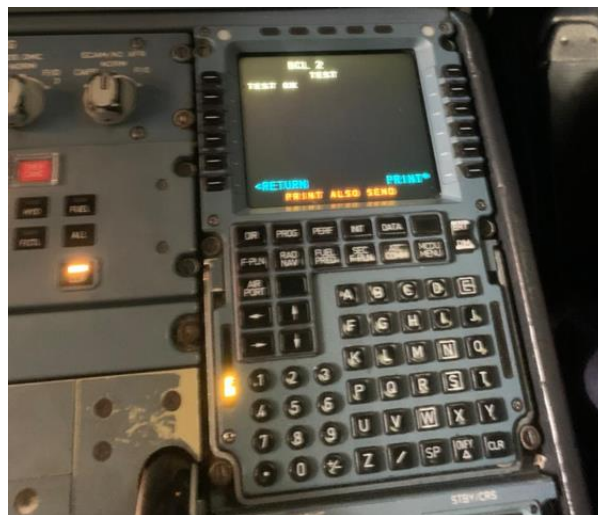
Gambar 3.12 MCDU

route navigasi, dan berkomunikasi dengan kontrol lalu lintas udara. MCDU menggunakan input pilot untuk berkomunikasi dengan FMC, yang kemudian menjalankan perintah yang diinginkan.

MCDU juga memainkan peran penting dalam komunikasi antara pilot dan kontrol lalu lintas udara. Pilot dapat mengirim dan menerima pesan, seperti meminta izin lepas landas, melaporkan posisi saat ini, atau menerima instruksi untuk menavigasi melalui wilayah udara yang padat. Pesan-pesan ini ditampilkan di layar MCDU, sehingga pilot dapat terus mendapatkan informasi terbaru dan merespons dengan tepat.

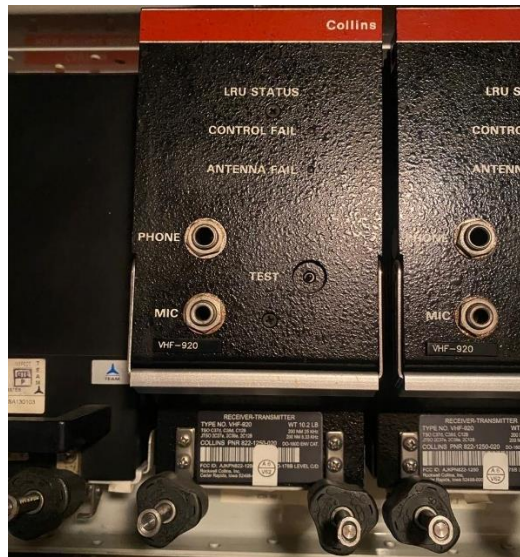
Gambar 3.13 VHF Transciever

Suatu peralatan untuk pemancar dan penerima yang digunakan untuk komunikasi antara pilot dengan ATC tower dalam bentuk suara yang bekerja pada frekuensi 108.000 MHz hingga 137.000 MHz yang dapat dilihat pada gambar 3.13.

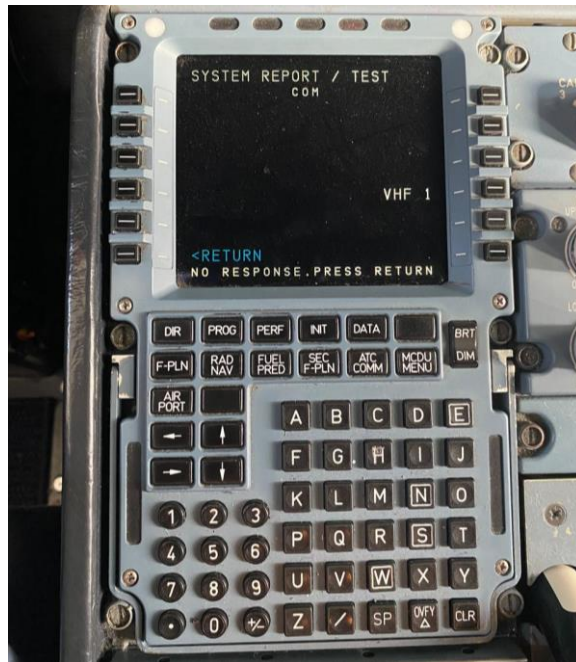
Setelah melakukan *BITE test* dengan hasil menunjukkan *VHF 1 Transceiver "system no response"* yang dapat dilihat pada gambar 4.3. *VHF 1 Transceiver system status page fault* yang dapat dilihat pada gambar 4.4. Dengan hal ini *engineer* mengambil Keputusan untuk melakukan *Non Routine Work Card* dengan *troubleshooting*.

Gambar 4.4 Invalid MCDU

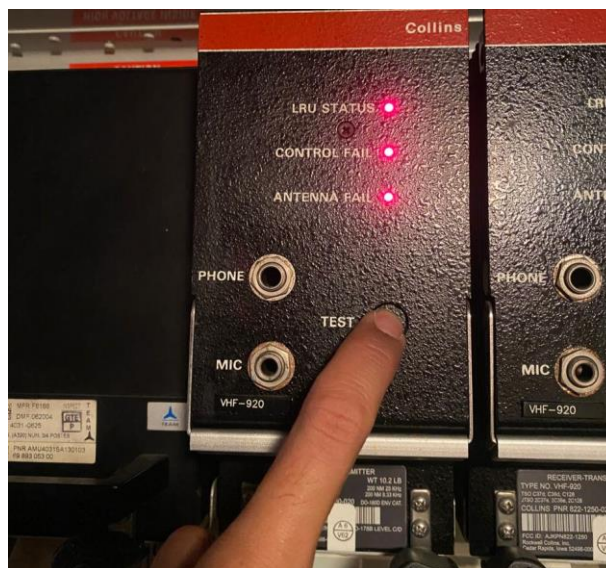
Gambar 4.5 System Status Page

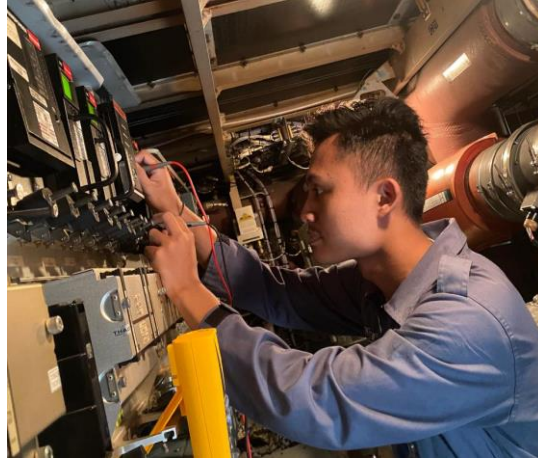
pada *connector* pin DC/2 menggunakan multimeter berdasarkan ref TSM 23-12-00-810-801-A yang dapat dilihat pada gambar 4.7

Gambar 4.7 Pengukuran VHF 1 Transciever

Setelah melakukan pengukuran maka mendapatkan hasil pengukuran yang sesuai yaitu 28 VDC sehingga berdasarkan ref TSM 23-12-00-810-801-A dilakukan *replacement VHF 1 Transceiver* berdasarkan ref AMM 23-12-33-000-001-A. Sebelum dilakukan tahapan *removal* maka dilakukan konfigurasi dengan menggunakan *tools* yaitu dengan *ACCESS PLATFORM 2M (6 FT) – ADJUSTABLE*, *CAP – BLANKING*, dan *SAFETY CLIP - CIRCUIT BREAKER* dengan tahapan sebagai berikut yaitu:

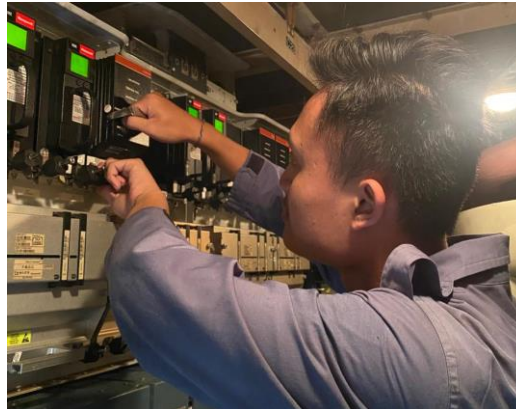
1. Loosen the nuts (3)
2. Lower the nuts (3)
3. Pull the VHF transceiver (5) on its rack (2), to disconnect the electrical connectors (1).
4. Remove the VHF transceiver (5)
5. Put CAP - BLANKING on the disconnected electrical connectors (1).

Gambar 4.10 Removal VHF 1 Transciever

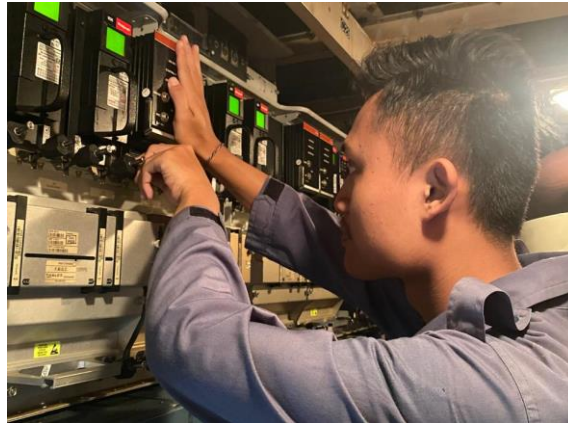
1. *Clean the component interfaces and the adjacent area.*
2. *Do an inspection of the component interfaces and the adjacent area.*
3. *Remove the blanking caps from the electrical connectors*
4. *Make sure that the electrical connectors are clean and in the correct condition.*
5. *Install the VHF transceiver on its rack*
6. *Push the VHF transceiver on its rack to connect the electrical connectors.*
7. *Engage the nuts on the lugs and tighten.*

Gambar 4.12 *Installation VHF 1 Transciever*

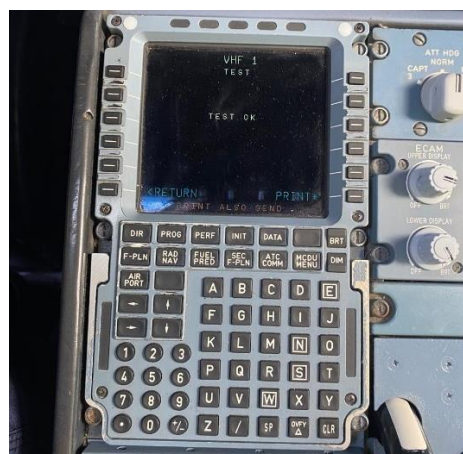
Setelah *replacement VHF 1 Transciever* maka dilakukan *functional test* berdasarkan ref AMM 23-12-33-400-001-A dengan melakukan *BITE test*, pada MCDU yang dapat dilihat pada gambar 4.13 dan tes fungsi guna memastikan *VHF 1 Tranceiver* benar-benar berfungsi secara normal.

Gambar 4.13 *Functional Test VHF 1 Transciever pada MCDU*

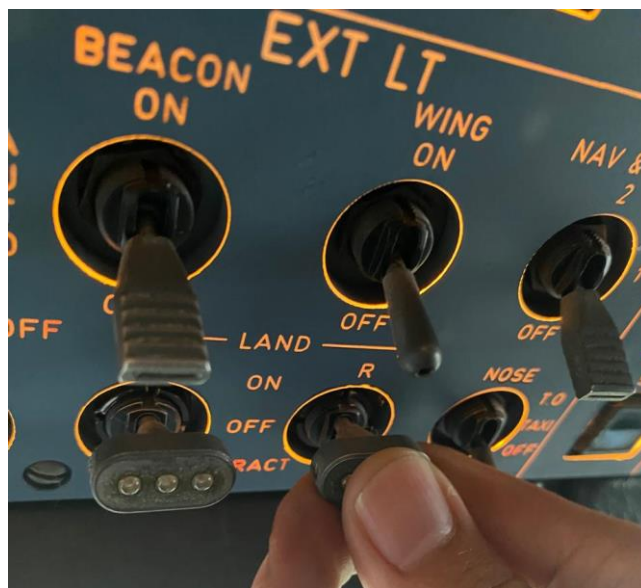
Setelah melakukan konfigurasi maka dilakukan *operational test landing light* yang dapat dilihat pada gambar 4.17

Gambar 4.17 *Operational Test Landing Light*

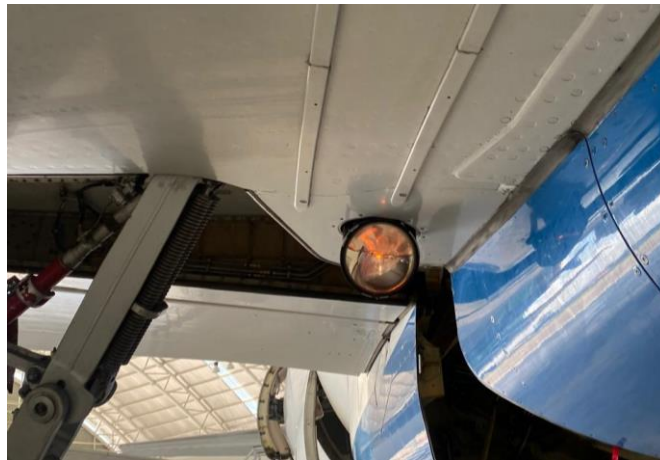
Gambar 4.21 *Landing light not illuminate*

Pada gambar 4.21 berdasarkan *operational test landing light* yang memberikan hasil yaitu *light not illuminate* maka dilakukan *rectification* dengan melakukan pengukuran pada *connector A/L* menggunakan multimeter berdasarkan ref TSM SUBTASK 33-42-00-810-051-A yang dapat dilihat pada gambar 4.22.

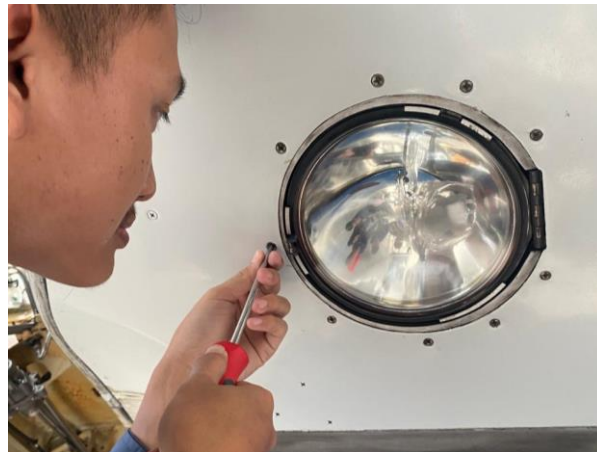
Setelah melakukan konfigurasi maka dilakukan *removal* yang dapat dilihat pada gambar 4.24 dengan tahapan sebagai berikut:

Gambar 4.24 Removal Connector Landing Light

- (a) Hold the GE sealed-beam landing-light-lamp (7) and remove the screw (5) and the clamp (6).
- (b) Examine the clamp (6). If the clamp (6) is defective remove and discard it.
- (c) Remove the GE sealed-beam landing-light-lamp (7) from the lamp housing (1) to get access to the two electrical terminals (3).
- (d) Remove the screws (2) and disconnect the two electrical terminals (3).
- (e) Remove the GE sealed-beam landing-light-lamp (7).
- (f) Examine the seal (4) on the lamp housing (1).
- (g) If the seal (4) is defective, remove and discard it.

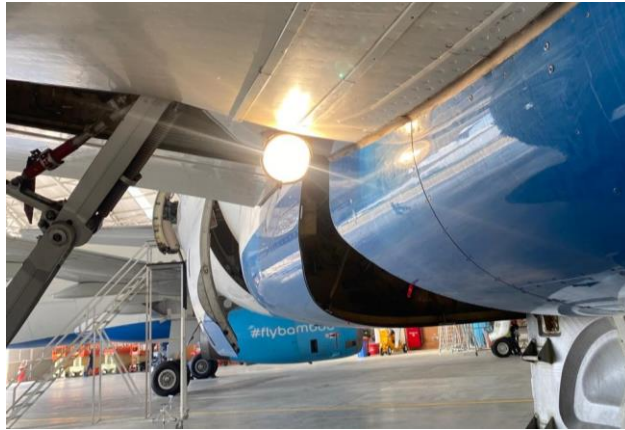
Setelah *replacement Landing Light* maka dilakukan *functional test* berdasarkan ref AMM 33-42-00-710-001-A pada *landing light* yang dapat dilihat pada gambar 4.28. Dan tes guna fungsi guna memastikan *landing light* benar – benar berfungsi secara normal.

Gambar 4.28 *Functional Test Landing Light*

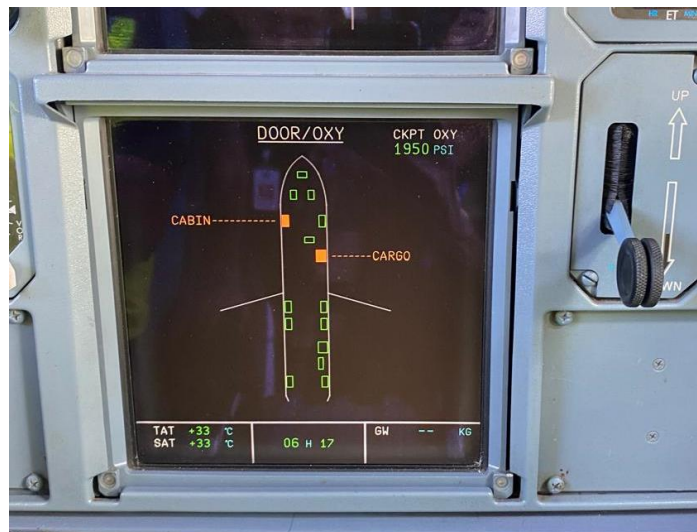
Berdasarkan ref TSM TASK 52-31-00-810-801-A setelah melakukan *EIS Start Procedure* maka dilakukan *rectification* dengan melakukan *operational test open and close FWD Cargo Door Compartment* yang dapat dilihat pada gambar 4.33.

Gambar 4.33 Operational Test FWD cargo door proximity sensor

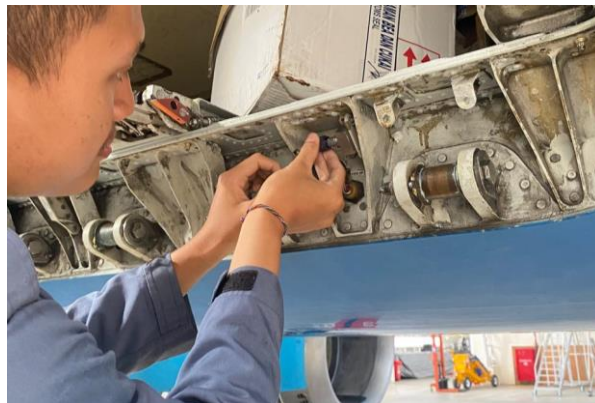
Berdasarkan ref TSM SUBTASK 52-31-00-710-050-A Setelah melakukan *operational test* yaitu dilakukan pengecekan pada ECAM dengan hasil yang didapat yaitu *FWD Cargo door proximity sensor indicator* berwarna amber sedangkan kondisi *FWD Cargo Door Compartment* yang sebenarnya *FWD cargo door tertutup*. Sehingga dilakukan pengecekan *connector proximity sensor* yang dapat dilihat pada gambar 4. 38

Gambar 4.38 *Connector proximity sensor check*

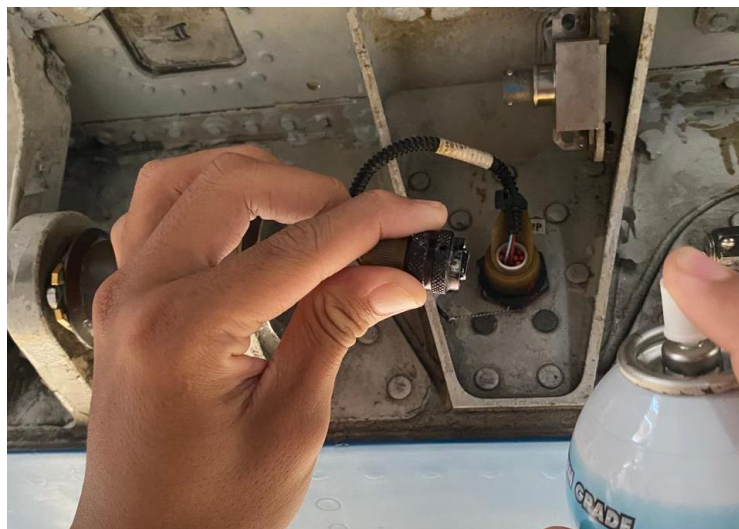
Setelah dilakukan pengecekan sehingga mendapatkan hasil *connector proximity sensor* kotor maka sesuai dengan ref ESPM 20-50-00 yaitu harus melakukan pembersihan *connector* menggunakan *contact cleaner* yang dapat dilihat pada gambar 4.39.

Gambar 4.39 Pembersihan *connector proximity sensor*
