**LAPORAN HASIL ON THE JOB TRAINING  
PESAWAT BOEING 737-900 ER  
PT. BATAM AERO TECHNIC**

**Tanggal 10 April – 30 Juni 2024**

**PROGRAM STUDI DIPLOMA 3 TEKNIK PESAWAT UDARA  
POLITEKNIK PENERBANGAN SURABAYA  
2024**

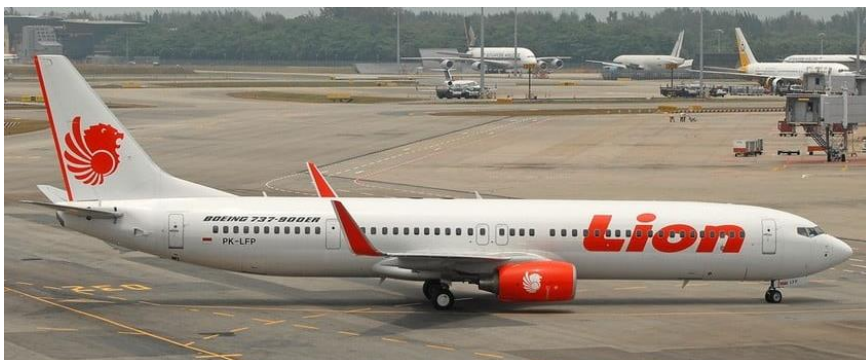
1. Rentang sayap : 35.79 m
2. Panjang : 42.1 m
3. Kecepatan jelajah : 823 km/j
4. Jangkauan maks. : 6.045 km
5. Penumpang maks. : 220
6. *Average seat pitch europe bussiness class* : 33 inci/ 84 cm
7. Rata-rata Jarak ke kursi depan untuk kelas ekonomi : 30 inci/ 76 cm

Gambar 3. 1 Boeing 737-900ER (Sumber: 737-900ER\_Lion\_Air\_Spijkers.jpg)

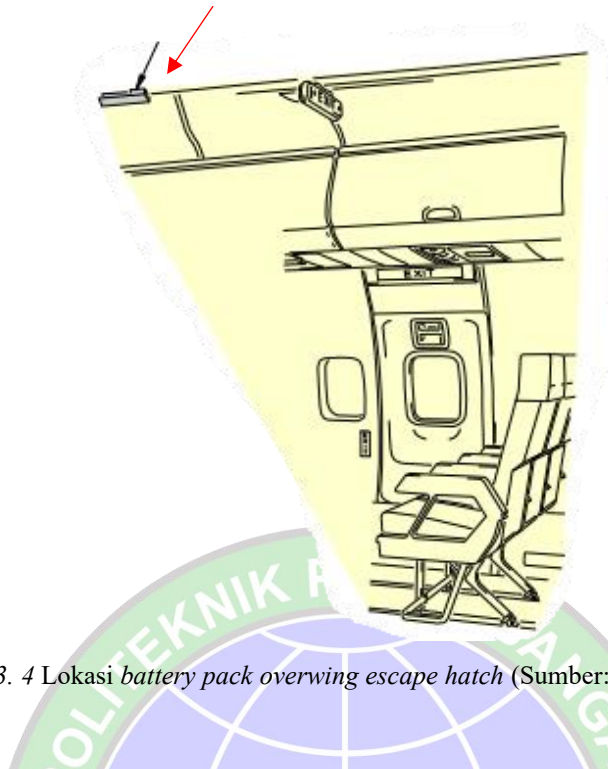
Gambar 3. 4 Lokasi battery pack overwing escape hatch (Sumber: AMM 33-51-06)

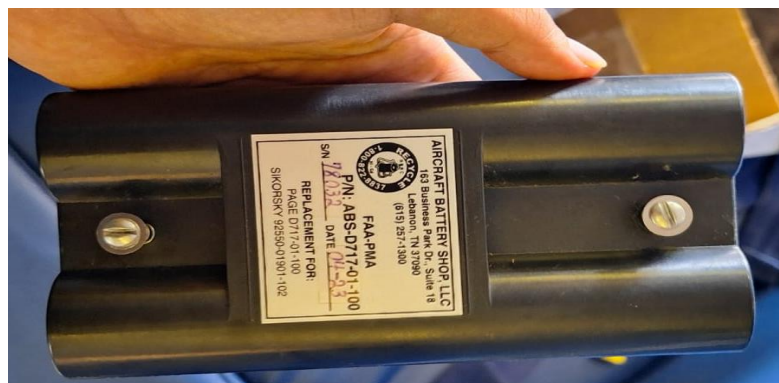
Gambar 3. 6 Battery Pack (Sumber: dokumentasi pribadi)

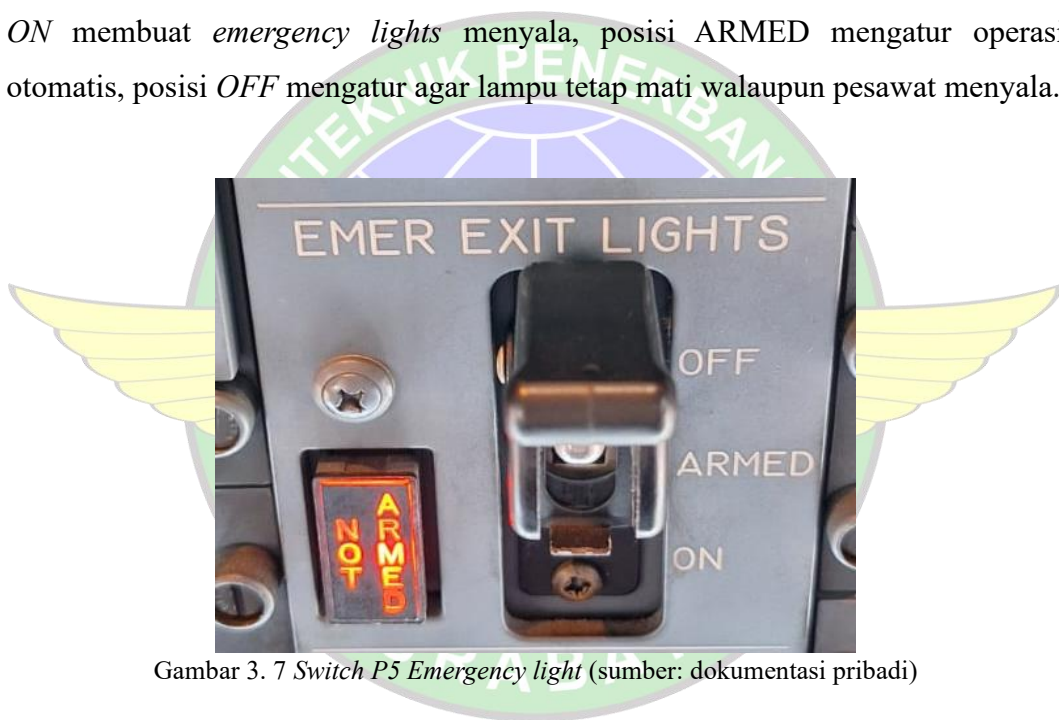
*Emergency exit light switch* terletak pada P5 *forward overhead* panel atau pada attendant panel. *Switches* control tersebut digunakan untuk mengoperasikan *emergency lights*. *Emergency exit light switch* pada P5 panel memiliki beberapa komponen:

- ON - *emergency lights* menyala
- OFF – mencegah operasi otomatis
- ARM – menyiapkan sistem untuk operasi otomatis

28 V DC bus 1 memberi daya ke indication lights ini. *Emergency exit switch* yang berada di attendant panel memiliki 3 posisi, ON , ARMED dan OFF. Posisi *ON* membuat *emergency lights* menyala, posisi ARMED mengatur operasi otomatis, posisi *OFF* mengatur agar lampu tetap mati walaupun pesawat menyala.

Gambar 3. 7 Switch P5 *Emergency light* (sumber: dokumentasi pribadi)

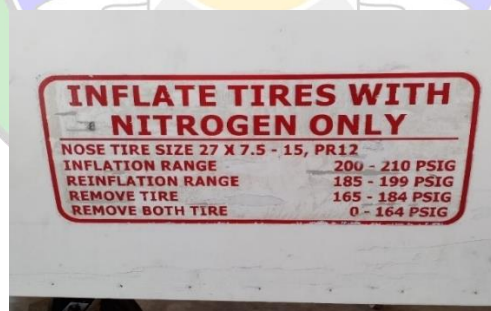
- *Nose Wheel* (roda depan): Sekitar 200-210 psi (PSIG)
- *Main Wheels* (roda utama): Sekitar 200-210 psi (PSIG)

Gambar 3. 12 Nose Wheel Pound per square inch gauge. (sumber: dokumentasi pribadi)

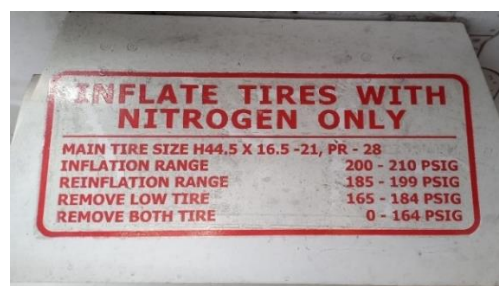
Gambar 3. 13 Main Wheel Pound per square inch gauge.(sumber: dokumentasi pribadi)

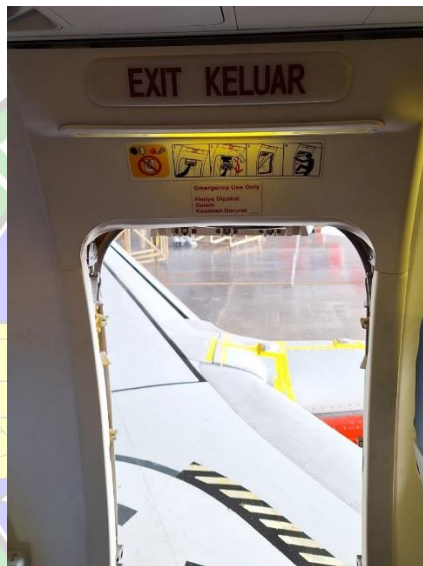
Pada tanggal 5 April 2024 dilakukan kegiatan berupa general visual inspection pada emergency light yang ada di kabin pesawat. Kegiatan ini merupakan bagian dari C- check pada pesawat Thai lion Boeing 737-800 dengan kode registrasi HS-LUZ. Pada saat dilakukan inspeksi ditemukan permasalahan pada *emergency light escape hatch left overwing* yaitu tidak dapat menyala.

Gambar 4. 4 *Emergency Light Escape Hatch* (sumber: dokumentasi pribadi)

Berdasarkan FIM 33-50 Task 801 yang ditunjukkan pada lampiran 14 terdapat dua possible cause yang menyebabkan lampu tidak dapat menyala diantaranya circuit breaker, wiring dan battery pack (Reff: FIM FIM 33-50 Task 801). Dalam pelaksanaannya engineer menemukan emergency exit light not illuminate pada escape hatch.

1. Pada *emergency light escape hatch* ini telah dilakukan nya replacement part dari *battery pack* nya, karena setelah dilakukanya pengecekan sesuai dengan FIM (Fault Insulation Manual) telah ditemukanya kerusakan pada *battery pack* nya dan harus digantikan dengan part yang baru.

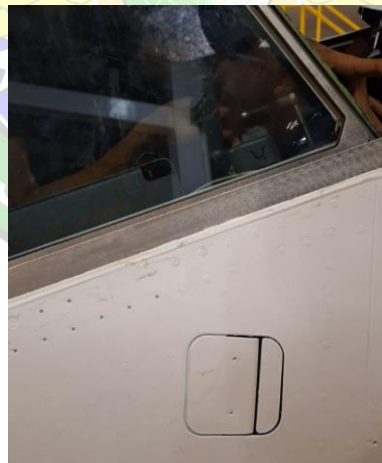
Pada tanggal 18 Mei 2024 dilakukan kegiatan berupa general visual inspection pada emergency light yang ada di kabin pesawat. Kegiatan ini merupakan bagian dari C- check pada pesawat Boeing 737-900ER dengan kode registrasi PK-LFO. Pada saat dilakukan inspeksi ditemukan permasalahan pada *emergency exit window* yaitu tidak dapat berfungsi.

*Gambar 4. 8 Lokasi emergency exit window (sumber: sumber pribadi)*

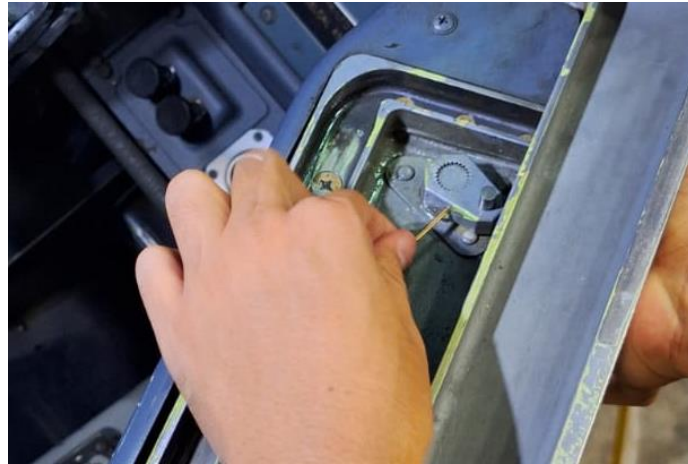
Gambar 4. 10 *Emergency Exit Release Adjustment* (sumber: dokumentasi pribadi)

Pada permasalahan kali ini terdapat kemungkinan yang bisa dilakukan performance untuk mengatasi troubleshoot yang terjadi, Melakukan adjusment pada bagian camshaft pin.

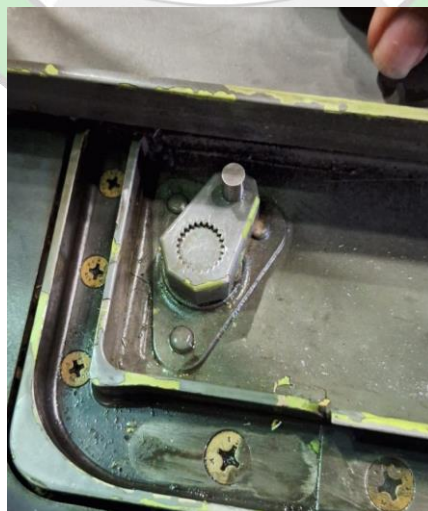
Gambar 4. 11 Lokasi *Camshaft* (sumber: dokumentasi pribadi)

Kegiatan Operational Check dilakukan setelah adjusment selesai. Operational check dilakukan oleh engineer berdasarkan referensi AMM 56-12-11-710-803 yang ditunjukkan pada lampiran 5. Engineer akan melakukan double check dan memastikan pemasangan window lights sesuai dengan prosedur, setelah dilakukannya Setelah dilakukan adjustment berdasarkan referensi AMM (Aircraft Maintenance Manual) TASK 56-12-11 pada lampiran 6, didapatkan hasil dengan kembalinya berfungsi *emergency window* dengan baik.

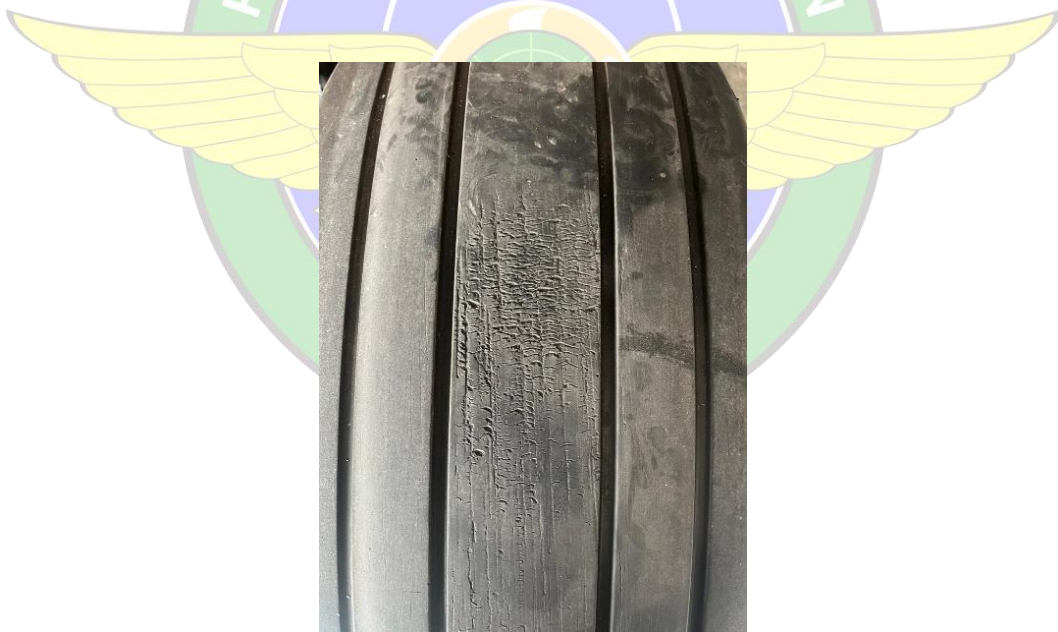
Kegiatan Inspection ini yang dilakukan mechanic ini digunakan untuk melihat kelengkapan bagian dari struktur yang mudah dilihat, untuk mengetahui apakah terdapat korosi, crack, dan mengukur tekanan tier tetap pada 200-210 PSIG (Pound per square inch gauge) untuk memastikan semua tire is good condition. Pada gambar 4.12 ditemukan deepcut pada tire sehingga perlu dilakukan replacement wheel dengan yang baru.

Gambar 4. 12 *Pound per square inch gauge* (sumber: dokumentasi pribadi)

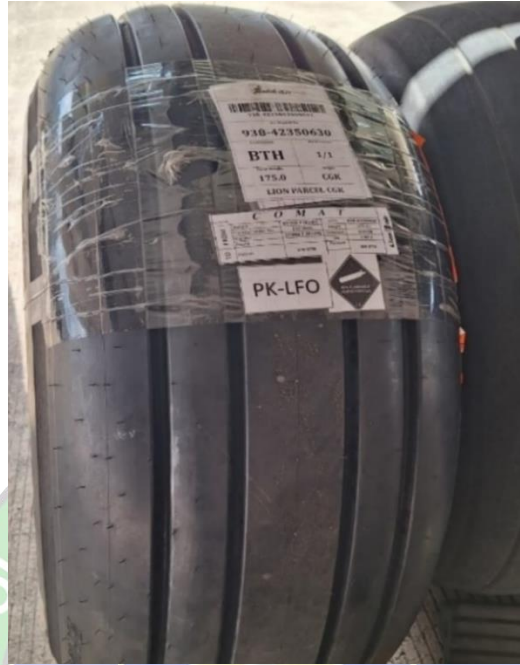
Gambar 4. 13 *Wheel PK-LFO* (sumber: dokumentasi pribadi)

number dari tire tersebut. Setelah dilakukan pemasangan dengan Tire yang baru, Main Landing Gear dapat beroperasi dengan maksimal dan safety.

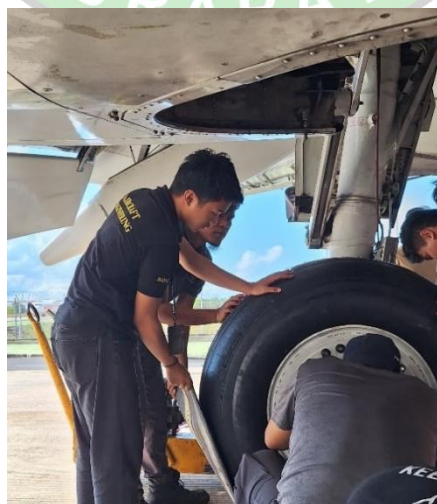
Gambar 4. 14 *Diassembly wheel* (sumber: dokumentasi pribadi)

Kegiatan *removal* yaitu membuka *access* main landing gear *wheel*. Procedure membuka main landing gear wheel tersebut yang sudah tertera pada AMM 32-45-11-400-801 pada lampiran 8, lalu mekanik melakukan *Detail Visual Inspection* pada main landing gear (L/H).

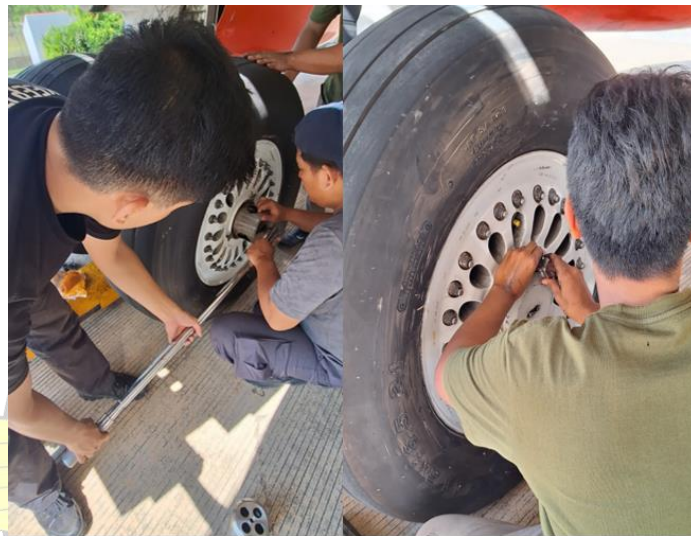
Gambar 4. 15 Servicing replacement wheel (sumber: dokumentasi pribadi)

Pada Kegiatan *installation* yaitu memasang dan menutup access pada bagian Main Landing Gear. Saat melakukan proses pemasangan Main Landing Gear Wheel and Tire, engineer dan mechanic harus memperhatikan ketepatan dan kesesuaian agar tidak terjadi kesalahan yang tidak diinginkan dapat dilihat pada lampiran 9.

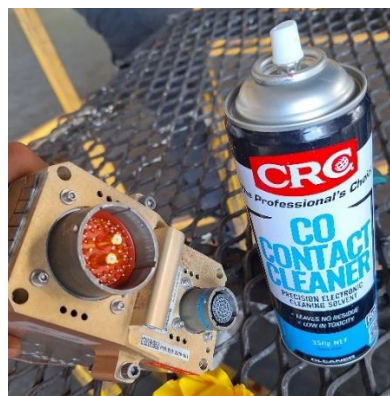
Gambar 4. 17 *Contact Cleaner* (sumber: dokumentasi pribadi)

- a) Perform an inspection of the Weather Radar Receiver/Transmitter from dust.
- b) Perform a cleaning of the connectors before installation.

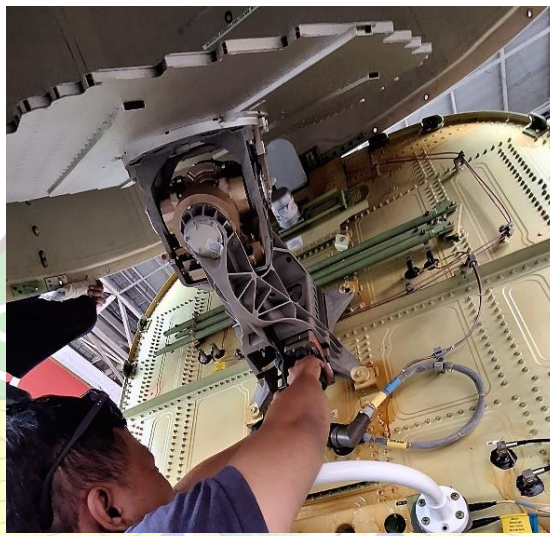
Gambar 4. 18 *Weather Radar Receiver/Transmitter Installation* (sumber: dokumentasi pribadi)

- c) Make sure the circuit breakers are open and have safety tags.
  - d) Remove the protective cover from the electrical connector.
  - e) To install the Receiver/Transmitter, perform the following tasks:
    - Attach the receiver/transmitter to the Antenna Drive Unit.
    - Tighten the captive screw to 30-35 pound-inches.
    - Connect the electrical connector.
1. Return the aircraft to its usual condition, close the radome access panel.

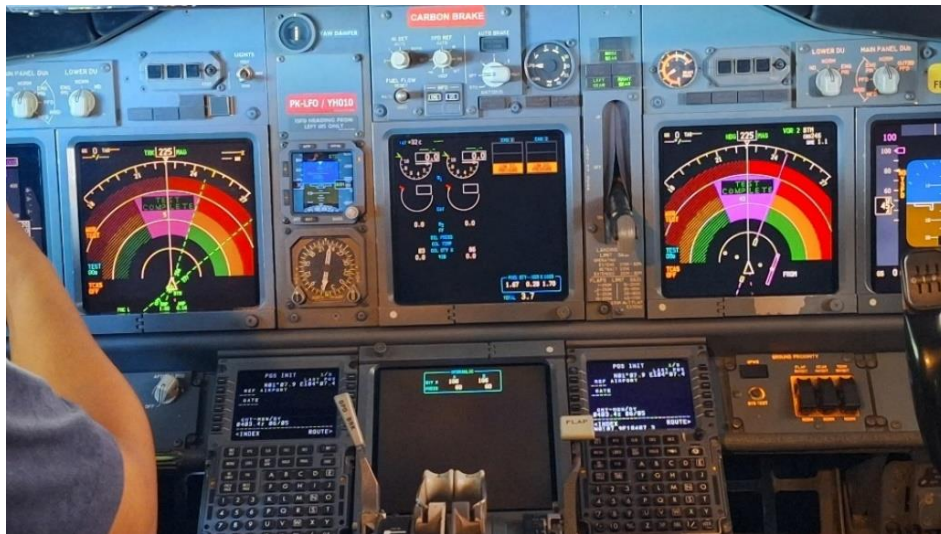
Gambar 4. 19 *Display weather radar* (sumber: dokumentasi pribadi)

Kegiatan Operational Check dilakukan setelah weather radar receiver/transmitter pada pesawat selesai dipasang. Operational check dilakukan oleh engineer berdasarkan referensi AMM 34-43-42-400-801 pada lampiran 12. Engineer akan melakukan double check dan memastikan pemasangan weather radar receiver/transmitter sesuai dengan prosedur, setelah dilakukannya pergantian part weather radar receiver/transmitter yang baru, didapatkan hasil dengan kembalinya berfungsi *display* weather radar.

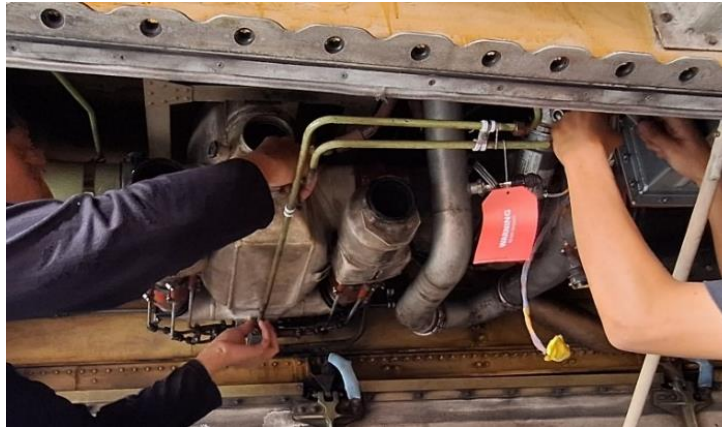
Gambar 4. 20 *Remove reheater from the frame assembly* (sumber: dokumentasi pribadi)

Sebelum melakukan removal reheater kita harus mengikuti prosedur yang telah di jelaskan pada AMM (Aircraft Maintenance Manual) pada lampiran 11 AMM 21-51-13-000-801 bagaimana cara melakukan removal/installation reheater.

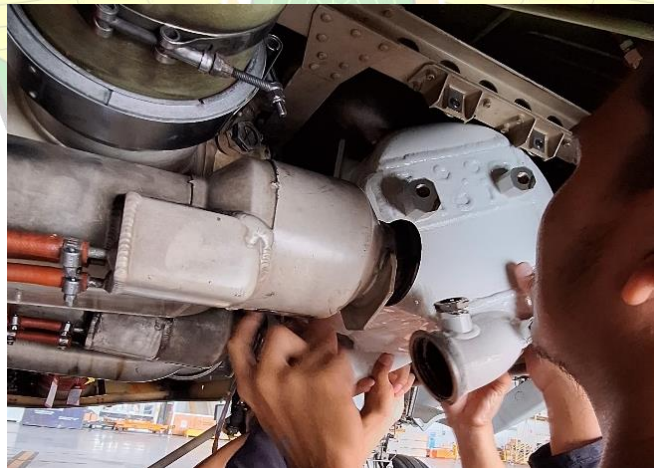
Gambar 4. 21 *Install the reheater on the frame assembly* (sumber: dokumentasi pribadi)

Pada Kegiatan *Installation* yaitu memasang dan menutup kembali. Saat melakukan proses pemasangan reheater, engineer dan mechanic harus memperhatikan ketepatan dan kesesuaian agar tidak terjadi kesalahan yang tidak diinginkan, prosedur re-assembly harus dilakukan sesuai dengan AMM 21-51-13-400-801 pada lampiran 11.
