**LAPORAN *ON THE JOB TRAINING* ATR 72-500/600  
PT. BATAM AERO TECHNIC**

**Tanggal 1 April – 30 Juni 2024**

**PROGRAM STUDI DIPLOMA 3 TEKNIK PESAWAT UDARA  
POLITEKNIK PENERBANGAN SURABAYA  
2024**

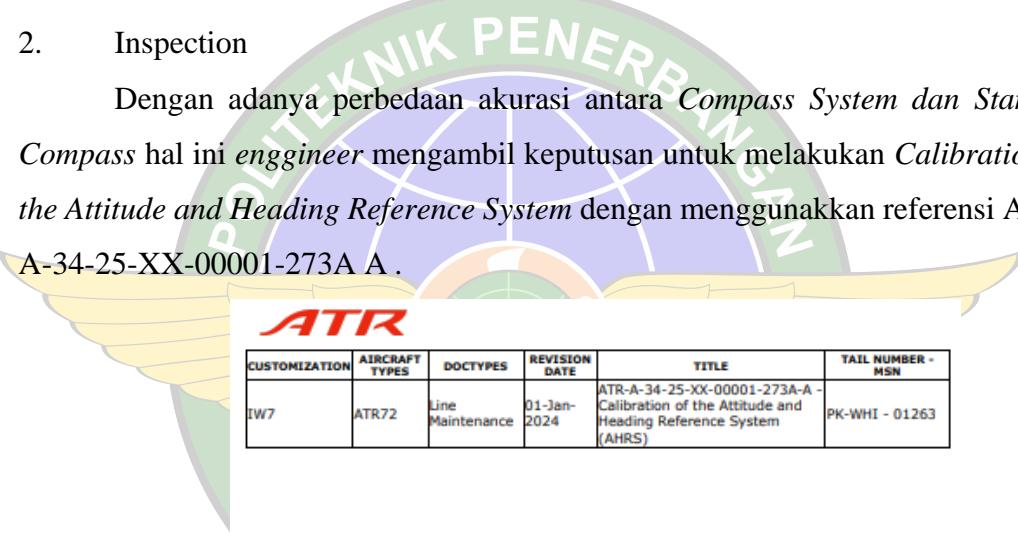
Dengan adanya perbedaan akurasi antara *Compass System* dan *Standby Compass* hal ini engineer mengambil keputusan untuk melakukan *Calibration of the Attitude and Heading Reference System* dengan menggunakan referensi ATR-A-34-25-XX-00001-273A A.

CUSTOMIZATION	AIRCRAFT TYPES	DOCTYPES	REVISION DATE	TITLE	TAIL NUMBER - MSN
IW7	ATR72	Line Maintenance	01-Jan-2024	ATR-A-34-25-XX-00001-273A-A - Calibration of the Attitude and Heading Reference System (AHRS)	PK-WHI - 01263

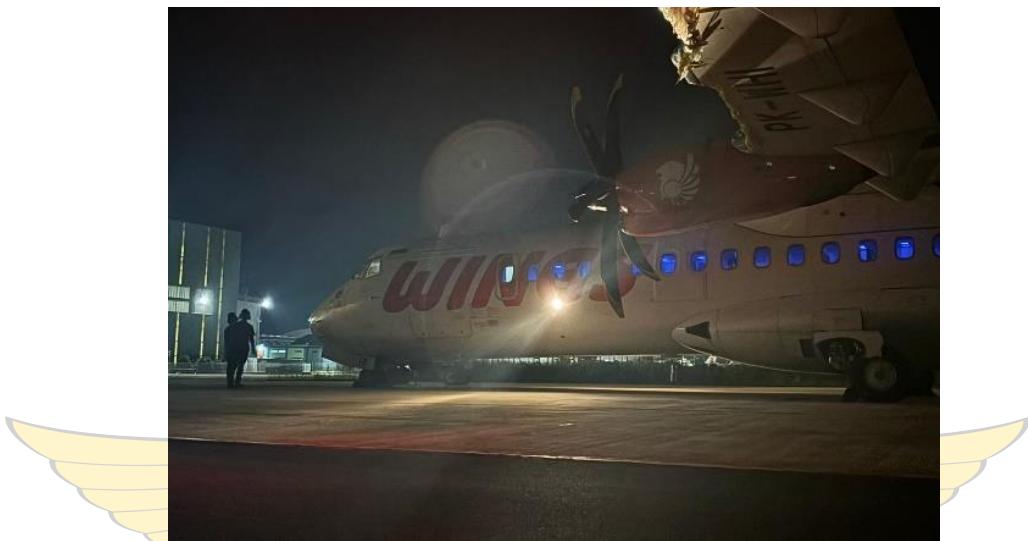
Gambar 4.3 Preparation for swing compass

Setelah melakukan identification dan inspection permasalahan maka dilanjutkan adalah melakukan *swing compass* untuk mengkalibrasi sistem kompas pada pesawat. Pada pesawat ATR 72-600 swing compass masih menggunakan swing konvensional dimana prosedur untuk memperoleh referensi heading magnetik, dengan compass-base yang berupa *master compass*.

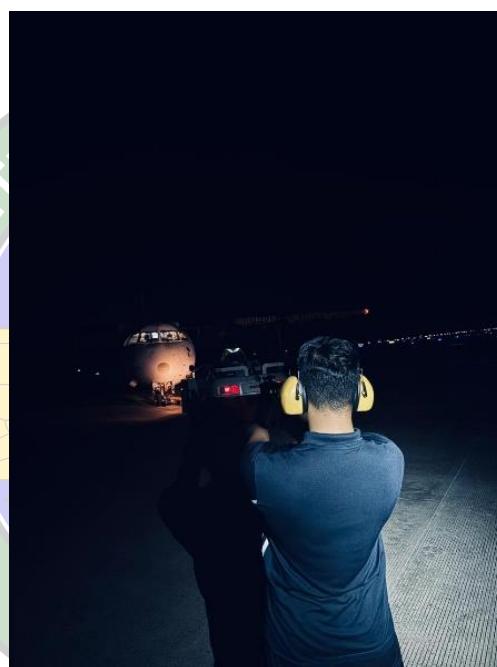
Gambar 4.5 Pelaksanaan *Swing Compass*

Pesawat lain tidak boleh berada dalam jarak kurang dari 100 yard. Personil yang melakukan kalibrasi tidak boleh membawa alat atau benda yang mengandung baja. Alat baja, pisau, dan sebagainya harus disingkirkan dari personil dan operator di kokpit. Pesawat harus diperiksa untuk memastikan semua peralatan terpasang dengan benar, dan tidak ada alat atau benda magnetik yang tertinggal di dalam pesawat.

Data yang dicatat adalah referensi heading yaitu master compass, AHRS *magnetic heading* dan *Standby compass magnetic heading*, selanjutnya kalibrasi dilakukan pada AHRS1, AHRS2, dan *standby compass* sesuai dengan SUBTASK 3425XX-50000020002, SUBTASK 3425XX-50000030002, SUBTASK 3425XX-50000040002, dan SUBTASK 3425XX-50000050002

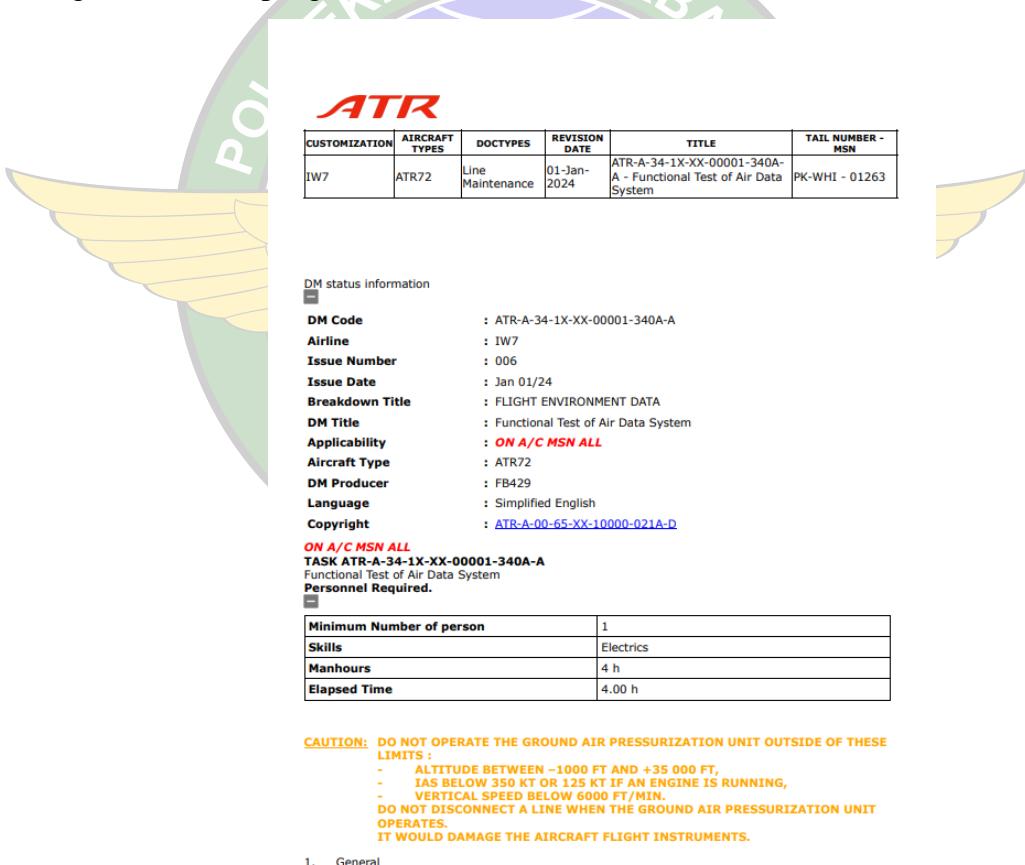
Gambar 4.1 Task Card Functional Test of Air Data System AMM TASK ATR-A-34-1X-XX-00001-340A-A

Pada saat pengerajan maintenance C Check pesawat ATR72-600/500 dengan registrasi PK-WHI terdapat *taskcard Functional Test of Air Data System*. Test ini dilakukan untuk mengecek air data system bekerja dengan baik dan sesuai dengan instrumen pengukuran.

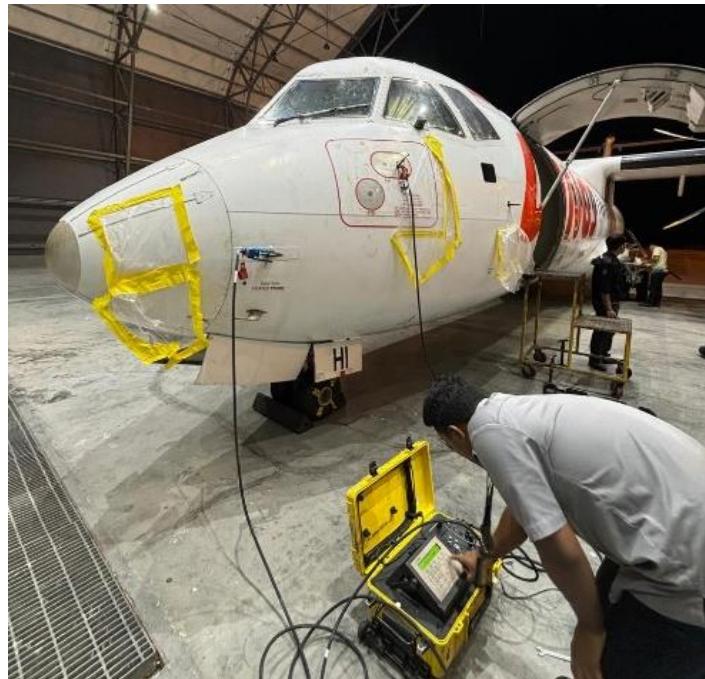
Gambar 4.2 *Install Pitot-Static Tester*

Pelaksanaan Functional Check dilakukan oleh engineer sesuai dengan task yang akan diperform, untuk langkah awal adalah dengan memberikan daya electrical AC, DC, dan ACW pada pesawat dan memastikan aliran udara pada electronics rack memadai untuk mengaktifkan *EXHAUST MODE* dengan cara menekan tombol yang berada pada *overhead panel* 22VU sesuai SUBTASK 341XXX-10100280001. Prosedur berikutnya adalah menyiapkan pemasangan *pitot-static tester* pada pesawat pada Gambar 4.7 dan *decade box* pada *temperatur probe connector* pin J dan E yang dapat dilihat pada Gambar 4.8 dan Gambar 4.9.

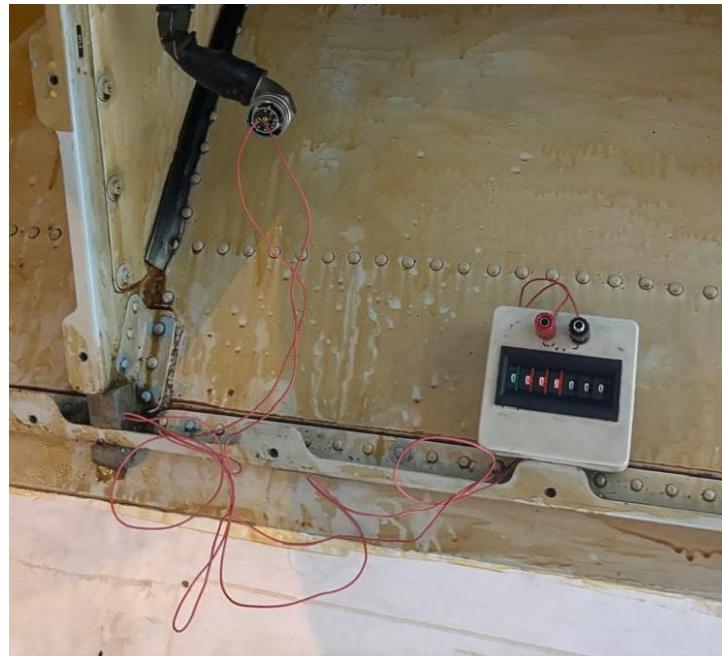
Gambar 4.4 Pemasangan Decade Box

*Functional test* dilakukan pada ADC1 (ADC2) *Pressure system, Total Air Temperature System, dan Leakage test* dari *Air Data System*. *Functional test* dilakukan oleh engineer sesuai prosedur TASK ATR-A-00-65-XX-10000-021A-D dan hasil yang didapat dicatat sesuai tabel yang ada pada ICN-ATR-A-341000-A-FB429-00U61-A-002-01 dan ICN-ATR-A-341000-A-FB429-00U62-A-002-01.

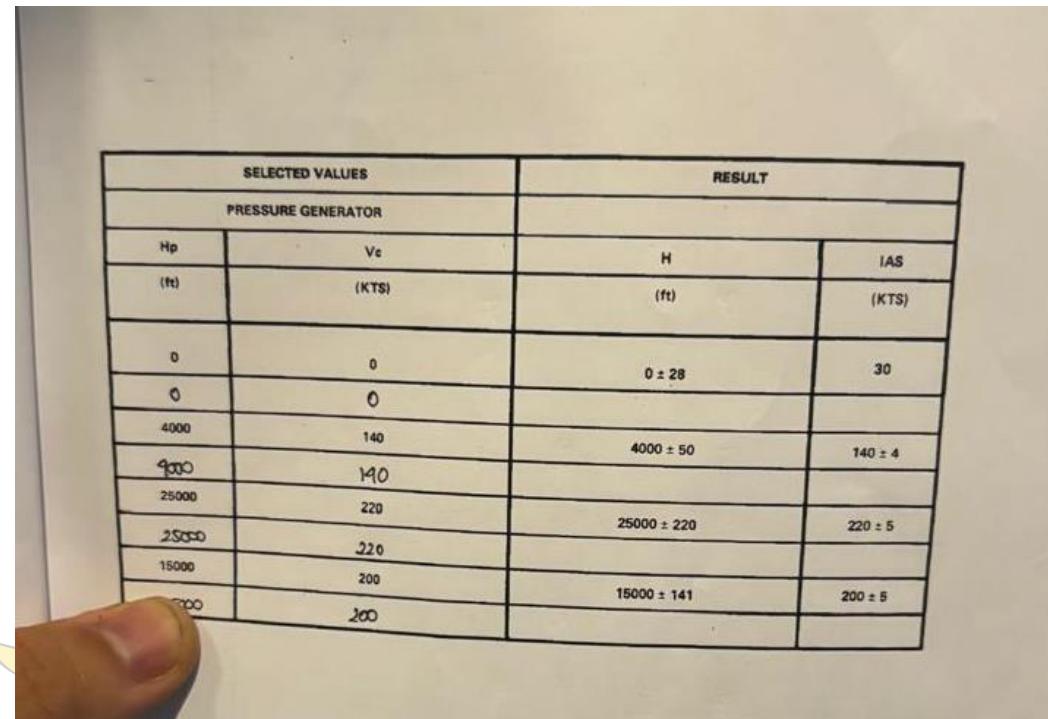
Gambar 4.6 Table of Values for Standby Air Data System AMM ATR-A-34-1X-XX-00001-340A-A

SELECTED VALUES		RESULT	
PRESSURE GENERATOR			
Hp (ft)	Ve (KTS)	H (ft)	IAS (KTS)
0	0	0 ± 28	30
0	0		
4000	140	4000 ± 50	140 ± 4
9000	140		
25000	220	25000 ± 220	220 ± 5
25000	220		
15000	200	15000 ± 141	200 ± 5
30000	200

Dari hasil yang didapat dan dicatat pada *table of values* pada gambar 4.10 dan 4.11 saat melakukan functional test dari *result* dan *tolerance* pada *table of value* memenuhi syarat tolerance dan dapat disimpulkan tidak adanya leak dan akurasi pada air data system masih memenuhi syarat dalam AMM ATR-A-34-1X-XX-00001-340A-A.

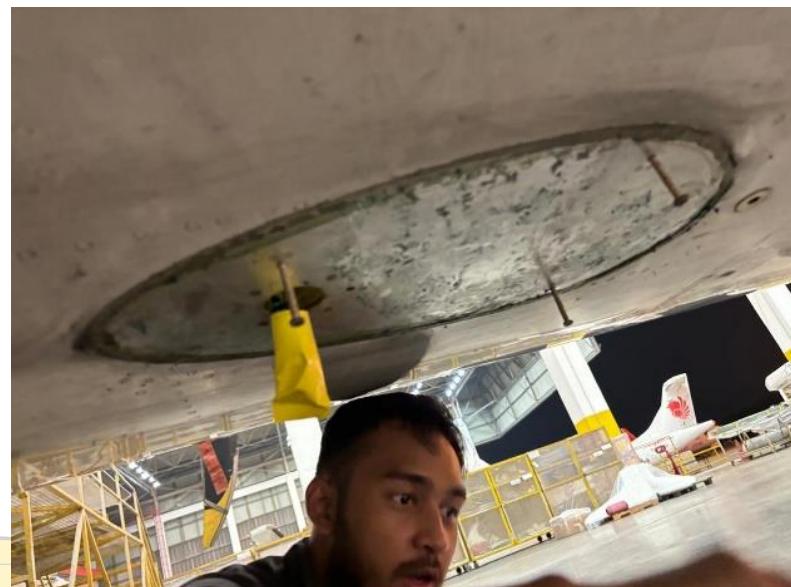
Gambar 4.8 Removal ADE Antenna

Untuk melakukan visual inspection dilakukan *removal* pada *navigation antennas* dan *connectors* sesuai SUBTASK 34XXXX-6000050001 pada saat pelaksanaan taruna membantu melepas antenna ADF.

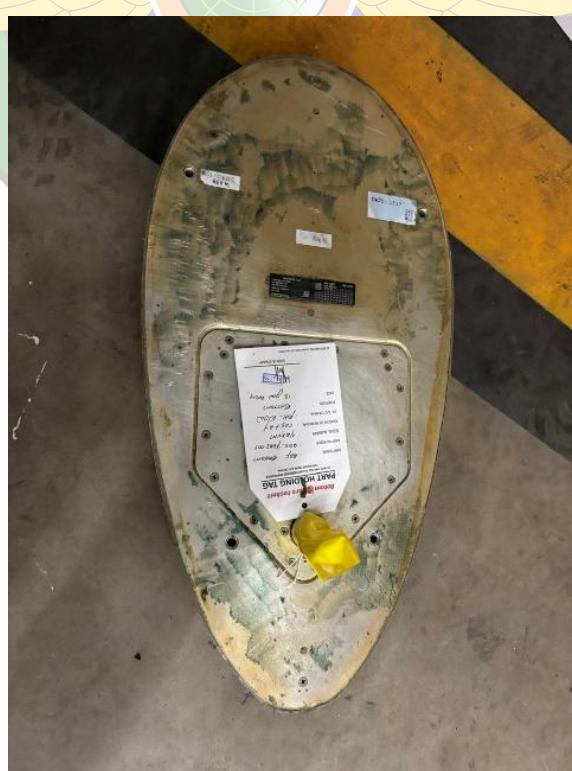
Gambar 4.9 *ADF Antenna*

Sebelum melakukan *visual inspection* ADF antenna harus dibersihkan dari bekas sealent dan gasket sebelumnya. Pada *visual inspection* pada antenna ADF tidak ditemukan adanya corrosion pada antenna dan connector. Visual Inspection dilakukan oleh engineer pada saat pelaksanaan C-Check .

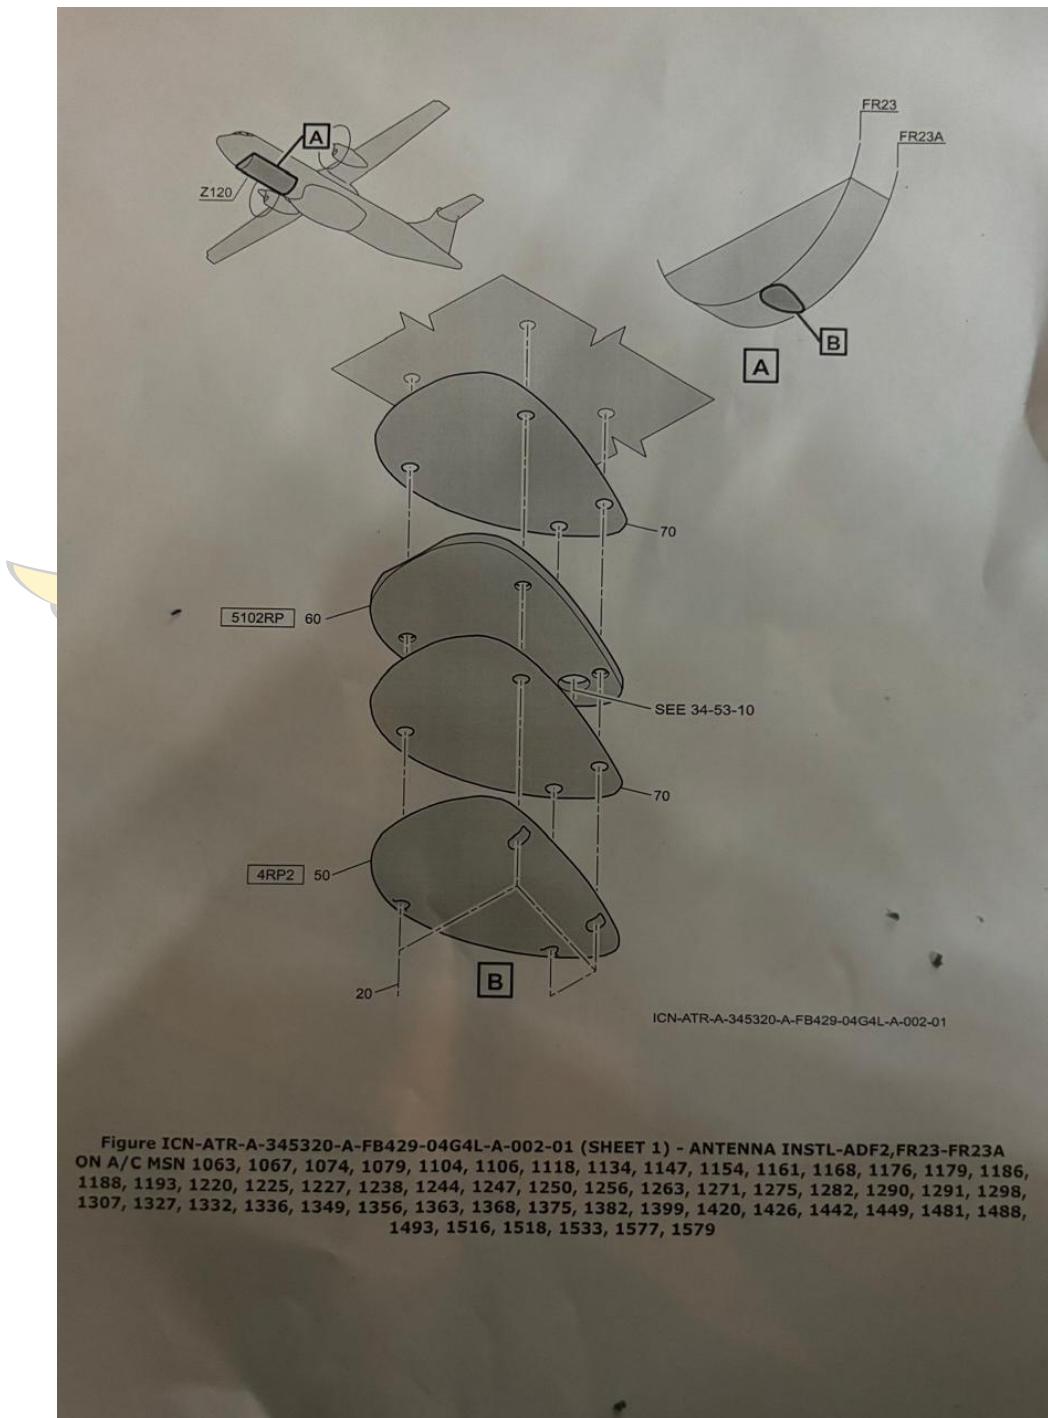
Gambar 4.11 *Intallation Gasket* ICN-ATR-A-345320-A-FB429-04G4L-A-002-01

Setelah dilakukan inspection dan keadaan *antennas dan connector* baik dilakukan assembly Kembali pada antenna. Pemasangan antenna dilakukan sesuai dengan ICN-ATR-A-345320-A-FB429-04G4L-A-002-01.

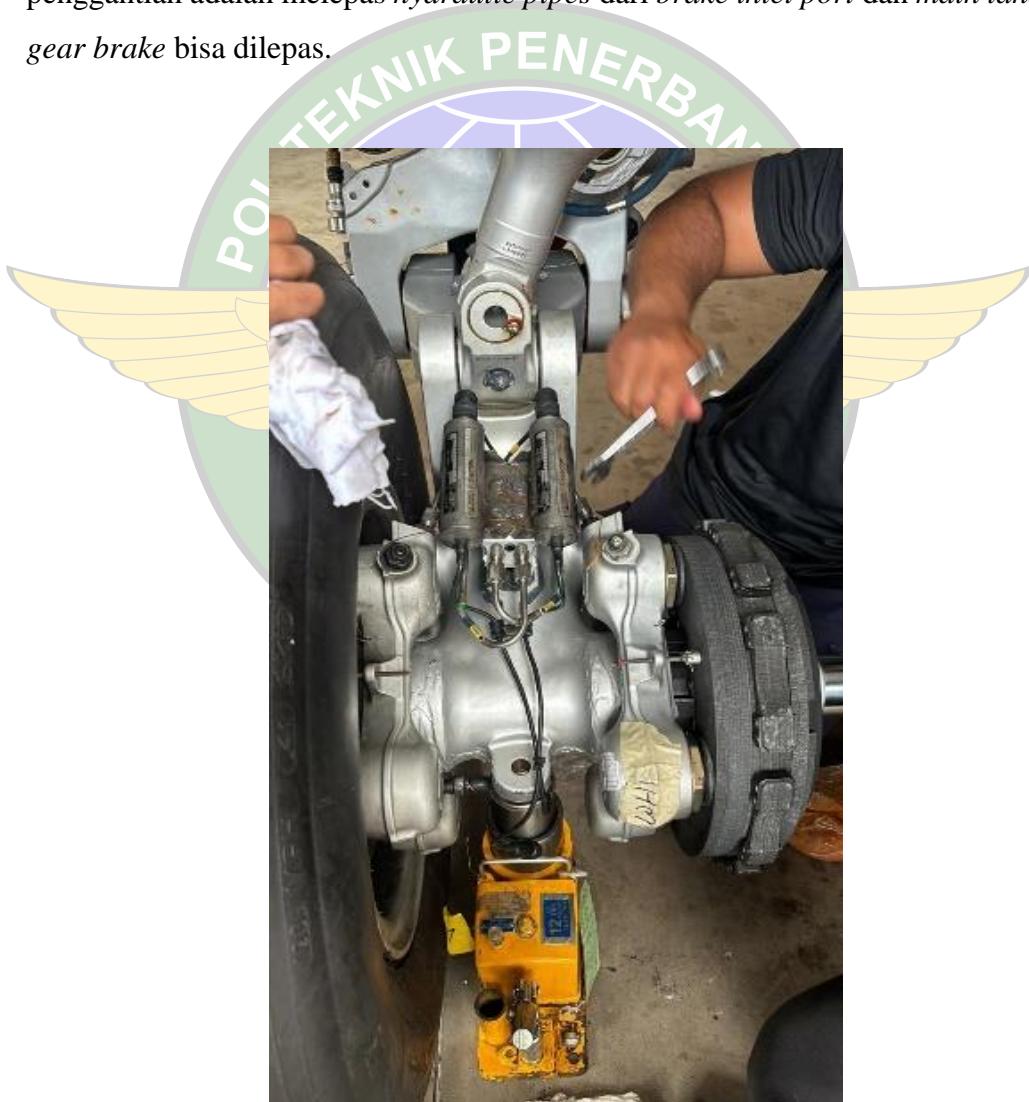
Gambar 4.14 Replacement Main Landing Gear Brake

Sebelum melaksanakan penggantian *main landing gear brake*, sesuai dengan SUBTASK 324250-86500010001 melepas *circuit breaker blue and green HYD PUMP PWR SPLY*. Selanjutnya *main landing gear* harus dalam posisi *jack* sesuai Ref. MP ATR-A-07-12-XX-00ZZZ-172Z-A. Lalu melepas main landing gear wheel/tire Ref. MP ATR-A-12-37-32-00ZZZ-520Z-A. dan melepas *temperature transducer* Ref. MP ATR-A-32-42-50-01ZZZ-520Z-A. Tahap berikutnya dalam melepaskan main landing gear brake untuk dilakukan penggantian adalah melepas *hydraulic pipes* dari *brake inlet port* dan *main landing gear brake* bisa dilepas.

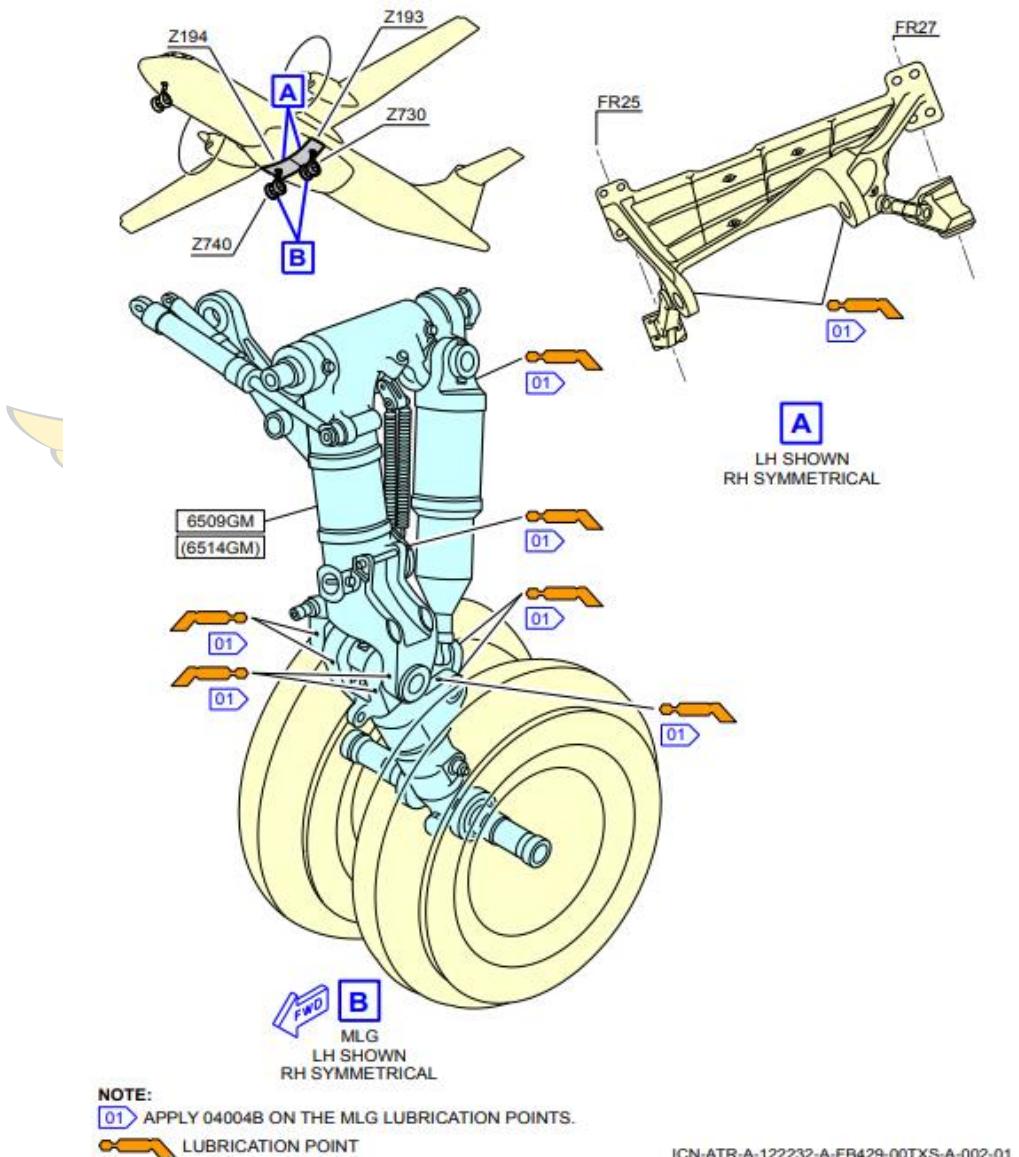
Gambar 4.17 Lubrication of the MLG Points AMM ATR-A-12-22-32-00001-240A-A

Pelaksanaan lubrication pada *main landing gear* ATR 72-600 dilakukan berdasarkan AMM TASK ATR-A-12-22-32-00001-240A-A *Lubrication of the MLG and the MLG Doors*. Sesuai dengan AMM ada beberapa lubrication point sesuai dengan SUBTASK 122232-30000050004.

Figure ICN-ATR-A-122232-A-FB429-00TXS-A-002-01 (SHEET 1) - Lubrication of the MLG Points

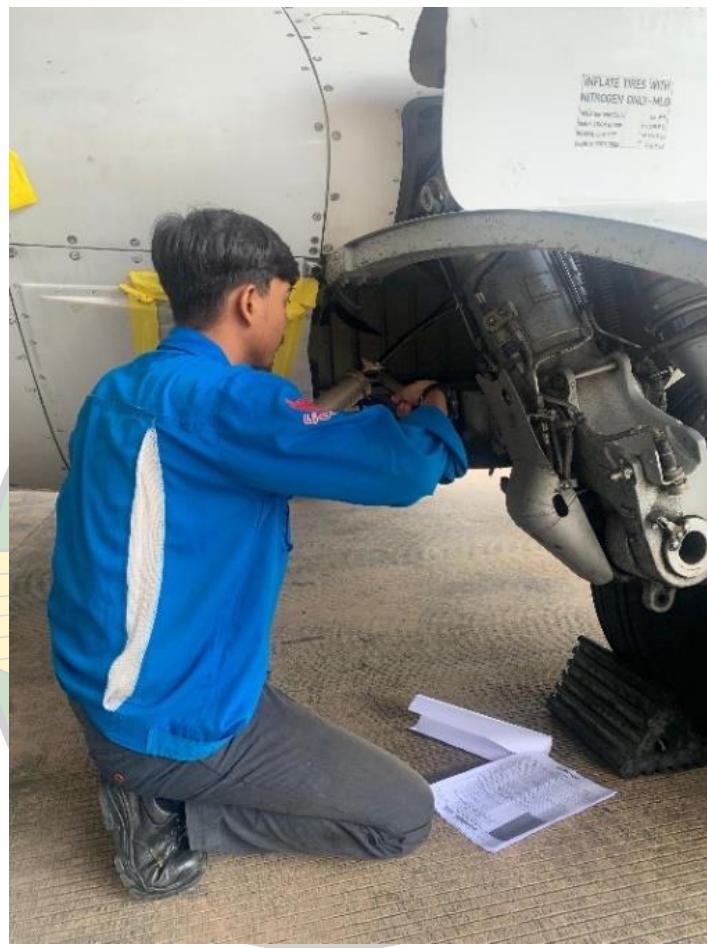
Gambar 4.20 Documentation Lubrication of the MLG

Saat pelaksanaan lubrication pastikan *Grease Gun* dan *nipple* dalam kondisi yang baik. Kondisi saat pelaksanaan lubrication harus dalam keadaan bersih dan membersihkan bagian yang terdapat sisa grease sebelumnya. SUBTASK 122232-30000130001.

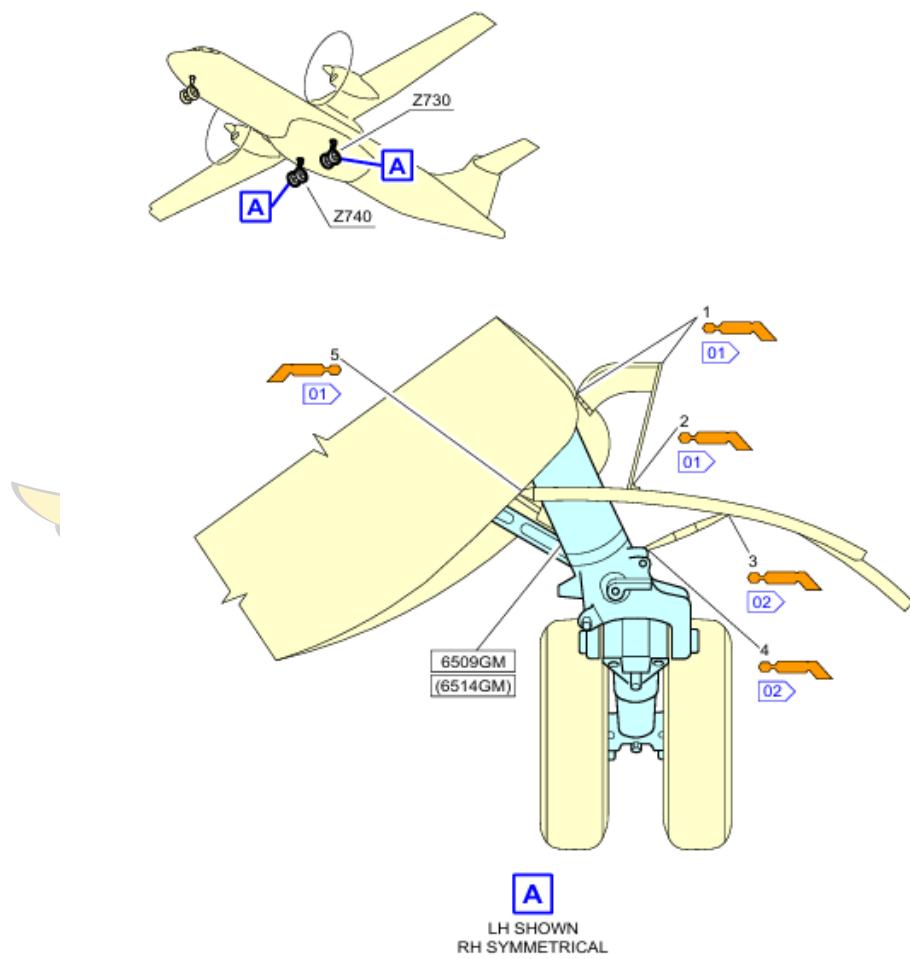
Figure ICN-ATR-A-122232-A-FB429-00TXX-A-002-01 (SHEET 1) - Lubrication of the MLG Door Points

- 01 APPLY 04004B MIXED WITH 5% OF 04007A ON THE MLG-DOOR LUBRICATION POINTS.
- 02 APPLY 04004B ON THE MLG-DOOR LUBRICATION POINTS.

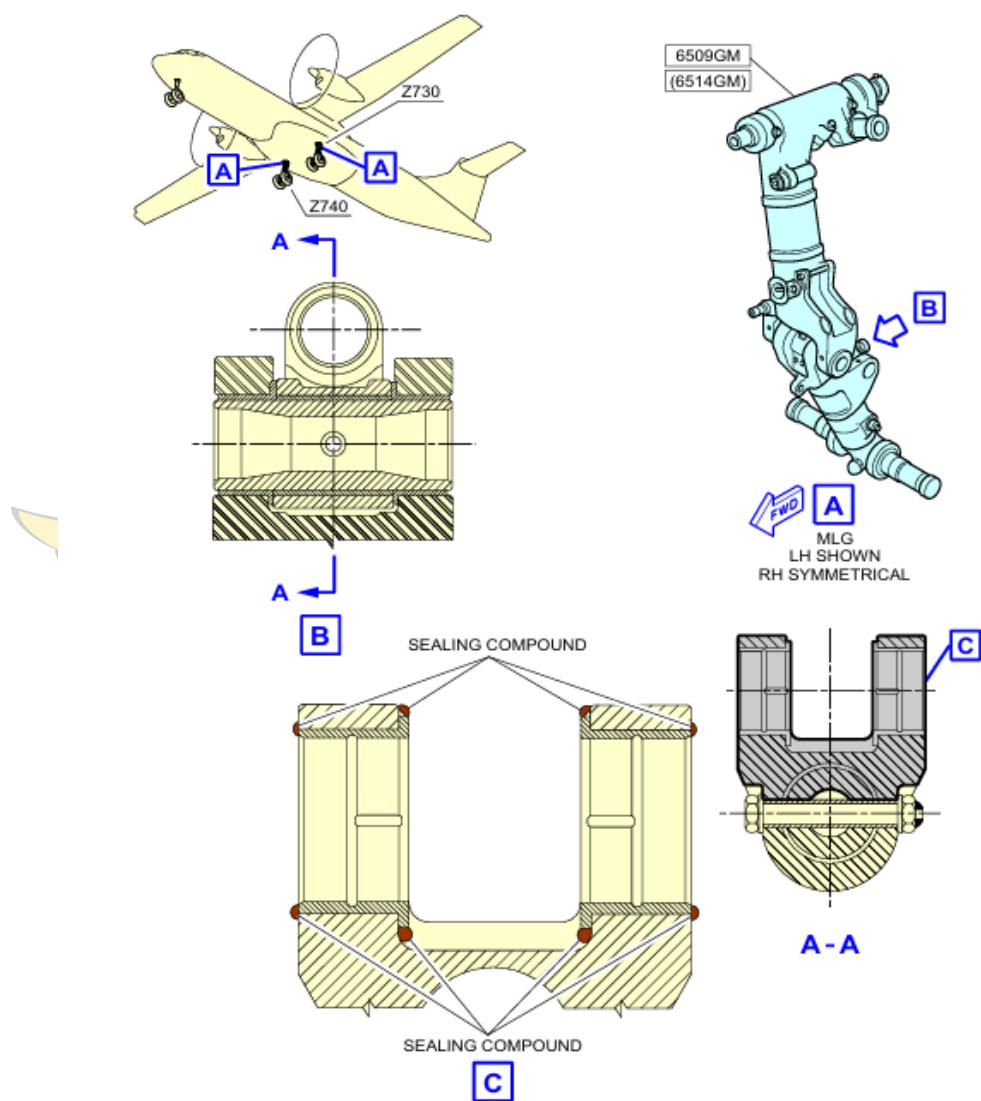
Figure ICN-ATR-A-122232-A-FB429-00TXY-A-002-01 (SHEET 1) - Sealing Compound General-Visual-  
Inspection for Integrity

- (1) Make sure that the [09002D \(Polysulfide sealant fast curing\)](#) bead around the two bushes are not removed. The possible conditions are as follows:
  - (a) The [09002D \(Polysulfide sealant fast curing\)](#) is removed but the bushes are in their initial positions.

- (2) Do the procedure related to the inspection results:
- NOTE:** Although the sealing compound bead has a crack, the positions of the bushes do not change. If there is a crack in the sealing compound bead, the sealing compound bead will not show that the bushes are moved. The sealing can show signs of crack because of its usual aging process. Thus, it is not necessary to replace the sealing bead that shows this specified sign given that the bushes are in their initial positions. If you are not sure, remove the sealing bead (refer the procedure below mentioned) for a better inspection or speak to messier-dowty or AI(R) product support.
