LAPORAN *ON THE JOB TRAINING*
DI FL TECHNICS INDONESIA – HANGGAR BALI
01 April 2024 – 30 Juni 2024

PROGRAM STUDI DIPLOMA 3 TEKNIK PESAWAT UDARA
POLITEKNIK PENERBANGAN SURABAYA

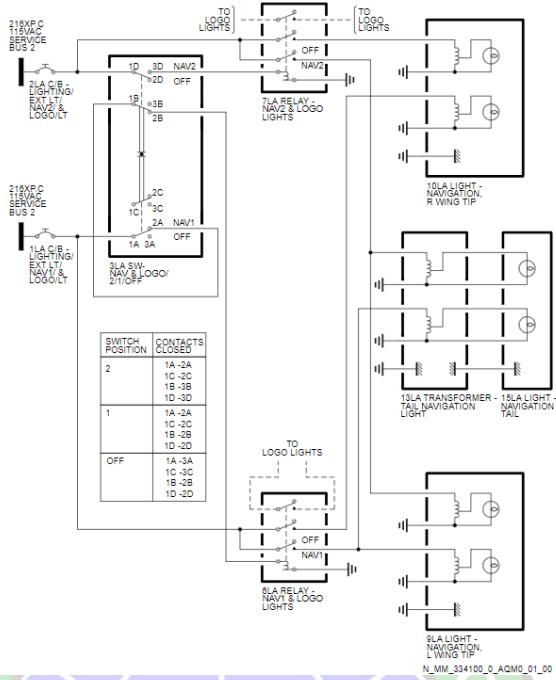
Gambar 3.4 Schematic Navigation Light

SERVICE BUS 2, 216XP memasok sistem lampu navigasi 1 dan 2 dengan 115VAC 400Hz. Daya dipasok ke setiap sistem melalui pemutus sirkuit terkait 1LA dan 2LA. Pemutus sirkuit ini dipasang pada panel 122VU di kokpit. Relai 6LA dan 7LA menghubungkan suplai ke trafo *step-down* dari lampu navigasi terkait. Relai ini dipasang pada panel 103VU. Rangkaian sirkuit *navigation light* dapat dilihat pada gambar 3.4.

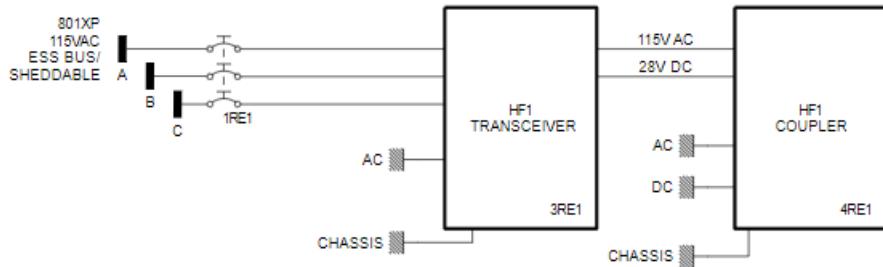
Gambar 3.7 Circuit Power Supply HF

Sistem komunikasi HF terdiri dari beberapa komponen utama, yaitu panel kontrol radio, *transceiver HF*, kopler antena HF, dan antena HF. Panel kontrol radio berfungsi sebagai antarmuka pengguna untuk mengoperasikan sistem, sementara *transceiver HF* berperan dalam mengirim dan menerima sinyal frekuensi tinggi. Kopler antena HF digunakan untuk menghubungkan *transceiver* dengan antena, serta untuk mengoptimalkan kinerja antena dalam menangkap sinyal. Antena HF sendiri bertugas menangkap dan memancarkan sinyal frekuensi tinggi, sehingga memastikan komunikasi yang efektif dan andal dalam sistem tersebut. Sistem HF1 dipasok dengan tiga fase 115VAC, dari *ESS BUS/SHEDDABLE 115VAC* (*sub-busbar 801XP*) melalui pemutus sirkuit 1RE1 yang terletak di panel *overhead 49VU*. *Transceiver HF1* (3RE1) menyediakan suplai ke penggandeng antena HF1 (4RE1) dengan 28VDC dan monofase 115VAC. Sirkuitnya dapat dilihat pada gambar 3.7.

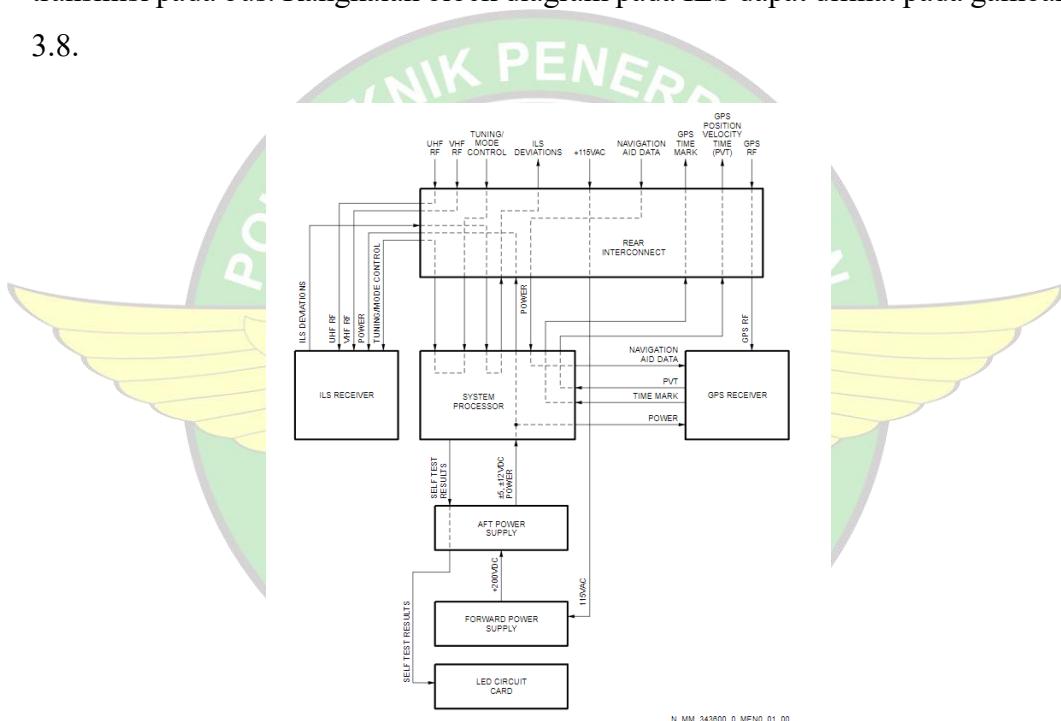
Gambar 3.8 Block Diagram ILS

Prosesor sistem mengontrol aliran data ke penerima ILS dan GPS termasuk pemilihan mode dan frekuensi, inisialisasi GPS, dan permintaan data pemeliharaan. Prosesor sistem juga mengontrol transmisi data output termasuk deviasi ILS, posisi GPS, kecepatan, waktu, integritas, tanda waktu, dan data pemeliharaan. Sirkuit pada prosesor sistem mengubah data yang diterima dari serial menjadi paralel dan juga memformat data paralel menjadi data serial untuk transmisi pada bus. Rangkaian block diagram pada ILS dapat dilihat pada gambar 3.8.

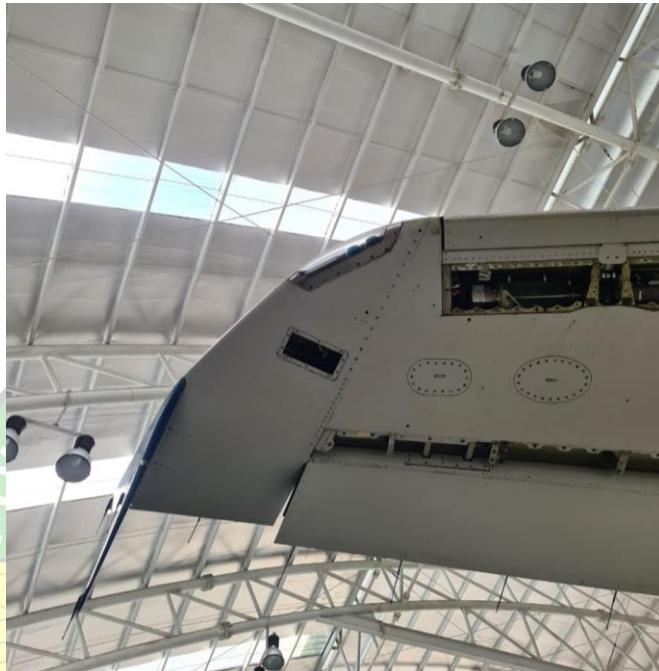
Gambar 4.1 *Navigation Light Fault*

menggunakan Ref. AMM 33-41-00-710-001-A. Ternyata saat switch nav light di kokpit pada *overhead panel* 25VU diatur pada posisi on, terdapat *navigation light* bagian sayap kanan mati padahal sebelah kiri sudah menyala, dapat dilihat pada gambar 4.1.

Meskipun berbagai percobaan telah dilaksanakan sesuai prosedur. Sehingga perlu dilakukan *replacement navigation light*.

Maka, hal yang harus dilakukan adalah dengan mengganti lampu dengan mengikuti *Ref. AMM 33-41-11-000-002-A* dan *Ref. AMM 33-41-11-400-002-A*. Sebelum mengerjakan penggantian lampu, terlebih dahulu adalah menyiapkan tools yang akan digunakan, diantaranya *Access platform 4m (13 ft), cap – blanking, safety barrier(s), safety clip - circuit breaker, warning notice(s), non aqueous cleaner-general, corrosion preventive compound-heavy duty hard film, textile-lint free cotton*. Setelah semua konfigurasi telah disiapkan maka lanjut ke prosedur pengerjaan remove dan install.

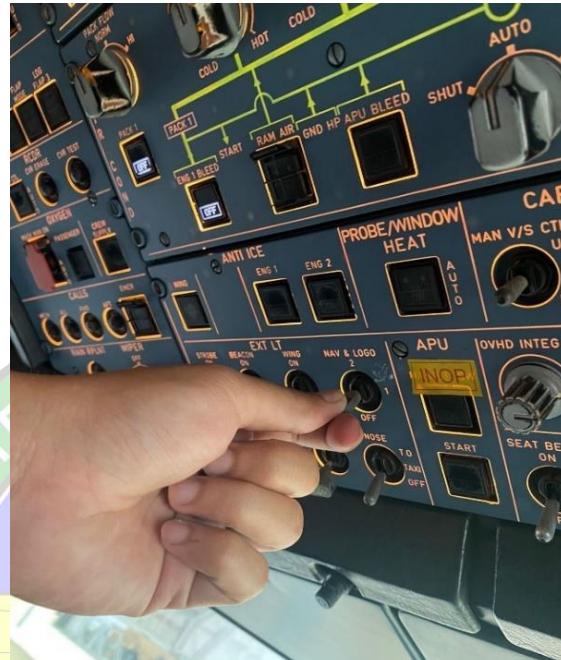
Gambar 4.2 Overhead Panel

Pastikan *NAV & LOGO on/off switch* yang terletak di section 25VU Overhead panel pada posisi on seperti gambar 4.2.

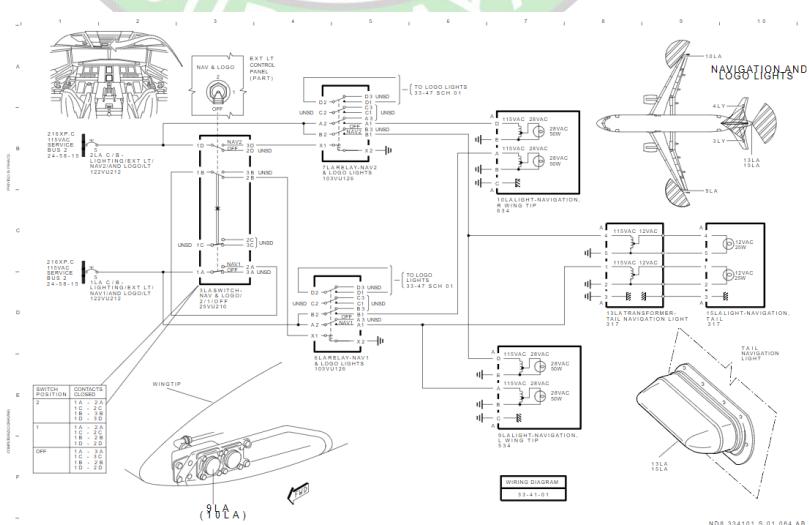
Gambar 4.3 Wiring Diagram Navigation Light

Tidak lupa untuk membaca *wiring diagram* pada *navigation light* untuk memastikan apakah memang sudah pada jalurnya, dapat dilihat pada gambar 4.3.

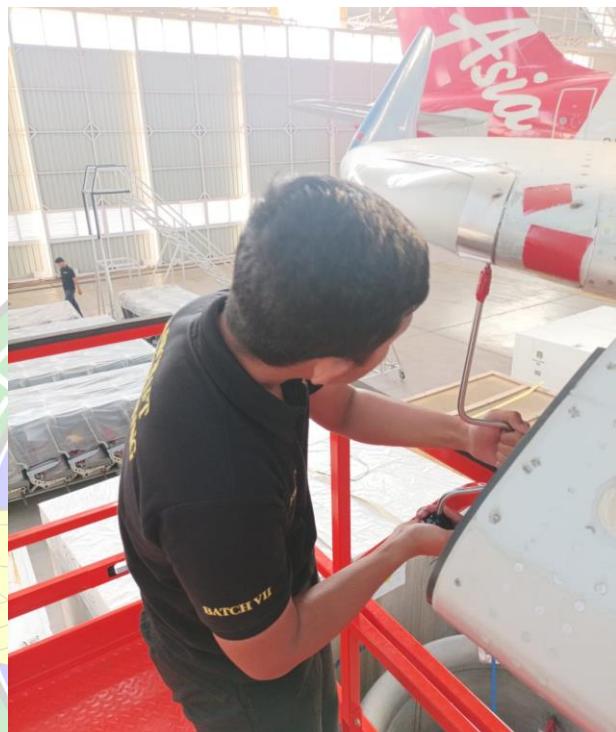
Gambar 4.4 Replacement Navigation Light

Kemudian lampu dilepas dan diganti dengan komponen yang sesuai dengan part number 727-1134-02, selanjutnya masuk ke fase *installation* dengan *ref. AMM 33-41-11-400-002-A*. dan tidak lupa untuk memperhatikan *warning* dan *caution* yang ada pada AMM yang telah tertera seperti pada gambar 4.4.

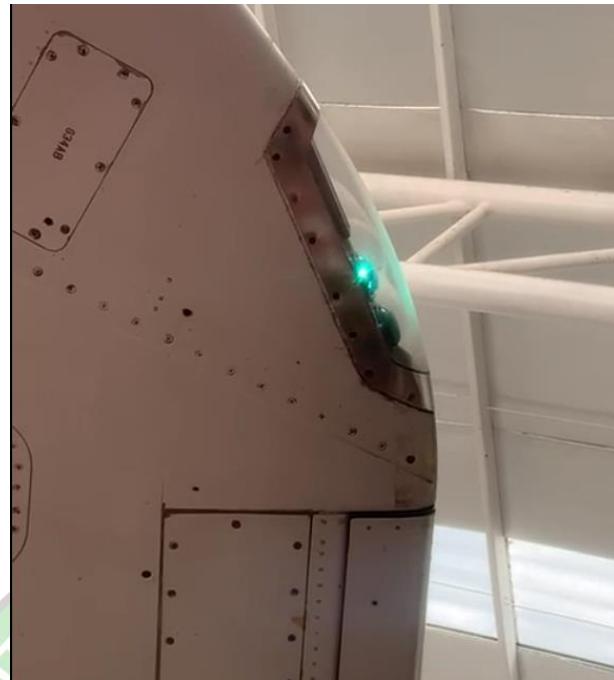
Gambar 4.5 Navigation Light

Setelah pelaksanaan *repair* dengan penggantian lampu baru pada wing kanan. Selanjutnya adalah dengan melaksanakan *operational test* kembali dengan mengikuti *Ref. AMM 33-41-00-710-001-A*. Didapat hasil bahwa navigation light kembali menyala saat switch on pada *overhead panel* yang artinya *navigation light* sudah berfungsi kembali secara normal yang dapat dilihat pada gambar 4.5.

Semua prosedur telah dilaksanakan dan komponen yang diperbaiki telah berfungsi dengan normal kembali. Maka, permasalahan ini dinyatakan selesai dan mendapat *approved* dari engineer.

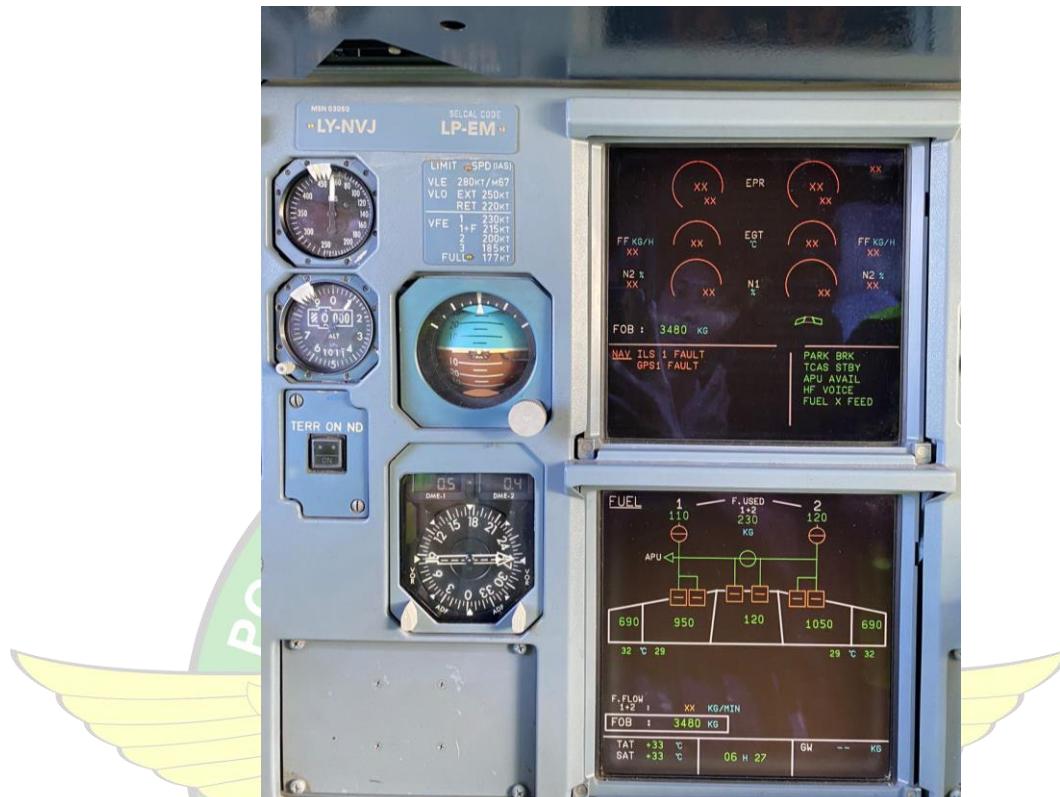
Gambar 4.6 Notifikasi ILS muncul pada ECAM

Pada saat pesawat dengan registrasi LY – NVJ tiba ke hangar setelah dilakukan *test flight*, pilot melaporkan adanya problem di bagian *Instrument Landing System*. Maka engineer mengambil keputusan untuk maintenance dengan alur pada bagan 4.2.

Setelah melakukan *Ground Scanning DMC* dan *Fault* terkonfirmasi dan didapatkan trouble pada MMR-1. Maka sesuai dengan *ref. TSM 34-36-00-810-804-A* langkah selanjutnya adalah dengan melakukan *replacement MMR-1*. Sebelum melaksanakan *replacement* diharapkan untuk menyiapkan dahulu konfigurasi yang akan digunakan saat pengerjaan. *Replacement MMR-1* ini nantinya berada di *Avionics Compartment*. Untuk tools yang harus disiapkan yaitu *access platform 2m (6 ft) – adjustable, cap – blanking, safety clip – circuit breaker*. Setelah semua disiapkan jangan lupa sebelum pengerjaan untuk *Open, safety and tag the circuit breaker* pada panel *NAV/MMR/1 (49VU)* dan *COM NAV/MMR/2 (121VU)*. Setelah *circuit breaker open*, siapkan *access platform 2m (6 ft)* di *avionics compartment*.

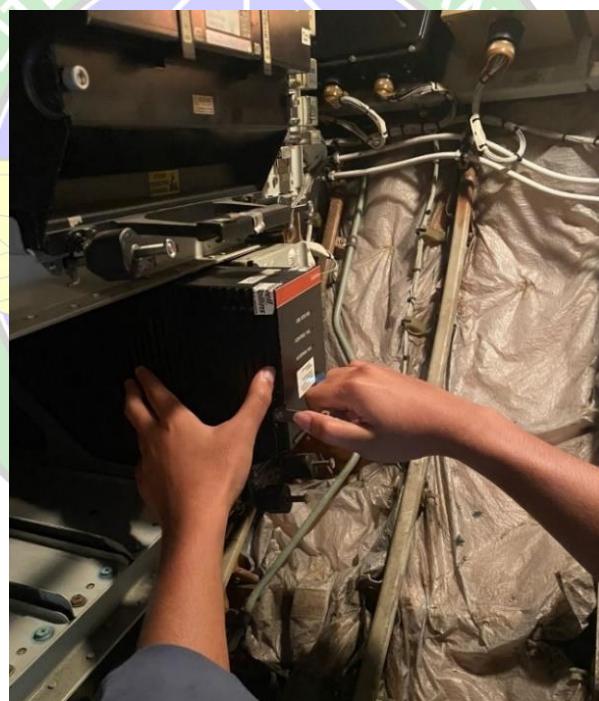
Gambar 4.7 Replace MMR-1

Langkah berikutnya mengganti komponen dengan MMR yang baru tentunya dengan part number yang sama yaitu 822-1152FC29 dengan serial number 01820 dan mengikuti Ref. AMM 34-36-31-400-001-B dapat dilihat pada gambar 4.7. dan 4.8. Setelah MMR telah terpasang dengan sempurna, sesuai dengan anjuran TSM dilaksanakan *BITE Test of the MMR*.

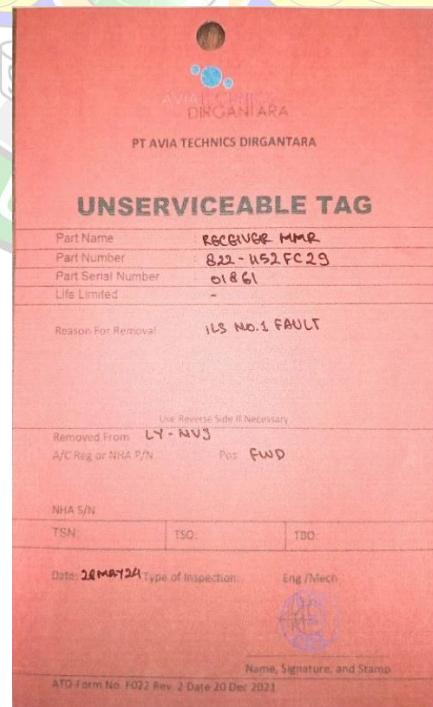
Gambar 4.9 *Unserviceable Tag MMR*

Selanjutnya untuk receiver yang lama akan dikembalikan ke main store yang nantinya akan dikirim ke shop. Untuk *unserviceable tag* dapat dilihat pada gambar 4.9.

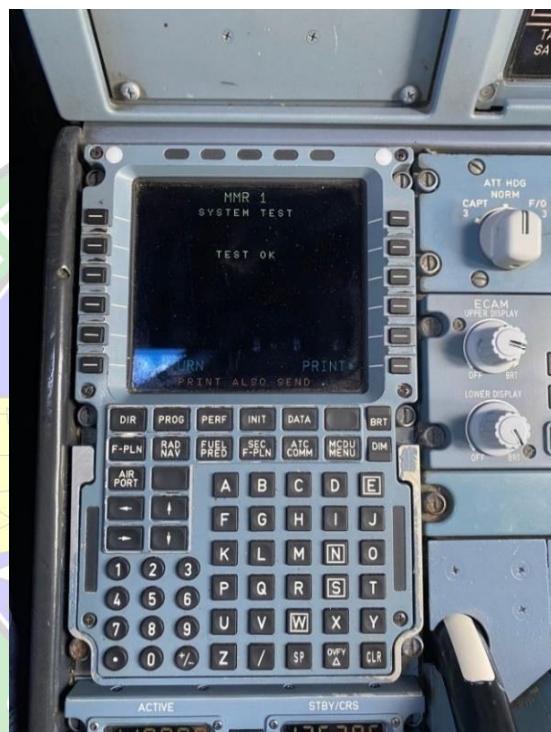
Gambar 4.10 *BITE Test MMR-1*

Selanjutnya setelah MMR-1 telah terpasang dengan sempurna, langkah berikutnya yaitu dengan melakukan *BITE test* ke MMR-1 melalui MCDU dengan mengikuti *Ref. AMM 34-36-00-740-003-A* tentunya dengan ditemani supervisor. Setelah dilaksanakan *BITE Test* dan didapatkan hasil “TEST OK” pada MCDU yang dapat dilihat pada gambar 4.10.

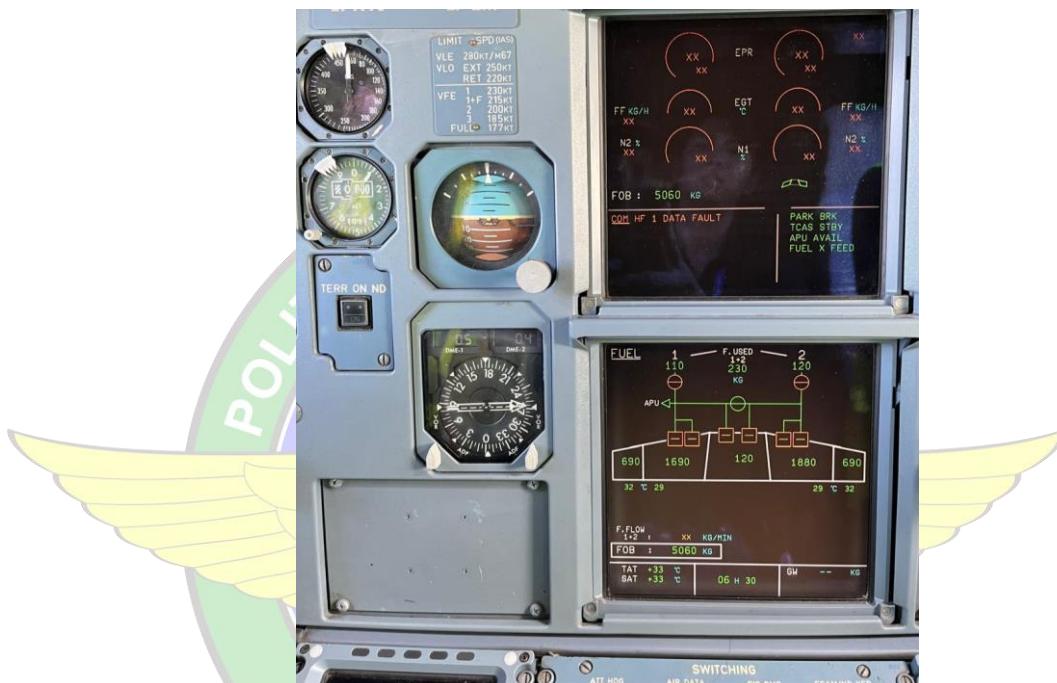
Gambar 4.11 Muncul Notifikasi HF 1 Data Fault

Permasalahan kali ini datang pada tanggal 12 Juni 2024 karena adanya laporan pada pesawat VN – A586 yang telah lama parkir/*After a Parking Period* dengan menggunakan Ref. AMM 10-30-00-554-804-A bahwa terdapat notifikasi pada *Electronic Centralized Aircraft Monitor* (ECAM) bahwa *HF 1 Data Fault*, dapat dilihat pada gambar 4.11.

Proses selanjutnya adalah dengan *Remove* dan *Install Transceiver HF*. Sebelum mengerjakan replacement diharuskan untuk menyiapkan tools yang akan digunakan, yaitu *access platform 2m (6 ft) – adjustable, cap – blanking, safety clip - circuit breaker*. Dan jangan lupa setelah tools telah disiapkan untuk *open circuit breaker* pada panel HF1 (49VU). Pertama melakukan *remove transceiver HF* yang lama dengan cara mengikuti *Ref. AMM 23-11-33-000-001-D*. Siapkan *access*

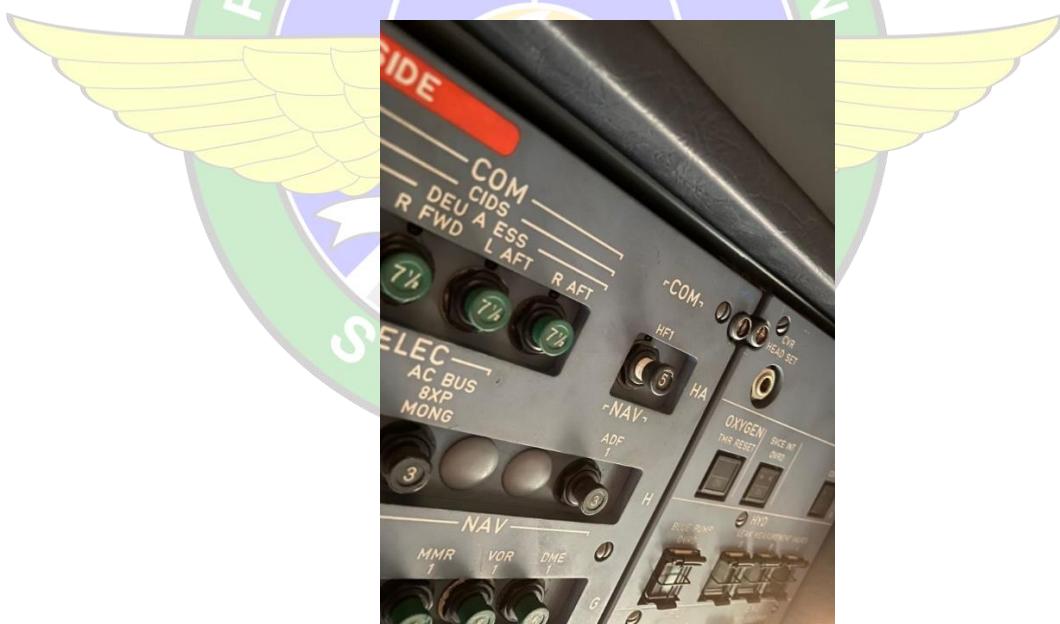
Gambar 4.12 *Circuit Breaker HF*

Setelah ditentukan *possible cause* selanjutnya dengan mengikuti TSM adalah dengan melakukan *BITE Test of the ATIMS* sesuai Ref. AMM 46-21-00-740-001-A. Setelah dilakukan *BITE Test* dan ditemukan hasil bahwa *found message HFDR1* yang berarti ada masalah pada HF. Dengan mengikuti anjuran dari TSM setelah itu dilakukan, pastikan *circuit breaker 1RE1, 3TX1, dan 5TX1* tertutup. Dan setelah itu melakukan *open and close circuit breaker 1RE1* untuk melakukan reset HFDR 1 yang dapat dilihat pada gambar 4.12.

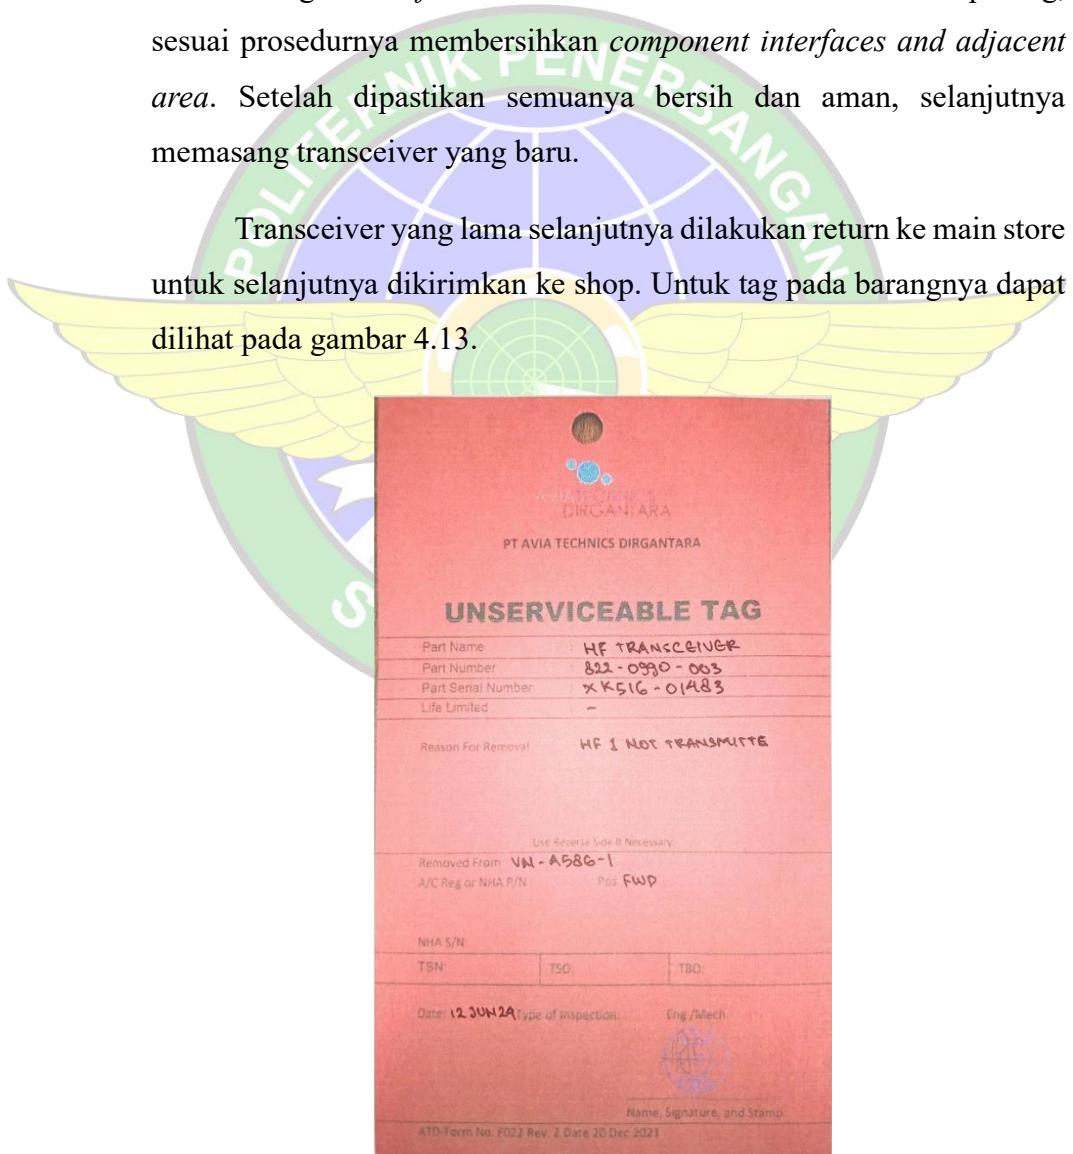
Gambar 4.13 *Unserviceable Tag HF Transceiver*

Transceiver yang lama selanjutnya dilakukan return ke main store untuk selanjutnya dikirimkan ke shop. Untuk tag pada barangnya dapat dilihat pada gambar 4.13.

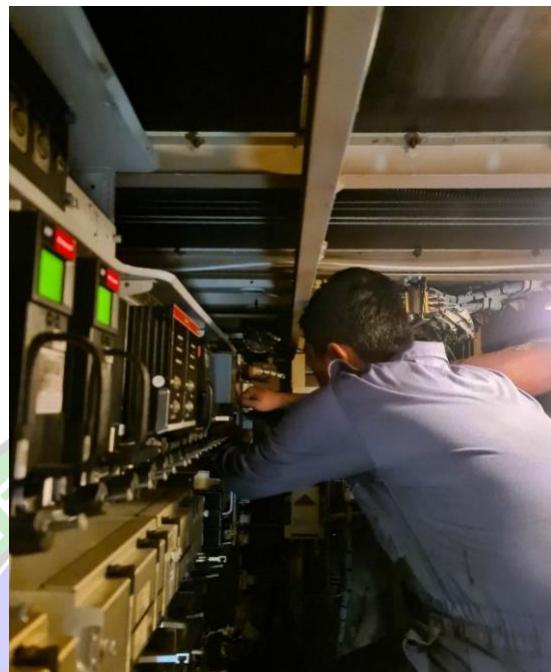
Gambar 4.14 Replace XCVR-HF1

Proses pemasangan *HF Transceiver* dan yang telah terpasang dapat dilihat pada gambar 4.14 dan gambar 4.15.

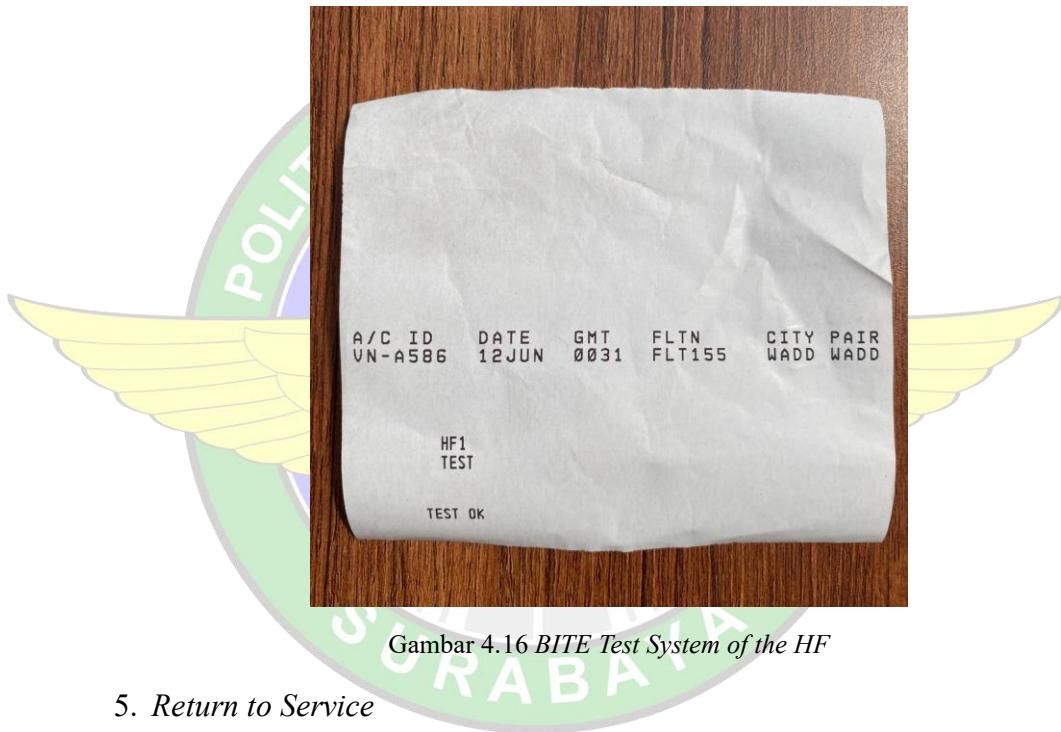
Gambar 4.16 *BITE Test System of the HF*

Setelah dilakukan *BITE Test* sesuai dengan prosedur pada *Ref. AMM 23-11-00-740-001*. Dan didapatkan hasil sesuai dengan yang ada di AMM yaitu “TEST OK”. Dapat dilihat pada gambar 4.16. Maka problem dinyatakan telah selesai.
