LAPORAN *ON THE JOB TRAINING*
DI AKADEMI PENERBANGAN INDONESIA BANYUWANGI
01 APRIL 2024 - 28 JUNI 2023

PROGRAM STUDI DIPLOMA 3 TEKNIK PESAWAT UDARA
POLITEKNIK PENERBANGAN SURABAYA
2024

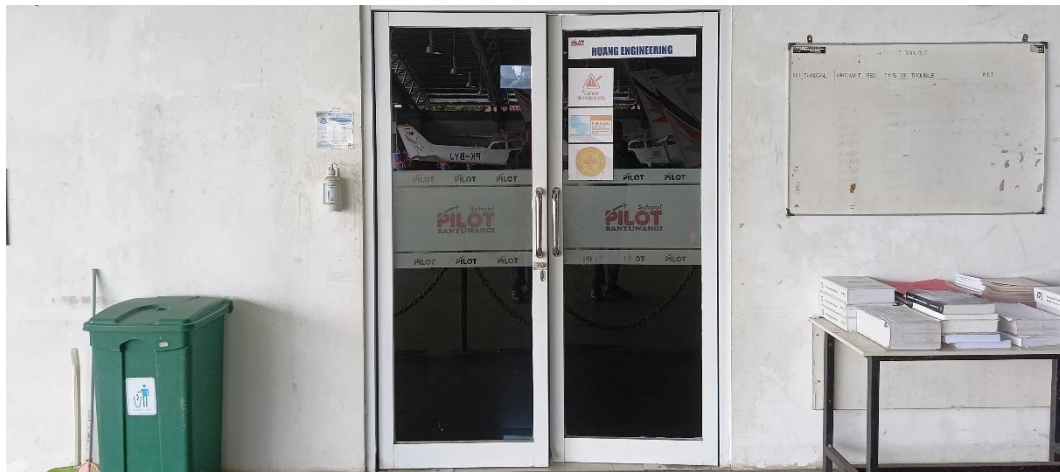
Gambar 2. 5 Ruang Engineering

Ruangan *Engineering*, untuk tempat penyimpanan rekaman data-data pesawat seperti *Aircraft Flight Maintenance Logbook* (AFML) serta untuk evaluasi dan merencanakan jadwal inspeksi yang akan dilaksanakan oleh para engineer dilapangan.

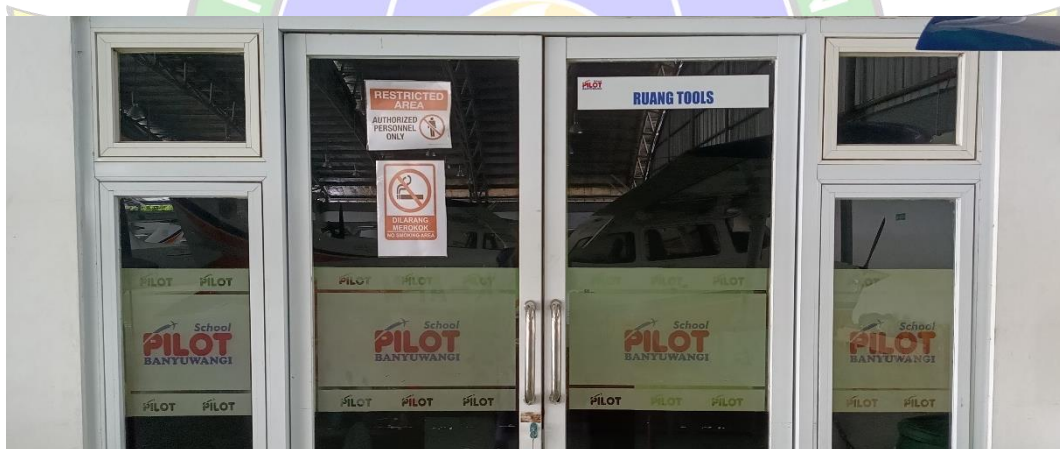
Gambar 2. 6 Ruang tools

Ruangan *Tools*, digunakan untuk menyimpan tools, special tools, dan alat-alat pendukung lainnya dalam melaksanakan perawatan maupun perbaikan pesawat udara.

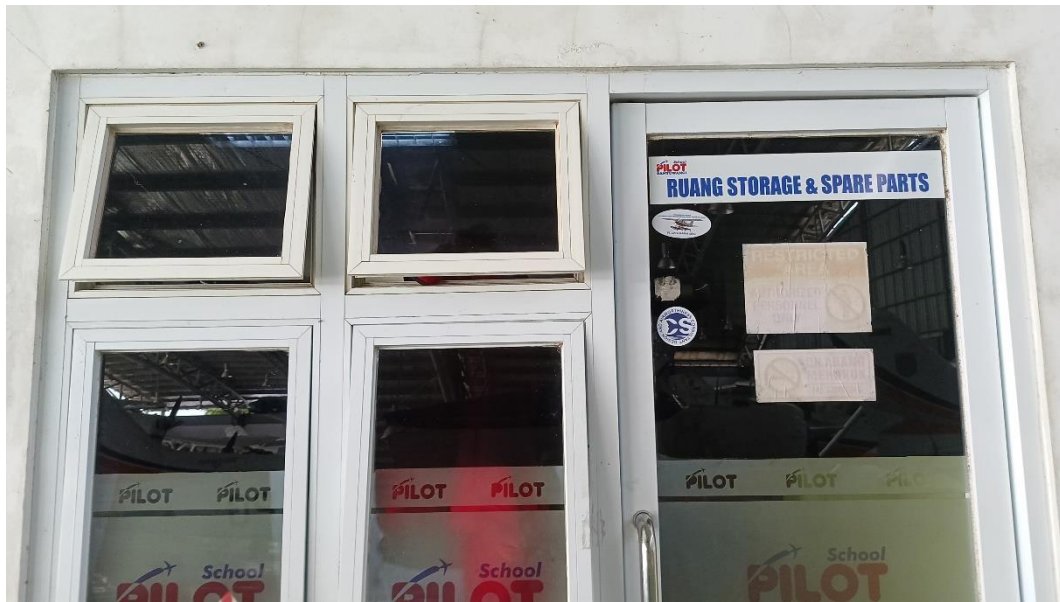
Gambar 2. 7 Ruang storage dan spare part

Ruangan *Storage & Spare Parts*, untuk menyimpan suku cadang (komponen pesawat) dan bahan-bahan pendukung seperti *Tire* dan *Oil*.

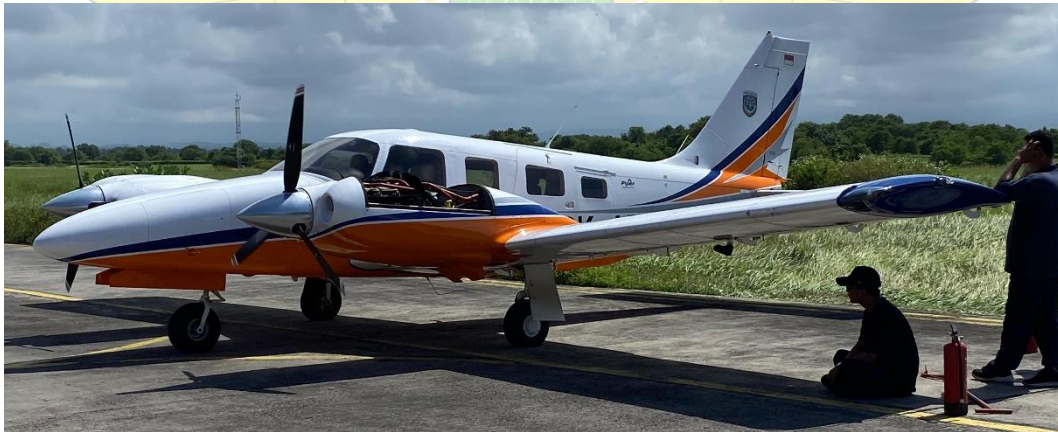
Gambar 2. 8 Pesawat Piper Seneca V

Akademi Penerbang Indonesia Banyuwangi mempunyai fasilitas pendidikan yaitu 33 unit pesawat latih single engine Cessna 172-S dan 2 unit multi engine Piper Seneca V serta 2 unit pesawat Seaplane .

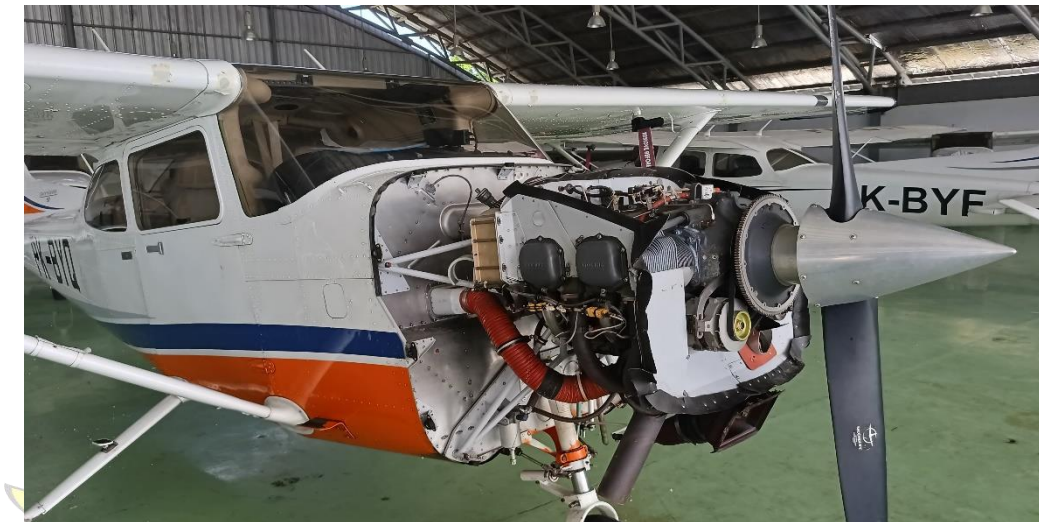
Gambar 3. 2 Maintenance Cessna 172S

Tujuan lain daripada perawatan pesawat udara adalah untuk mempertahankan pesawat dalam kondisi terbaik pada saat dioperasikan oleh pengguna. Untuk dapat melakukan perawatan dengan benar, maka setiap pesawat udara diharuskan memiliki Program Perawatan (*Maintenance Program*) gambar 3.2 yang berisi informasi detail tentang apa, kapan dan bagaimana sebuah pesawat udara dirawat.

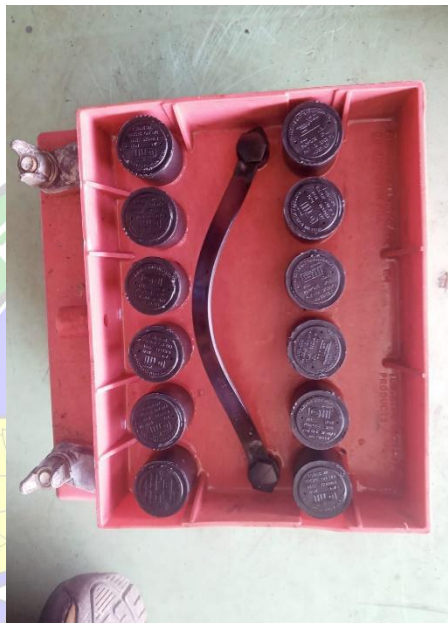
Gambar 3. 5 *Standby battrey*

Standart dari *Main Battery* pesawat pada gambar 3.7 adalah 24volt, 8 Amp-hours dengan tipe *flooded lead-acid battery*. *Optional tipe wooded* 10.0 Amp-Hour serta tipe tertutup sebesar 13.6 Amp-Hour. *Main Battery* pada pesawat Cessna 1725 dipasang di sisi kiri depan *firewall* dibawah *electrical power junction box*.

Main Battery berfungsi memasok daya listrik sebesar 24 volt untuk menghidupkan *engine* dan memberikan sumber daya cadangan jika terjadi kegagalan *alternator*. Pengoperasian *Main Battery* dikendalikan oleh *Switch master alternator battery*, *switch* ini dapat ditemukan pada bagian sisi kiri *panel switch* yang mana untuk *battery* pada *switch* bagian kanan. *Swicth master battery*, ketika dioperasikan menghubungkan *battery contractor coil* atau ke *ground* sehingga kontak menutup dan mensuplai daya ke sistem hanya *dari main battery*.

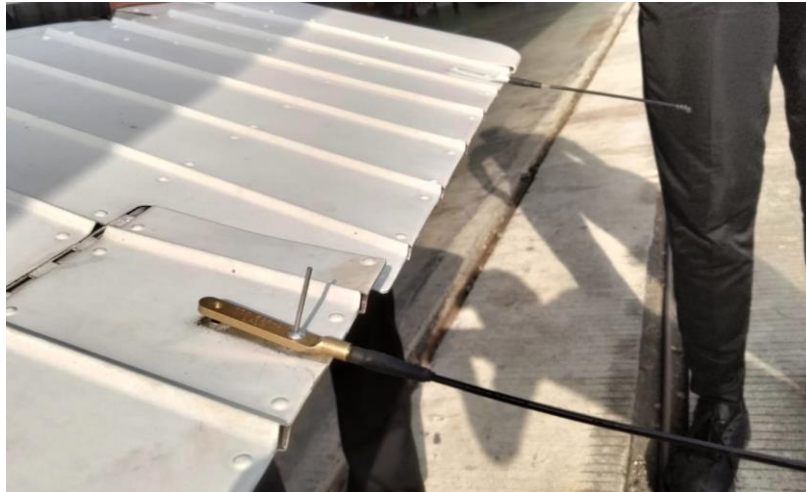
Gambar 3. 6 *Static discharge*

Sistem kerja *static discharge* sebagai Penyalur muatan listrik statis, muatan dialihkan keluar dari pesawat agar. penumpukan muatan karena sambaran petir tidak terjadi, sehingga instrumen pesawat yang digunakan sebagai alat navigasi dan komunikasi bisa bekerja tanpa ada masalah. Pembuangan listrik statis ke atmosfer bisa mencegah penumpukan muatan statis di struktur pesawat dengan menentukan letak dimana *static discharge* itu dipasang pada pesawat terbang. Dengan menggunakan metode bola gulir, bisa untuk mengetahui potensi yang terkena sambaran petir itu terletak dimana saja dan juga bisa menentukan tempat-tempat yang akan dipasang *static discharge*. Sehingga mendapatkan hasil yang sesuai dengan keamanan dan kelaikan pesawat pada saat sedang melakukan

penerbangan maupun pada saat *parking*. ketika *static discharge* bekerja dengan normal sangat kecil kemungkinan bila pesawat terbang terkena oleh sambaran petir yang menyebabkan gangguan pada elektronik maupun *body* pesawat terbang.

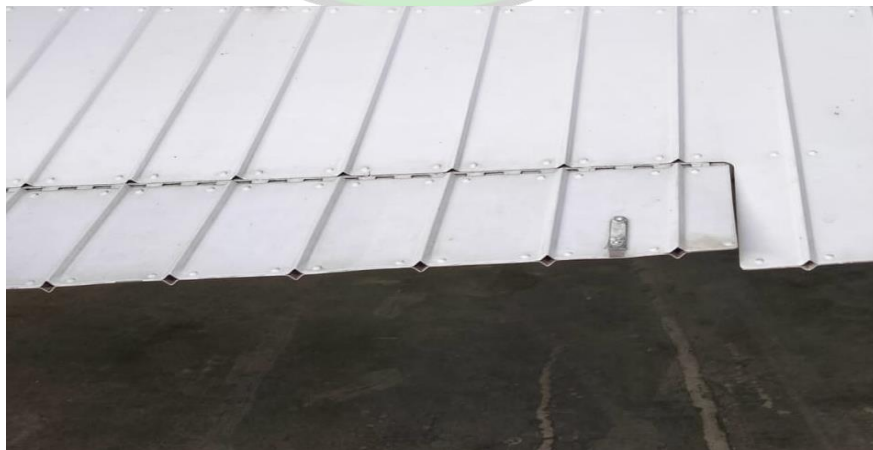
Gambar 4. 1 *static discharge*

Pesawat Cessna 172S dengan registrasi PK BYD dilakukan perbaikan pada tanggal 07 juni 2023 karena *static wick* putus saat pelaksanaan *pre flight* di pagi hari, sesuai dengan *MM chapter 23-60-00 Page 601* sebagai pedoman, *engineer* mengganti *static discharge* yang telah patah.

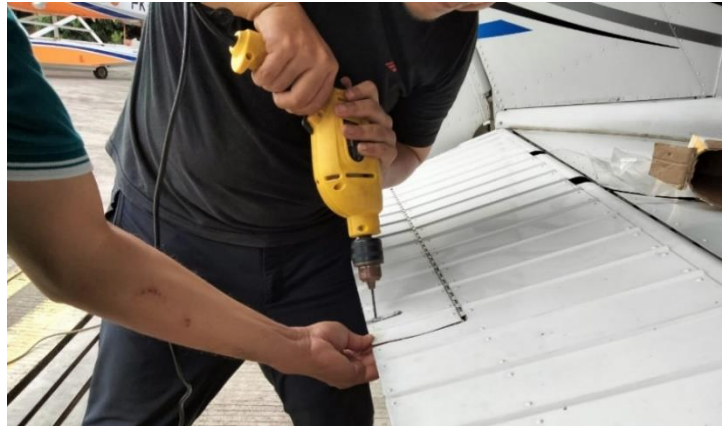
Gambar 4. 2 *Removal static discharge*

Setelah melakukan identifikasi permasalahan maka selanjutnya adalah *disassembly* dengan melepas *static discharge* yang putus pelaksanaan *disassembly* ini dilaksanakan dengan melepas *rivet* terlebih dahulu menggunakan *punch*.

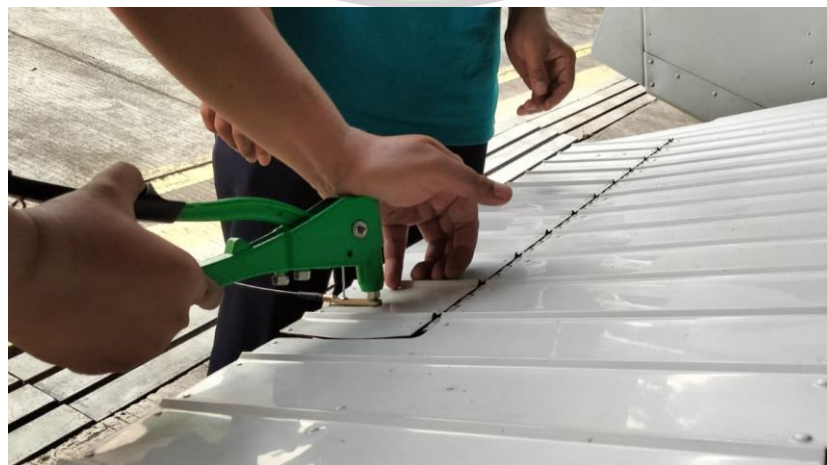
Gambar 4. 3 *installation static discharge*

Reassembly dilaksanakan dengan membersihkan *skin* pada bagian *static wick* yang akan dipasang menggunakan *rivets* agar terpasang dengan rapat lalu tahap akhir dari *reassembly* yaitu melakukan *repaint*.

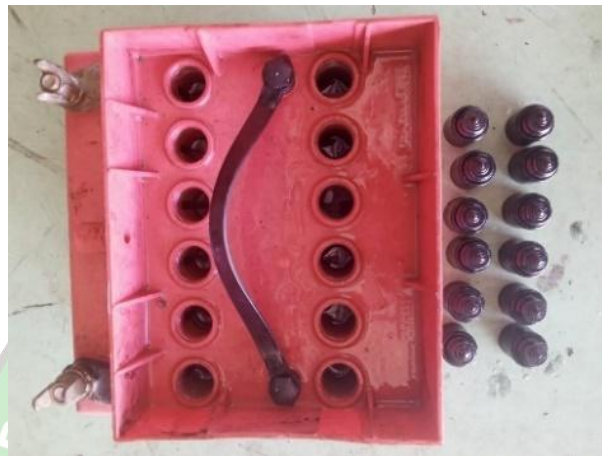
Gambar 4. 4 Inspeksi pada *distilled water*

Melepas *vent caps* dan melihat ketinggian *elektrolit* harus berada diatas pelat berbahan *separator*. Ketika dicek *Battery* mengalami kekurangan *distilled water* maka dilanjutkan dengan tahap *servicing*

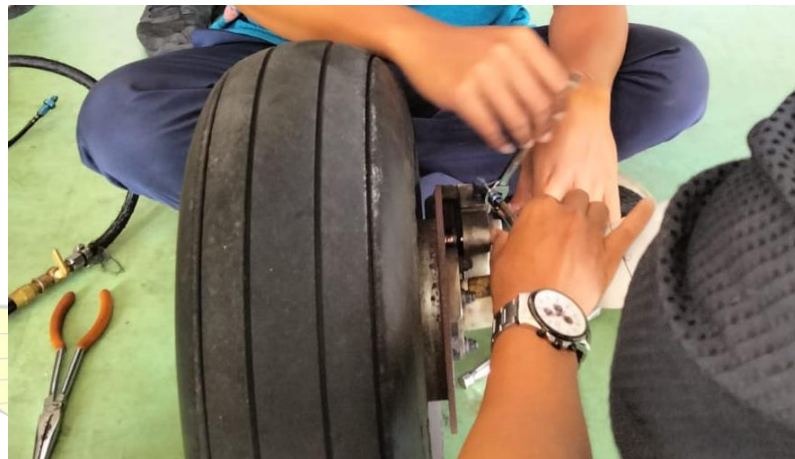
Gambar 4. 6 inspeksi pada *brake*

Pemeriksaan pada *Flexible lines* diperiksa apakah ada keretakan, keausan dan kerusakan ternyata terdapat *bubble* pada *brake line* setelah diperiksa kembali sesuai dengan *maintenance manual* engineer mengganti *fluid* pada *brake line* dengan mengeluarkan *fluid* sebelumnya terlebih dahulu.
