**LAPORAN ON THE JOB TRAINING (OJT)  
DI PESAWAT AIRBUS A320  
BATAM AERO TECHNIC (BAT)  
DIVISI BASE MAINTENANCE BATAM**

**PROGRAM STUDI DIPLOMA 3 TEKNIK PESAWAT UDARA  
POLITEKNIK PENERBANGAN SURABAYA  
2024**

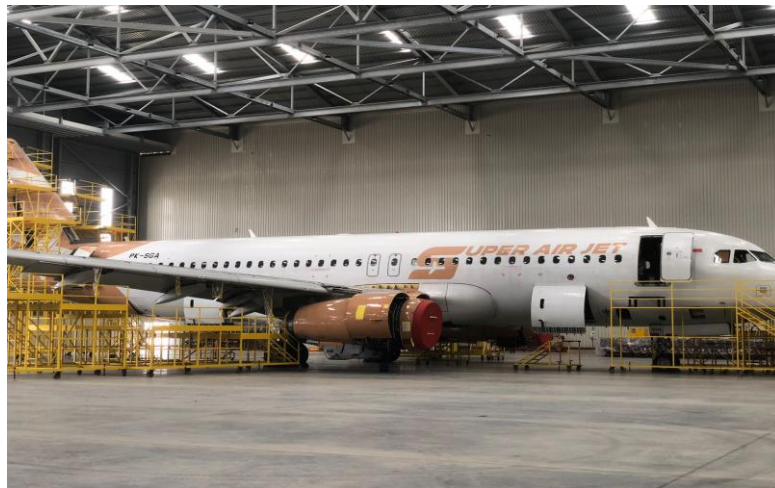
Gambar 3. 1 Pesawat Airbus A320 PK-SGA

Sebuah pesawat *narrow body* buatan Airbus yang memiliki ukuran sama dengan Boeing 727 dapat menawarkan teknologi lebih maju, meningkatkan keekonomisan operasi dan kapasitas penumpang beragam. Teknologi digital yang dimiliki oleh A320 menjadi lompatan teknologi sebanyak dua generasi dibandingkan 727 yang masih analog dan satu generasi di depan Boeing 737 seri -300/-400/-500. A320 ditargetkan menjadi pengganti armada global dari 727 dan varian awal dari 737.

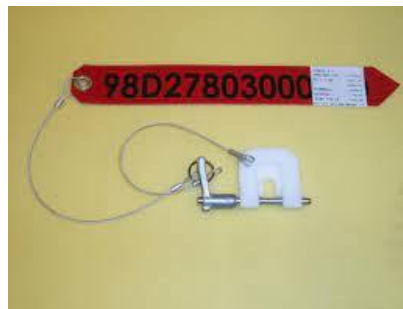
Gambar 3. 5 *Locking tool flap slat lever* (Sumber: Aviotools)

*Locking Tool Flap Slat Lever* digunakan untuk mengunci *flap slat lever* pada saat melakukan *maintenance* agar *flap* dan *slats* tidak dioperasikan terlebih dahulu sebelum *maintenance* itu dinyatakan selesai.

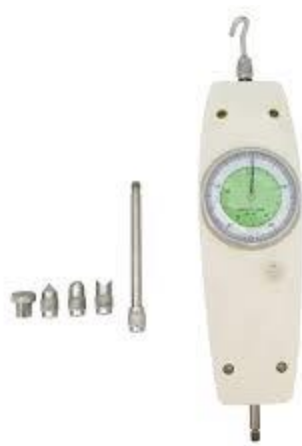
Gambar 3. 9 *Tool push pull gauge 150 lb* (Sumber: Ravi Scientific Industries)

*Push pull gauge* adalah alat ukur yang digunakan untuk mengukur gaya, baik gaya dorong (kompresi) atau gaya tarik (ketegangan) suatu objek. *Push pull gauge* umumnya berukuran kecil, sederhana, dan portabel dengan sistem yang dioperasikan secara digital (layar LCD) maupun mekanik (dial).

*Push pull gauge* berfungsi untuk mengukur gaya suatu objek, meliputi gaya tarik, gaya dorong, daya rekat, gaya koefisien gesek, dan gaya lainnya. *Push pull gauge* dapat digunakan sebagai alat pengukur genggam sederhana, atau sebagai penguji gaya yang akurat dalam kombinasi denganudukan uji khusus.
