**LAPORAN *ON THE JOB TRAINING***  
**DI AKADEMI PENERBANGAN INDONESIA BANYUWANGI**  
**01 APRIL 2024 – 28 JUNI 2024**

**PROGRAM STUDI DIPLOMA 3 TEKNIK PESAWAT UDARA**  
**POLITEKNIK PENERBANGAN SURABAYA**  
**2024**

**LAPORAN ON THE JOB TRAINING  
DI AKADEMI PENERBANGAN INDONESIA BANYUWANGI**

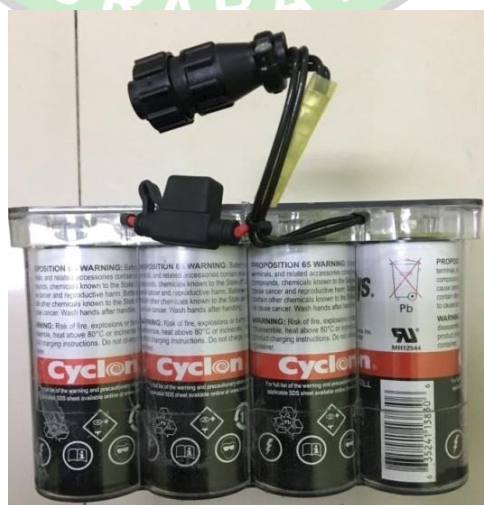
Gambar 3 5 Standby Battery

*Standby battery* pada pesawat terletak di belakang *Primary Flight Display*. *Standby battery PC board* dipasang di bagian belakang *switch panel*. *Standby battery PC board* mengontrol dan memantau pelepasan daya listrik ke dan dari *standby battery*.

Pengoperasian *Standby Battery*, dikendalikan oleh switch STDY BATT pada tiga posisi (ARM-OFF-TEST). Level energi *Standby Battery* dapat diuji dengan menempatkan *switch* pada posisi TEST selama 10 detik dan mengamati pencahayaan yang benar dari *test lamp*. Pada operasi *normal flight* dengan *switch* pada posisi ARM memungkinkan *standby battery* mengisi daya dari Bus Esensial G1000. Jika terjadi *alternator failure*, *standby battery controller* tidak akan membiarkan *standby battery discharge* ke Bus Esensial G1000 hingga habis atau rusak dari *main battery*. Maka dari itu hal ini diperlukan selama *preflight* untuk melakukan "energy level" acceptance test.

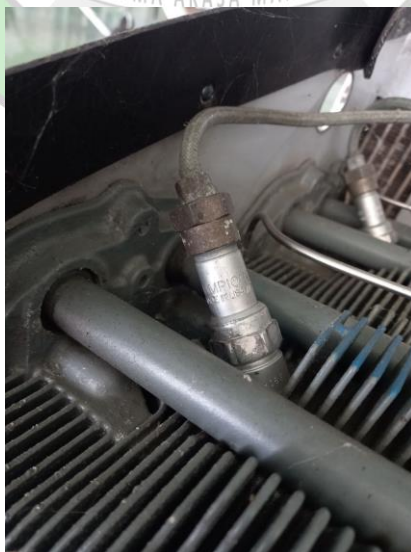
Gambar 3 6 Posisi Spark Plugs

Busi pesawat memiliki dua elektroda (cabang) di kedua sisi elektroda. Kesenjangan antara elektroda menciptakan percikan api yang menyulut campuran bahan bakar dan udara. Sistem pengapian pesawat, biasanya sepasang magnet, mengalirkan arus listrik ke busi. Setiap pesawat bersertifikat memiliki dua busi per silinder. Itu untuk pengapian yang lebih efisien, dan berfungsi sebagai redundansi keselamatan dasar. Jika salah satu busi rusak, silinder akan tetap menyala. Spark plug yang rusak akan menyebabkan silinder berhenti menghasilkan tenaga, yang akan membuat pesawat bergetar belum lagi kehilangan tenaga dalam jumlah besar. Anda dapat melihat efisiensi ini beraksi selama pemeriksaan magneto sebelum lepas landas. Saat berpindah ke kiri atau kanan, Anda mematikan separuh busi, sehingga mengakibatkan penurunan daya.

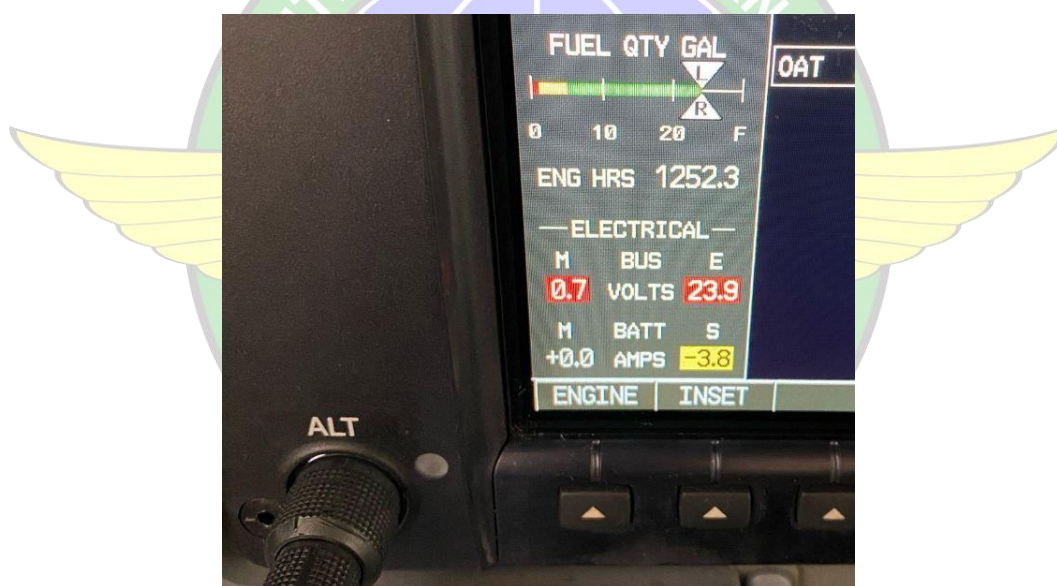
Gambar 4. 1 Standby Battery Tidak Charging

Pada tanggal 13 mei 2024 pesawat dengan registasi PK-BYL mendapatkan laporan bahwa pesawat ini saat groun run diketahui bahwa standby battery tidak *charging*. Permasalahan ini diketahui pada saat melakukan *engine run up* pagi hari. Dengan hal ini *engineer* mengambil Keputusan untuk menarik pesawat kembali ke hanggar untuk dilaksanakan *troubleshooting*

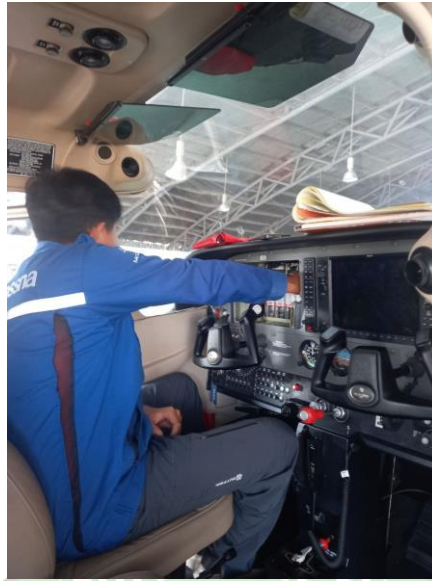
Gambar 4. 2 Remove Standby Battery

Sebelum melakukan Tindakan ketahap selanjutnya hal yang harus dilakukan pertamakali yaitu *removal* dengan mengikuti prosedur sesuai dengan aircraft maintenance manual (AMM) yang dilakukan sebagai berikut.

1. Berdasarkan permasalahan pertama pada bab 4, dapat disimpulkan bahwa *troubleshoot* ini terjadi akibat sekring rusak sehingga menyebabkan *standby battery* tidak *charging*. Dikarenakan sekring tidak dapat menahan arus daya yang besar sehingga mengalami *shorted*/rusak
2. berdasarkan permasalahan kedua pada bab 4, dapat disimpulkan bahwa terdapat spark plug yang mati/*broken* pada *cylinder* ke-4 yang mengakibatkan engine menjadi *vibrate*. Dikarenakan Penggunaan fuel yang terlalu boros/tidak meratanya fuel ke tiap-tiap *cylinder* sehingga mengalami spark plug yang mati
3. berdasarkan permasalahan ketiga pada bab 4, dapat disimpulkan bahwa terdapat kotoran/kerak/karbon di bagian sensor *oil temperature* yang mengakibatkan *indicator oil temperature* menjadi tinggi/*high*.

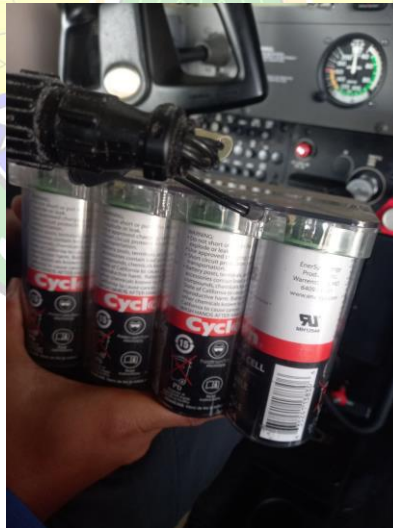
Gambar 4. 3 Inspection Standby Battery

Setelah dilaksanakan *removal* pada *standby battery* maka diperlukan Tindakan pengecekan / *inspection* pada *stanby battery* tersebut guna mengetahui permasalahan pada *stanby battery*.

Setelah di inspeksi ditemukan bahwa *standby battery* tersebut tidak *charging* menurut engineer disebabkan karena sekringnya *shorted*/rusak disebabkan karena tidak dapat menahan arus daya yang berlebihan sehingga *shorted*

Langkah selanjutnya yaitu mengganti sekring yang baru sesuai kapasitas yang dibutuhkan yaitu 25 *ampere*.

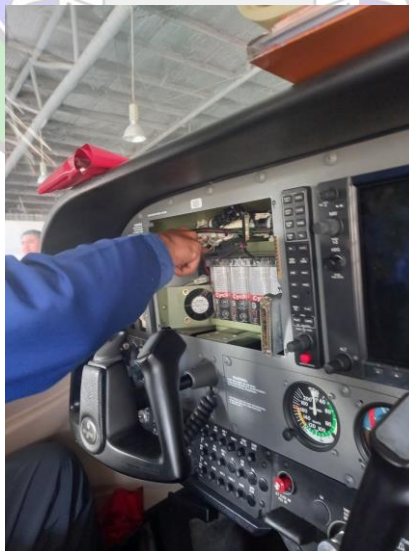
Gambar 4. 5 Install Standby Battery

Langkah-langkah *installation*/pemasangan standby battery kembali ke tempat awalnya sesuai dengan *book aircraft maintenance manual* Cessna 172S

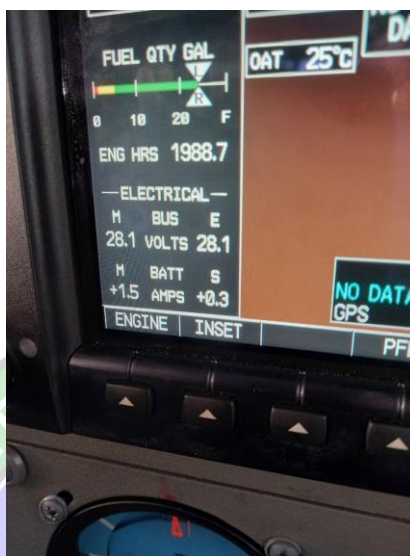
Gambar 4. 6 Tampilan Voltage Setelah Sekring di connectornya di ganti

Untuk memastikan standby battery beroperasi dengan baik dengan melakukan ground run up. Setelah diganti sekring yang baru bahwa standby battery dapat charger dengan baik yaitu +0.3 volts

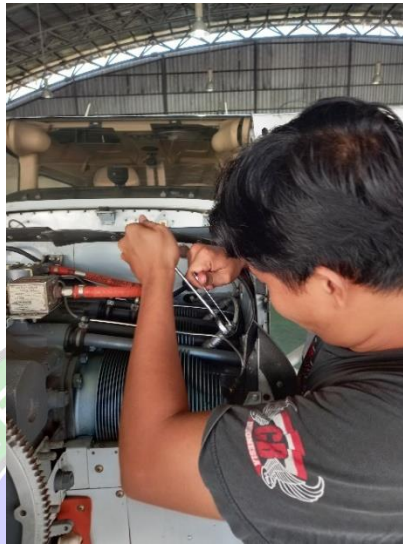
Gambar 4. 7 Removal Spark Plugs

Sebelum melakukan Tindakan ketahap selanjutnya hal yang harus dilakukan pertamakali yaitu *Removal/melepas spark plugs* dengan mengikuti prosedur sesuai dengan *aircraft maintenance manual (AMM)*

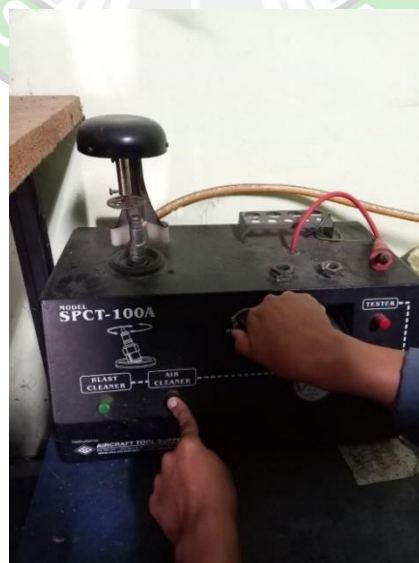
Gambar 4. 8 Cleaning Spark Plug

Setelah dilaksanakan *removal* spark plugs pada cylinder diperlukan Tindakan pengecekan/inspection pada spark plugs tersebut guna mengetahui permasalahan pada spark plugs yaitu dengan pengecekan gap, cleaning, and pengetesan

Setelah di cleaning dan pengetesan spark plug menggunakan alat apakah masih ada percikan atau tidak. Setelah dilakukan Pengetesan Spark Plugs ternyata pada spark yang *defective*/mati tidak mengeluarkan percikan api yaitu *spark plugs* pada *cylinder* ke-4

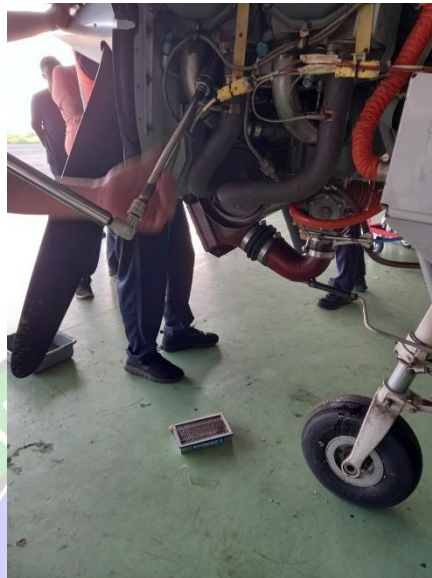
Gambar 4. 11 Installation Spark Plug

Setelah dilaksanakan pembersihan, pengetesean, dan penggantian *spark plugs* yang baru pada *cylinder* ke-4, dilanjutkan dengan pemasangan kembali *spark plugs* sesuai dengan *aircraft maintenance manual (AMM)*.

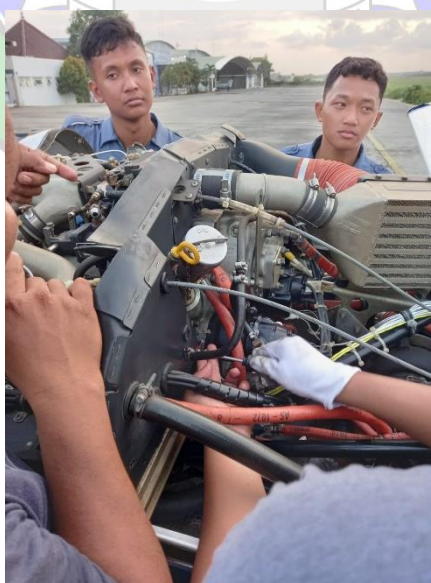
Gambar 4. 13 Remove Oil Temperature

Sebelum melakukan ketahap selanjutnya hal yang harus dilakukan pertamakali yaitu *removal* dengan mengikuti prosedur sesuai dengan *aircraft maintenance manual* (AMM) yang dilakukan.

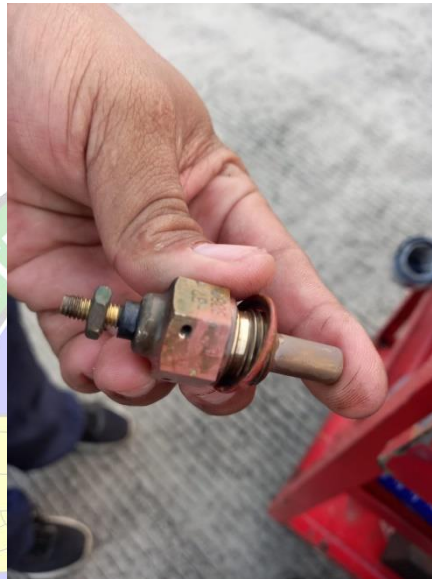
Gambar 4. 14 Inspection Oil Temperature

Setelah dilaksanakan removal pada *oil temperature* diperlukan Tindakan pengecekan / *inspection* pada *oil temperature* tersebut guna mengetahui permasalahan pada *oil temperature*. Saat dilakukan *inspection* ditemukan terdapat kotoran/kerak di area *connector* sensor *oil temperature* yang mengganggu sensor bekerja sehingga dalam indikator temperature menjadi tidak stabil

Sebelum dipasang kembali, *Oil Temperature* dibersihkan bagian *Connector* sensornya terlebih dahulu menggunakan *contact cleaner*. Lalu dikeringkan terlebih dahulu menggunakan majun/lap kain hingga benar-benar kering.

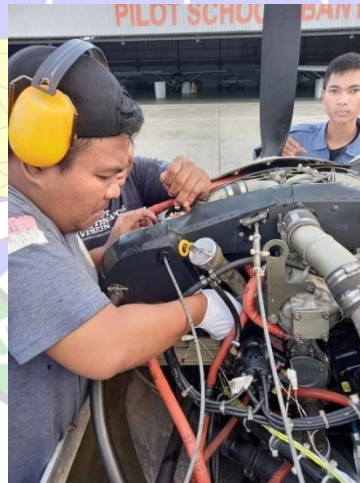
Gambar 4. 16 Installation Oil Temperature

Setelah dilaksanakan *cleaning* pada sensor *oil temperature* tersebut selanjutnya yaitu dengan *installation oil temperature* sesuai dengan *aircraft maintenance manual (AMM)*.

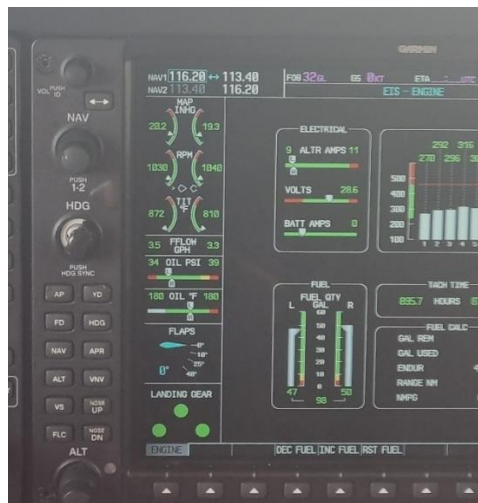
Gambar 4. 17 Tampilan Indicator Oil Temperature Setelah di Cleaning

Setelah proses *installation* selesai maka dilanjutkan dengan *functional test* dengan melakukan *ground run* untuk memastikan *oil temperature* normal sesuai *Aircraft Maintenance Manual (AMM)* yaitu 100-240°F dan memastikan bahwa pesawat tidak terdapat masalah terkait dengan *high oil temperature* lagi
