**LAPORAN *ON THE JOB TRAINING***  
**DI AKADEMI PENERBANGAN INDONESIA BANYUWANGI**  
**01 APRIL 2024 – 28 JUNI 2024**

**PROGRAM STUDI DIPLOMA 3 TEKNIK PESAWAT UDARA**  
**POLITEKNIK PENERBANGAN SURABAYA**  
**2024**

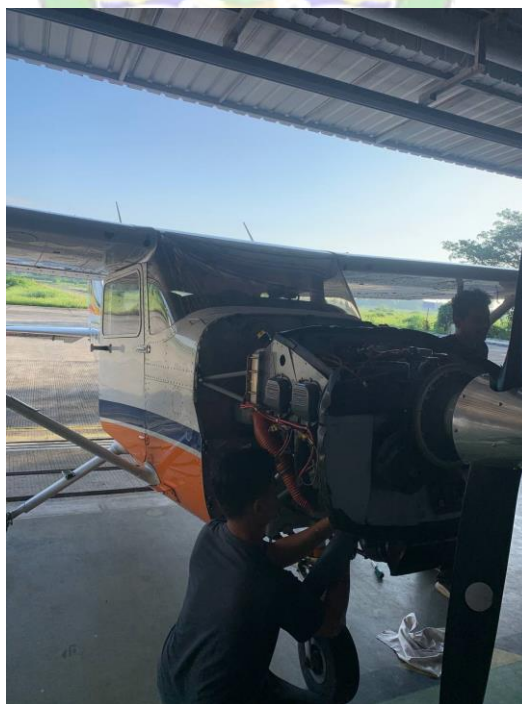
Gambar 3. 2 Maintenance Cessna 172S

Unit bengkel Akademi Penerbang Indonesia Banyuwangi menerapkan tradisional inspeksi, dimana inspeksi dilakukan setiap interval waktu tertentu menggunakan pedoman *flight hours* yang didasarkan pada jumlah jam operasional suatu pesawat terbang. Operasi yang tersisa mencakup semua persyaratan inspeksi yang jatuh tempo pada interval lain.

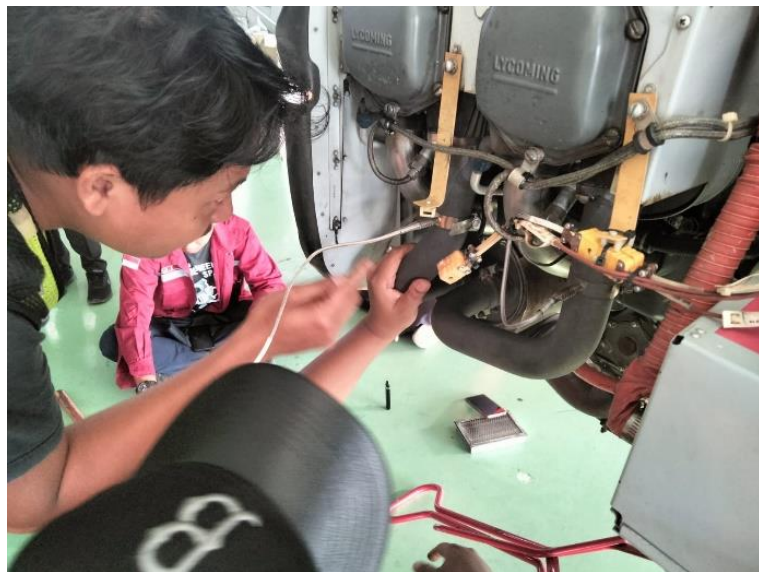
*Inspection* yang dilakukan adalah mengecek *connector* dari GEA dan membersihkannya dengan *contact cleaner*, tidak ada masalah pada konektor kemudian dipasang kembali. Tapi setelah dibersihkan *indicator* EGT dan CHT masih mengalami *red cross*, kemudian tindakan selanjutnya *engineer* mengganti/*replace* EGT dan CHT sesuai dengan *Maintenance Manual Chapter 77* seperti pada gambar 4.2, hasilnya ternyata sudah tidak terjadi *redcross* pada EGT dan CHT.

Gambar 4. 1 Inspeksi sensor *CHT*

Setelah dilakukan inspeksi kemudian *engineer* memutuskan *replace* sensor *CHT* dikarenakan *wire* yang menghubungkan sensor ke *GEA 71* mengalami *burn*.

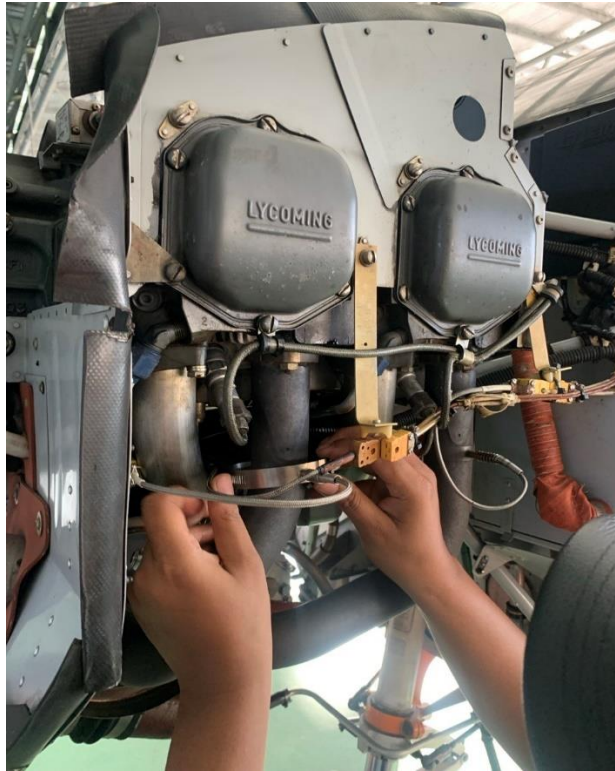
Gambar 4. 2 melepas sensor CHT

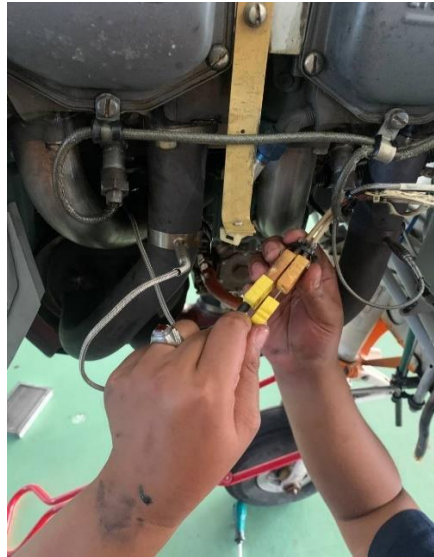
Langkah untuk *reassembly* sesuai dengan *Maintenance Manual Chapter 77*. Pada umumnya giat ini merupakan pemasangan kembali CHT pada gambar 4.3 ke *engine* dan menutup kembali panel yang di buka.

gambar 4. 4 Reassembly CHT

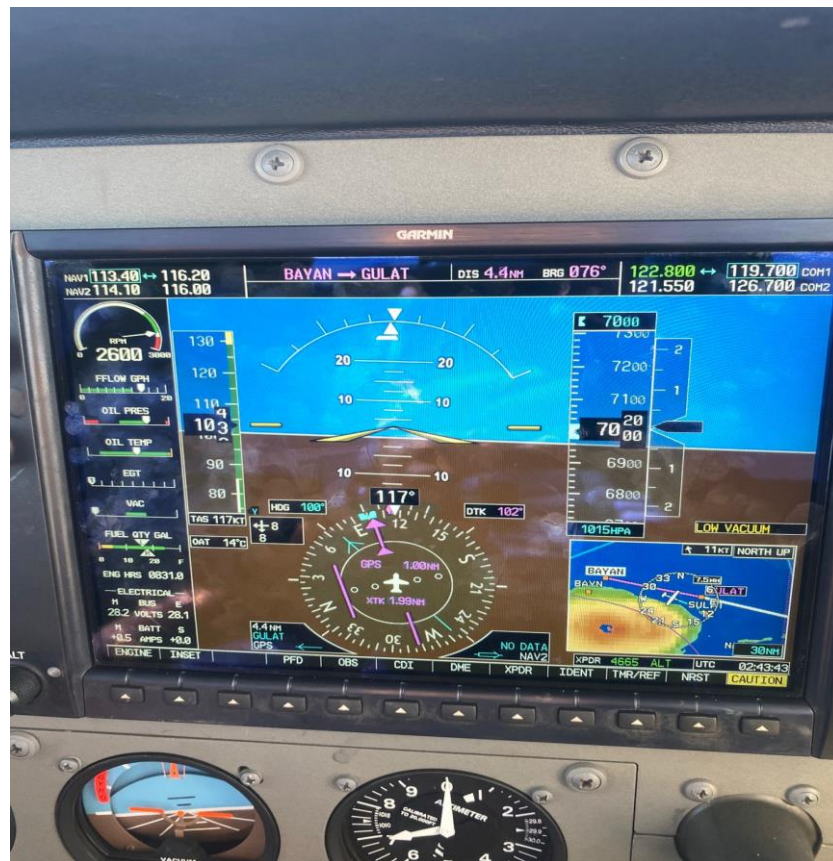
Trouble yang dialami pada *vacuum pump* kali ini adalah failed. Failed yang terjadi pada *vacuum pump* ini mengakibatkan tidak berkerjanya *vacuum pump*

meskipun saat engine menyala. Hal ini dikarenakan shear coupling yang menghubungkan gear pada vacuum pump dengan accessories gear pada engine mengalami kerusakan berupa putus atau patah. Bahan pada shear coupling ini dari berbahan hampi menyerupai plastic dan karet yang keras dan sedikit banyak untuk penggantian shear coupling baru yaitu on condition melihat kondisi *shear coupling*.

Gambar 4. 8 Low vacuum pada Garmin 1000

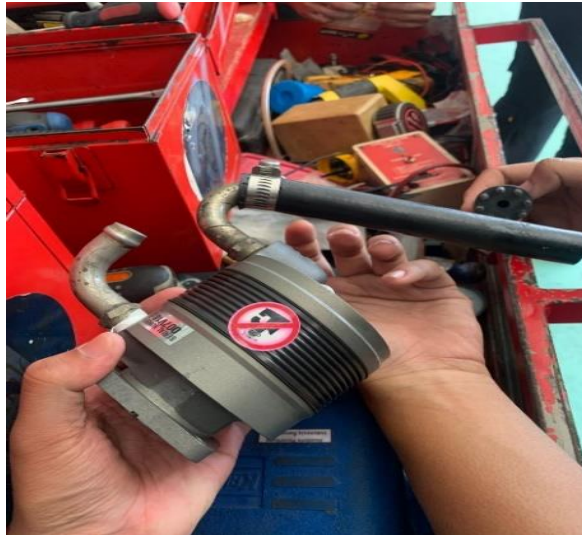
Inspection dilakukan untuk mengetahui permasalahan yang ada di *vacuum pump*. Pada saat inspeksi ditemukan bahwa *shear coupling* yang ada di dalam *vacuum pump* patah yang disebabkan karena *friction*, bisa dilihat seperti pada gambar 4. 11

Gambar 4. 11 Komponen *vacuum pump*

Setelah mengetahui permasalahan pada *vacuum pump* yakni terjadi aus dan patah pada *shear coupling* maka engineer memutuskan untuk dilakukan tindakan *replace* pada *vacuum pump*.

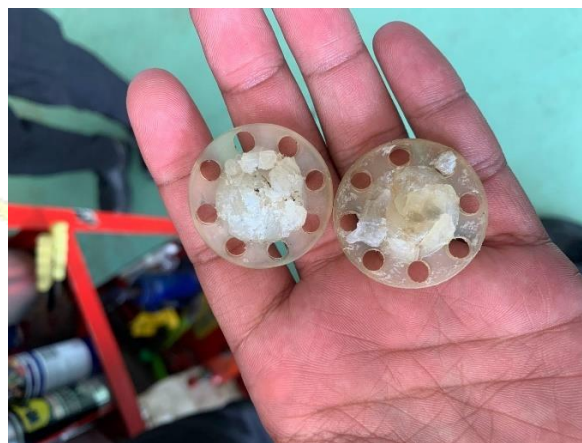
gambar 4. 12 Shear Coupling

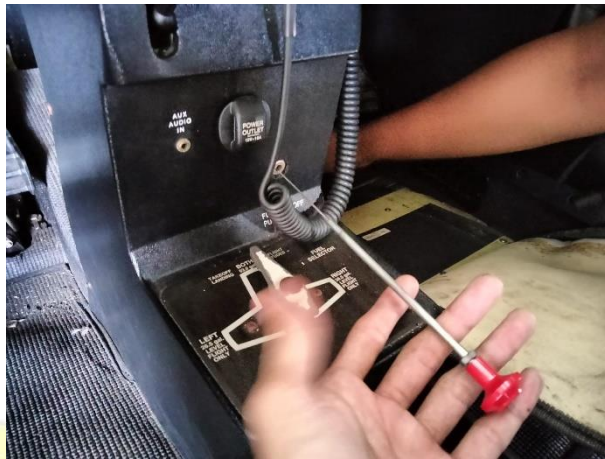
Setelah *screw* dan *lock nut* terlepas selanjutnya dilakukan inspeksi pada gambar 4.24 ternyata *shutoff valve cable* nya putus dikarenakan pilot terlalu kencang saat menarik.

Gambar 4. 14 *Fuel shutoff valve control cable* terputus

Pada gambar 4.25 setelah dilakukan inspection kemudian engineer memutuskan untuk melakukan *replace* pada *fuel shutoff valve control cable* dengan yang baru sesuai dengan part number yaitu S1533-9

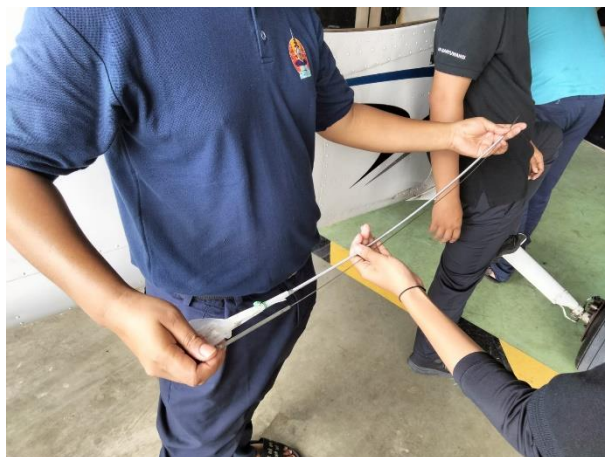
Gambar 4. 15 *Replace pada fuel shutoff valve control cable* sesuai part Number S1533-9

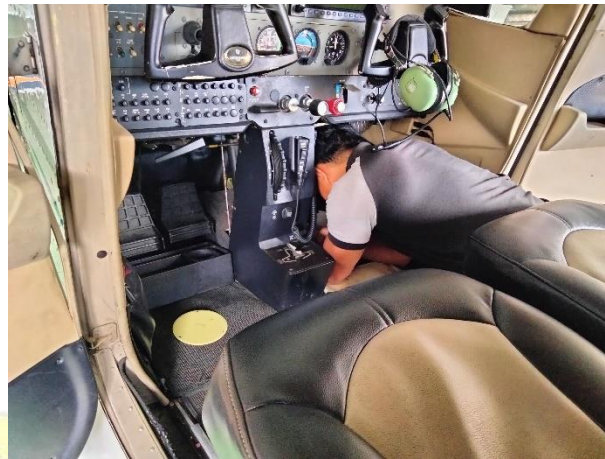
Setelah dilakukan *replace* pada *fuel shutoff valve control cable* dengan yang baru kemudian pada gambar 4. 26 *engineer* melakukan *installation* pada komponen sesuai dengan AMM ata chapter 28-20-00 page 215, pasang *lock nut* lalu kencangkan hingga minimum 15 inch/pouuds dan pastikan *control arm* bergerak dengan lancar . Setelah itu kencangkan *screw* dan pasang kembali *copilot's rudder pedal shields*.

Gambar 4. 16 *Installation fuel shutoff valve control cable* sesuai AMMCessna 172S Skyhawk.

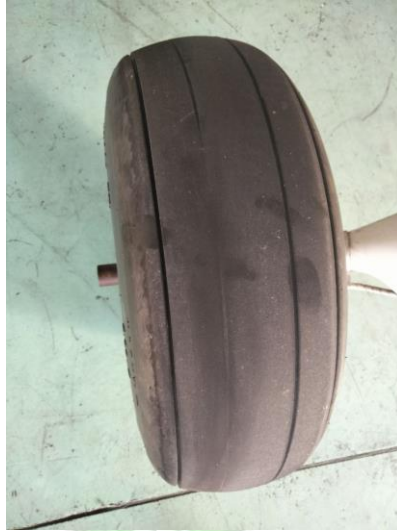
Pada tanggal 25 juni 2024 *engineer* menemukan *defect* pada saat inspeksi preflight secara visual pagi hari, ditemukan bahwa *left main wheel* pada pesawat PK-BYS mengalami *spot* atau aus seperti pada gambar 4. 33,

sehingga *engineer* memutuskan untuk membawa pesawat tersebut ke hanggar c untuk dilakukan *replace* pada *left main wheel*.

Gambar 4. 17 *Left main wheel spot*

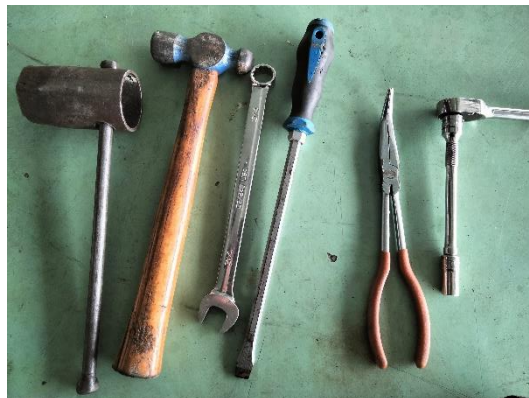
Gambar 4. 18 *Tool* yang digunakan untuk *melepas left main wheel*

Dilakukan *disassembly* sesuai AMM ata chapter 32-40-00 seperti pada lampiran 10 di mulai dengan memberi *jack* pada *strut left main wheel* pesawat setelah itu melepas *cotter pin* dengan *cutting plier*; lalu lepas *nut* menggunakan *special tool* seperti pada gambar 4. 34, lalu melepas *bolt* yang terpasang pada *back plate assembly* dan *pressure plate assembly* lalu melepas *backing plate* lalu menarik *wheel* dari *axle* lalu membuka *tire* seperti pada gambar 4. 35.

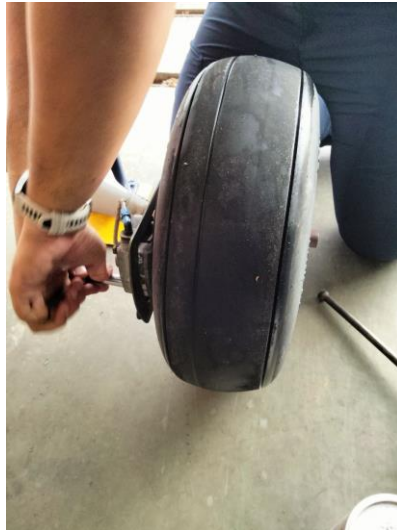
Gambar 4. 19 *Disassembly left main wheel PK-BYS*

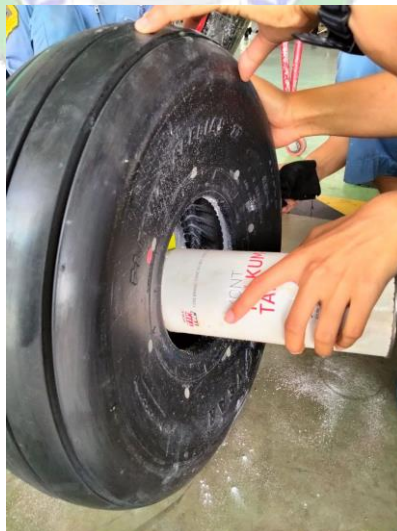
Setelah *disassembly* kemudian langkah selanjutnya memberi *mont talkum talc* pada *main wheel* yang berfungsi menyerap kadar air didalam *wheel* seperti pada gambar 4. 36. setelah itu dilakukan pemasangan *main wheel* dengan yang baru seperti pada gambar 4. 36. Kemudian diberi tekanan 42 *psi*

Gambar 4. 20 Memberi *mont talkum talc* pada *wheel*

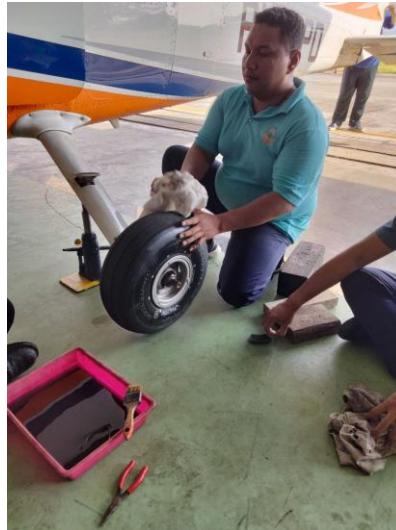
Gambar 4. 21 Setelah dilakukan *replace* pada *main wheel*
