**LAPORAN ON THE JOB TRAINING PT. BATAM AERO TECHNIC  
BASE MAINTENANCE BATAM  
Tanggal 19 Januari-26 Maret 2026**

**PROGRAM STUDI DIPLOMA 3 TEKNIK PESAWAT UDARA  
POLITEKNIK PENERBANGAN SURABAYA  
2026**

Gambar 3. 4 Airbus 330-900neo PK-LES

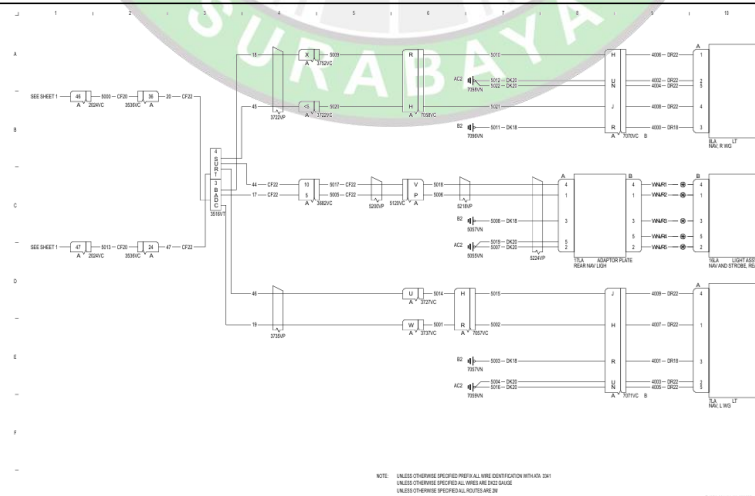
Gambar 3. 5 Wairing Diagram Strobe Light Tail Cone

Figure 33-41-01 P 0033 (SHEET 2/2) - LIGHTS - NAVIGATION LIGHTS - PWR SPLY & CTL  
\*\* ON A/C FSN 051-052, 054-055, 057-100

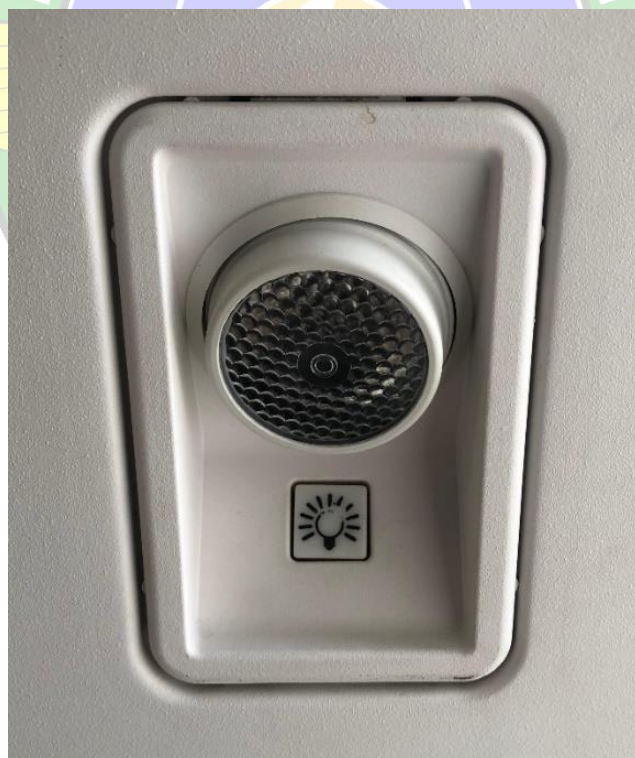
Gambar 3.7 pushbutton switch light reading door 1 R/H

Pada tanggal 12 Februari 2026 pada saat melaksanakan *perform task card* (A330-521104-01-1-02-IDN) pada pesawat dengan registrasi PK-LES ditemukan faindingan pada *light reading door 1 R/H can not operate*, setelah itu dilakukan *visual inspection* dan ditemukan pushbutton switch tidak dapat dioperasikan dengan baik. *faindingan* tersebut akan di *record* pada MDRR (*Maintenance Deffect and Rectification Report*) untuk diserahkan ke *engineer* untuk memastikan Langkah apa yang akan diambil untuk menyelesaikan faindingan tersebut.

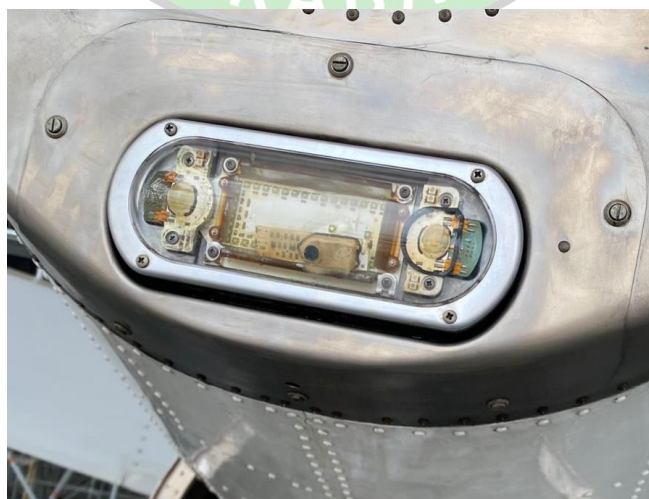
Gambar 3. 7 rear strobe light

Pada tanggal 19 Febuari 2026, Dilakukan *operational test* pada *Rear strobe light* dengan ref. Taskcard A330-2L-311-01-1-IDN. Pada pelaksanaan operational check ditemukan adanya trouble pada rear strobe light, Dimana lampu tersebut tidak dapat menyala, setelah dilakukan identifikasi pada part tersebut ditemukan *defect* pada rear strobe light, seperti pada gambar 3.5, lampu dalam kondisi terlepas atau tidak terhubung pada konektor yang ada. Maka dari itu Engginer melakukan trouble shoot pada *rear strobe light*.

Permasalahan rear strobe light yang tidak menyala disebabkan oleh kerusakan pada unit lampu itu sendiri (*internal failure*). Tindakan perbaikan yang dilakukan adalah dengan mengganti komponen rear strobe light dengan unit yang layak pakai (*serviceable*), sehingga sistem *anti-collision light* dapat beroperasi kembali secara normal sesuai dengan prosedur yang tercantum dalam Aircraft Maintenance Manual (AMM).

| <b>Indam aero technic</b> | | <b>MAINTENANCE DEFECT &amp; RECTIFICATION REPORT</b> | | | MDRR NO. : <b>221460</b> | |
|---|---|---|---|---|---|---|
| 1. | <b>PERFORM REPLACEMENT INSTALLATION OF THE REAR NAVIGATION AND STROBE LIGHT ASSEMBLY HAS BEEN DONE<br/>REF AMM : 33-41-17-400-801-A</b> | <b>1.0</b> | | <b>19 / Feb 2026</b> | | |

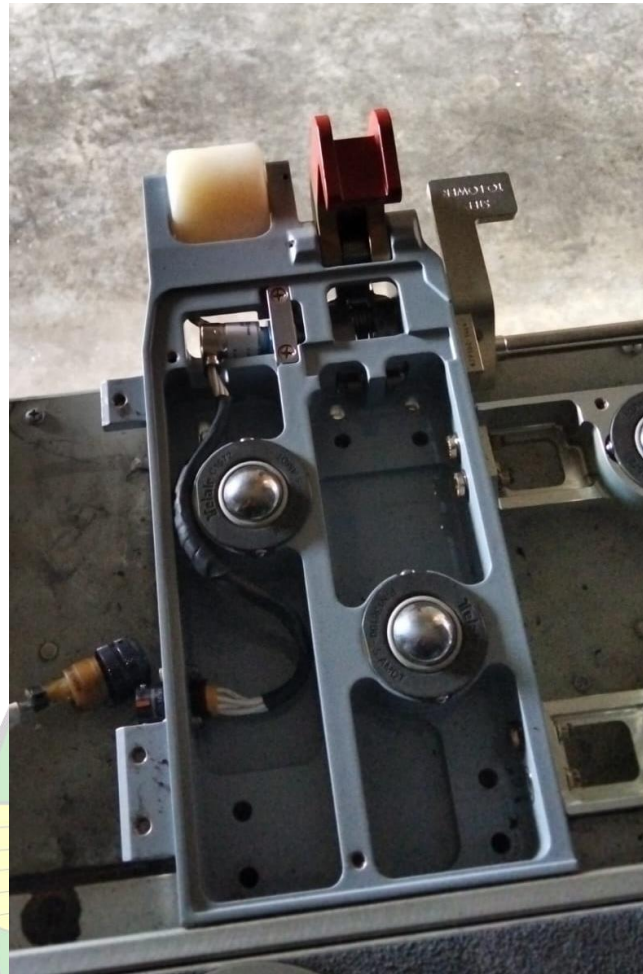
Gambar 3.8 doorsill latch aft cargo door

Pada tanggal 10 Januari 2026 pada saat melaksanakan *perform task card* (A330-ZL-822-01-1-IDN, *general visual inspection of aft cargo compartment door, including lock fittings at door sill, door seals, door frames at fuselage and visible part of door sill* *ewis*) pada pesawat dengan registrasi PK-LES dilakukan *visual inspection* dan ditemukan kerusakan pada *latch cargo door*, faindingan tersebut akan di *record* pada MDRR (*Maintenance Deffect and Rectification Report*) untuk diserahkan ke *engineer* untuk memastikan Langkah apa yang akan diambil untuk menyelesaikan faindingan tersebut.

Dari hasil pemeriksaan awal, ditemukan bahwa *door sill latch* mengalami kerusakan fisik (*broken*) sehingga tidak dapat berfungsi dengan baik.

Berdasarkan hasil pemeriksaan tersebut, disimpulkan bahwa kerusakan disebabkan oleh kegagalan struktural pada *door sill latch* itu sendiri (*mechanical failure*), bukan akibat sistem lain.

Setelah dilakukan proses penggantian (*replacement*) pada komponen door sill latch menggunakan part yang serviceable, dilanjutkan dengan pelaksanaan functional check pada sistem cargo door sesuai referensi Aircraft Maintenance Manual (AMM). Hasil pengujian menunjukkan bahwa door sill latch dapat berfungsi dengan baik dalam proses penguncian (*locking*) dan pembukaan (*unlocking*) cargo door. Mekanisme latch dapat engage dan disengage secara sempurna tanpa adanya hambatan, kelonggaran (*looseness*), maupun misalignment pada struktur pintu.
