**LAPORAN *ON THE* JOB TRAINING**  
**DI FL TECHNICS INDONESIA HANGGAR BALI**

**PROGRAM STUDI DIPLOMA 3 TEKNIK PESAWAT UDARA**  
**POLITEKNIK PENERBANGAN SURABAYA**  
**2024**

### LAPORAN *ON THE JOB TRAINING* (OJT) DI PT. AVIA TECHINICS DIRGANTARA (FL TECHINICS INDONESIA)

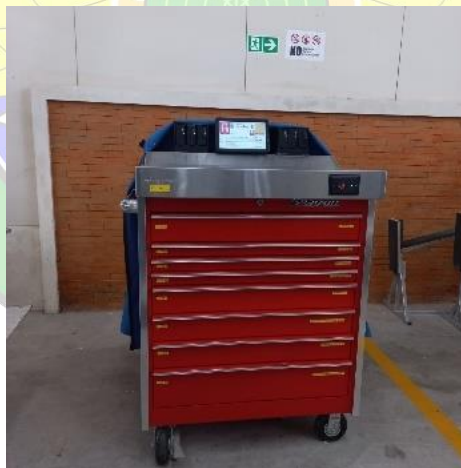
Gambar 2. 12 Automated Tool Control

*Tools rack* seperti pada gambar 2. 12 , memiliki beberapa laci dan memiliki *automated tool control system* yang berfungsi untuk mencatat alat mana saja yang dipakai dan telah dikembalikan oleh teknisi.

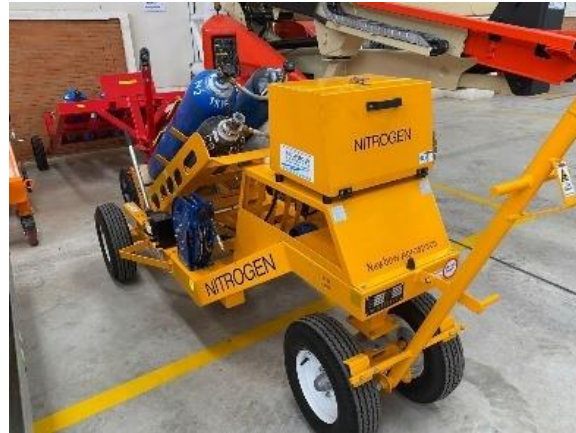
Gambar 2. 13 Nitrogen Service Cart

*Nitrogen Service Cart* adalah jenis GSE yang digunakan untuk menyediakan dan mengisi sistem pesawat dengan nitrogen yang

dirancang khusus untuk menyimpan, mengangkut, dan mengalirkan nitrogen ke pesawat dapat dilihat pada gambar 2. 13.

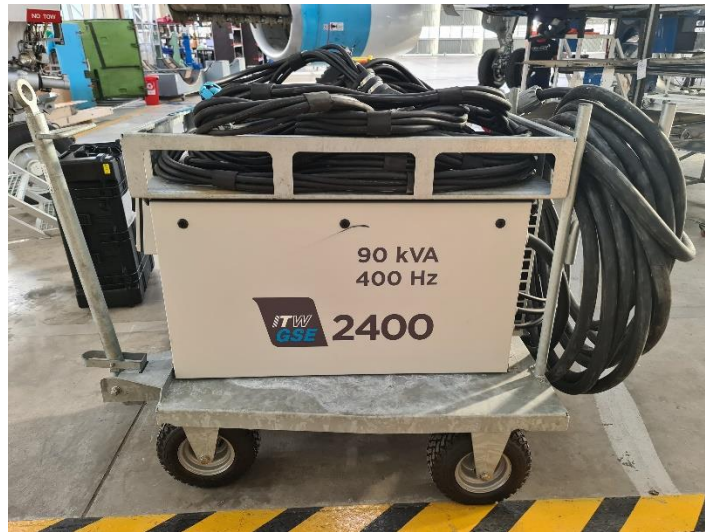
Gambar 3. 2 Ground Power Unit

*Ground Power Unit (GPU)* yang dapat dilihat pada gambar 3. 2, merupakan penyuplai daya listrik ke pesawat saat berada di *ground* dan ketika mesin dimatikan. Pesawat terbang memerlukan daya pada frekuensi listrik 115 volt dan 400 Hz, sedangkan pesawat kecil memerlukan daya 28

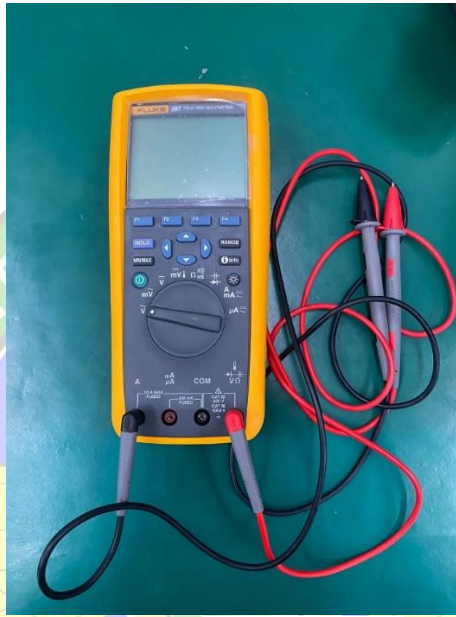
Gambar 3. 5 Multimeter digital

Multimeter digital yang dapat dilihat pada gambar 3. 5 dan tabel 3. 3, digunakan untuk mengukur besaran listrik seperti tegangan, kuat arus, dan hambatan listrik. Akurasi pengukuran dengan multimeter digital sangat tinggi. angka yang ditampilkan sebagai hasil pengukuran dapat memiliki beberapa angka desimal.

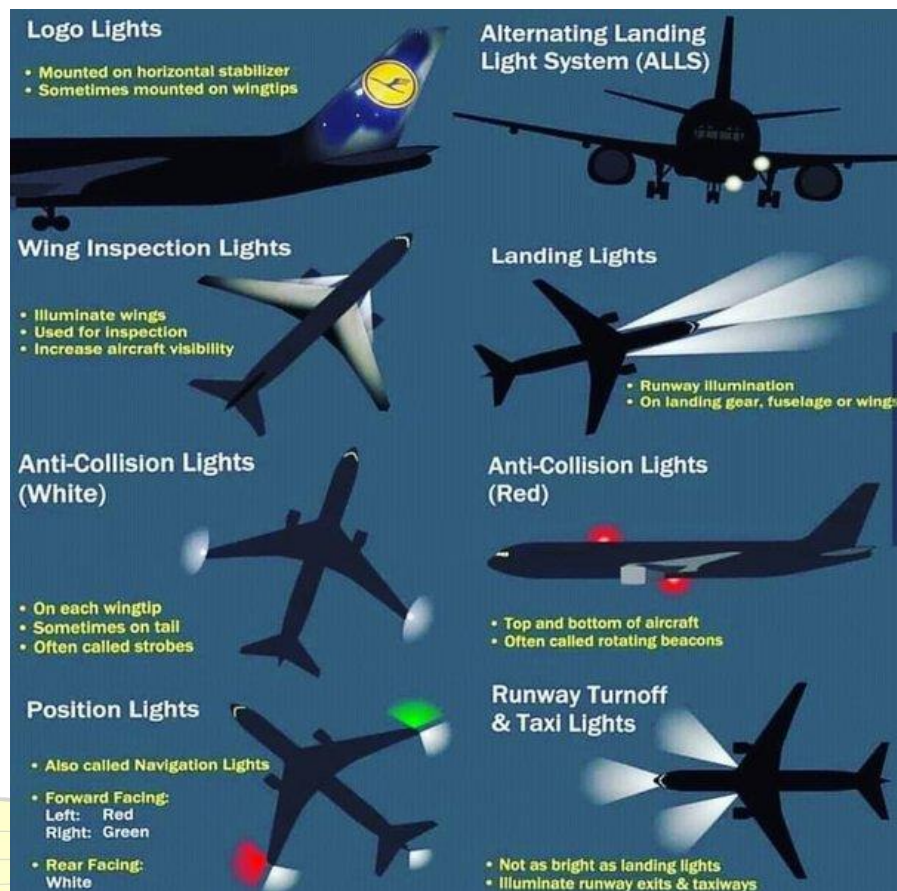
Gambar 3. 7 Exterior Lighting  
(Sumber: Quora)

*Exterior lighting* yang dapat dilihat pada gambar 3. 7 dan tabel 3. 4, merupakan penerangan bagian luar dari pesawat terbang untuk keperluan *landing, taxi, dan position navigation*.

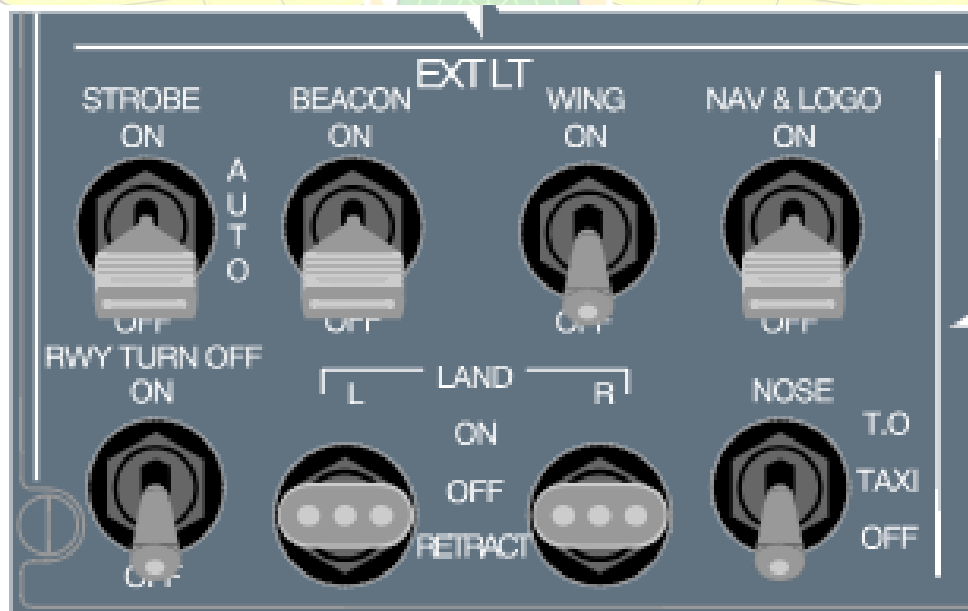
Gambar 3. 8 Overhead Panel Exterior Light

Lampu ini biasa juga disebut *wing inspection lights* yang berfungsi sebagai lampu penerangan sayap. lampu ini ditempatkan pada badan pesawat dibagian depan sayap dan sejajar dengan level lantai kabin. lampu ini ada dua, yaitu pada bagian sebelah kanan dan kiri badan pesawat. Daya untuk lampu ini adalah 28 V AC melalui panel P18 *circuit breaker wingscan*. *Wing scanning light* dapat dikendalikan melalui cockpit tepatnya pada *overhead panel exterior light* (P-5) yang dapat dilihat pada gambar 3. 8 dan *Wing Scanning Light Wiring Diagram* pada gambar 3. 9.

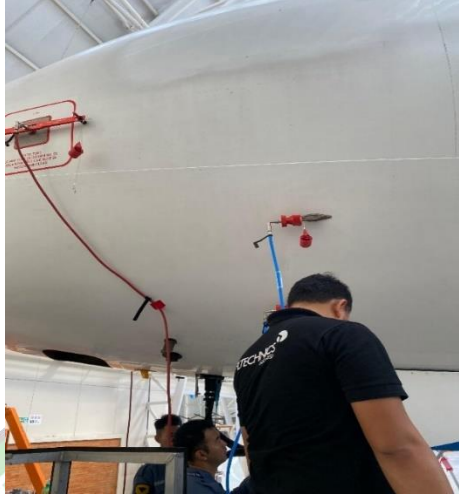
Gambar 3. 12 Pitot probe

Dapat dilihat pada gambar 3. 12 *pitot probe* terhubung pada *pitot static* melalui *pitot tube* dan *static line*. *Pitot static system* beroperasi pada 2 tipe *pressure*:

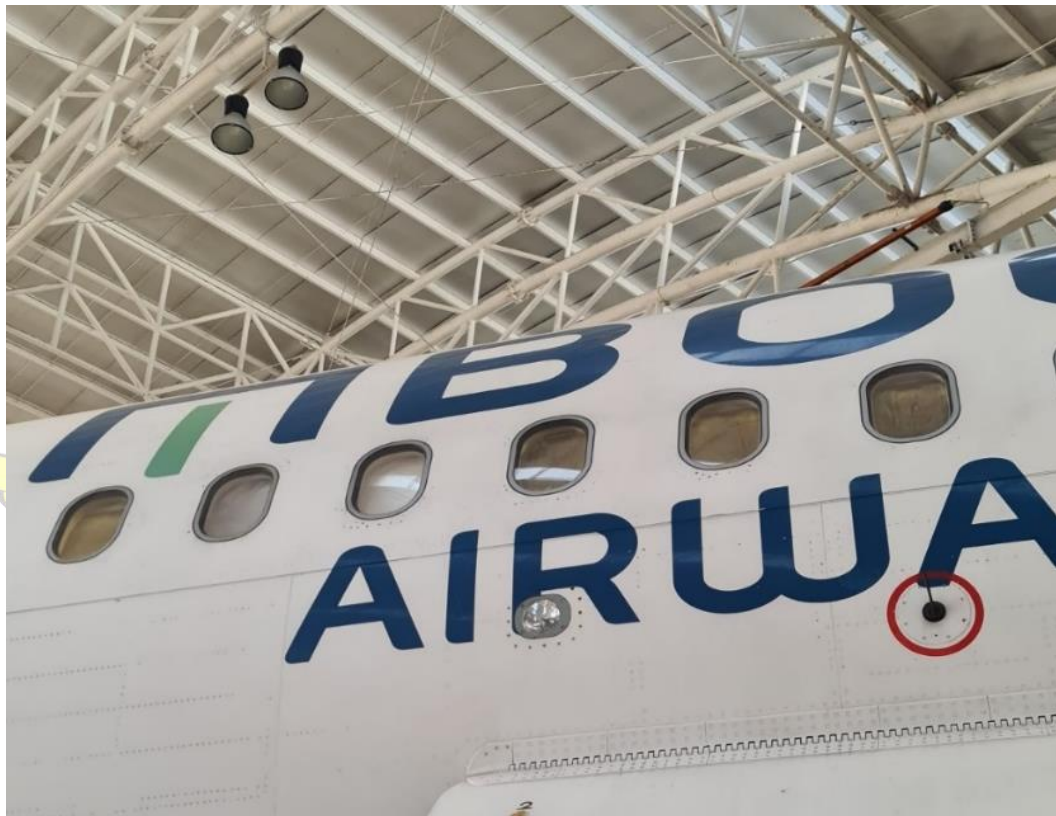
Gambar 4. 3 R/H Wing Scanning Light Not Illuminate

Pada tanggal 6 May 2024, saat melakukan *daily check* pesawat Airbus A320 CEO dengan registrasi VP-CCI, saat sesi *external light check*, setelah *switch wing and engine scanning light* di kokpit pada *overhead panel 25VU* di on kan, *Right Wing and Engine Scan Lighting* tidak menyala dan dapat dilihat pada gambar 4. 3.

Setelah melakukan *rectification*, *engineer* dapat mengetahui penyebab kerusakan dan tindakan yang dilakukan untuk memperbaiki kerusakan tersebut dengan melakukan *Replacement of the Lamp of the Wing and Engine Scan Light* yang dapat dilihat pada gambar 4. 5.

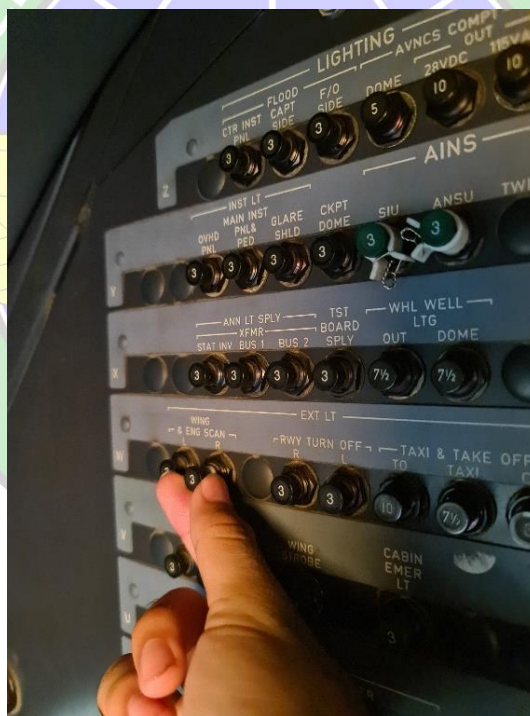
Gambar 4. 4 Circuit Breaker Wing Scanning Light

Untuk mengetahui sumber permasalahan pada *wing scanning light* dengan memastikan *circuit breaker* dalam keadaan *close* dapat dilihat pada gambar 4. 4.

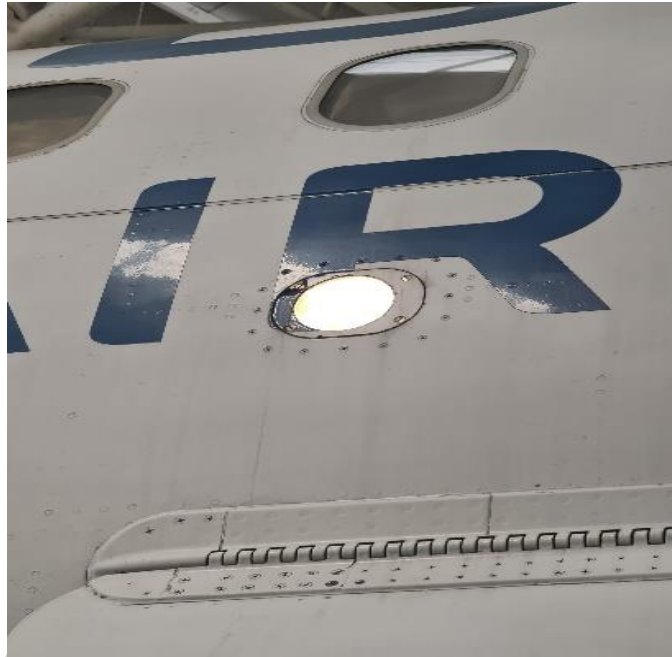
Gambar 4. 6 R/H Wing Scanning Light Illuminate

Setelah pelaksanaan *replacement* maka dilakukan, *Functional Test* yang dilakukan dapat dilihat pada tabel 4. 3. *Right wing scanning light* benar-benar berfungsi secara normal dapat dilihat pada gambar 4. 6.

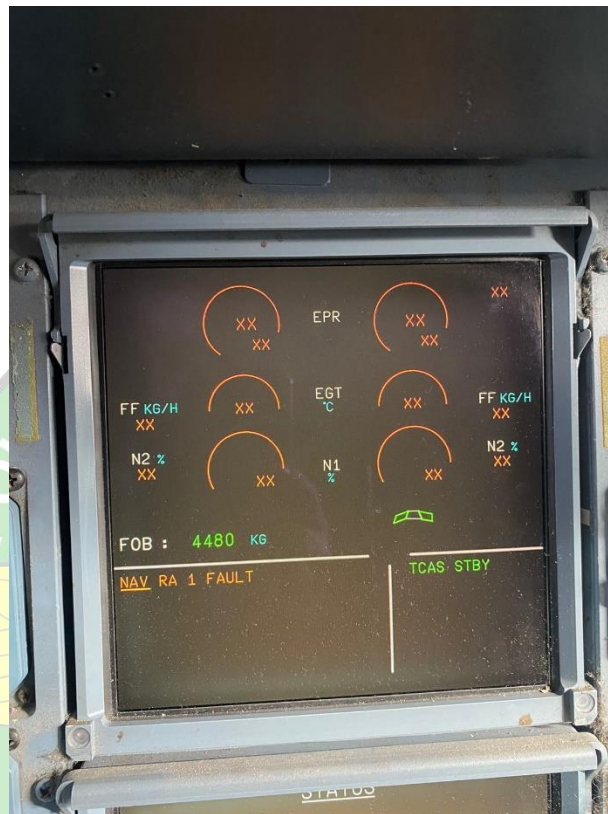
Gambar 4. 9 Radio Altimeter No. 01 Fault

Pada tanggal 10 May 2024, pada saat teknisi melakukan *Bite Test Radio Altimeter 1 and 2* ditemukan pada *Electronic Centralized Aircraft Monitor (ECAM)*, *RA 1 Fault* yang dapat dilihat pada gambar 4. 9.

*Repair* yang dilakukan, yaitu *Replacement CVR- RA* yang dapat dilihat pada gambar 4. 10.

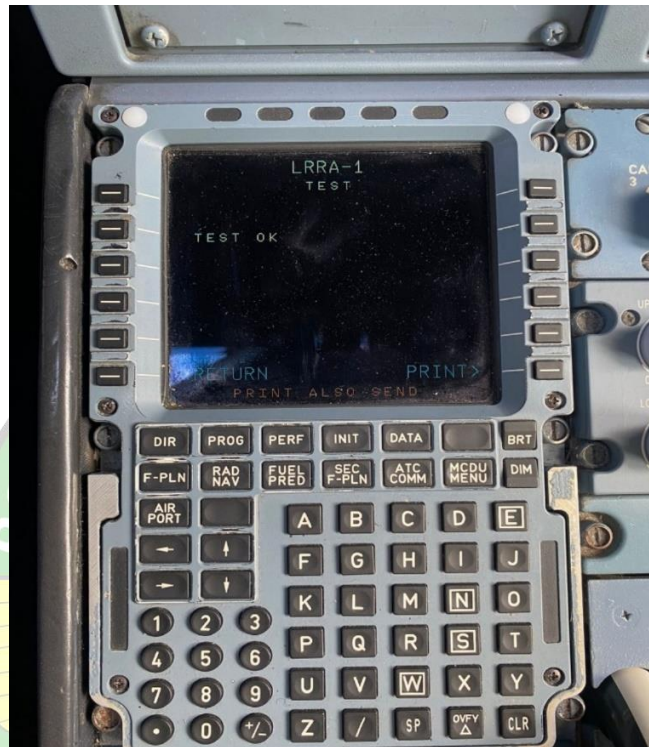
Gambar 4. 12 LRRA-1 Result Satisfied

Setelah semua prosedur dilakukan dan komponen berfungsi kembali secara normal maka permasalahan ini dapat dinyatakan telah selesai yang dapat dilihat pada gambar 4. 12.

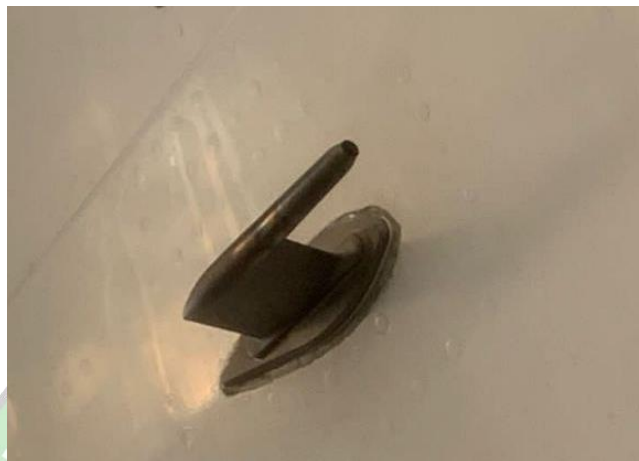
Gambar 4. 14 Pitot Probe

| No | Action | Result | Conclusion |
|---|---|---|---|
| 1 | Melakukan <i>Visual Inspection</i> pada <i>Static Probe</i> | <i>Problem still exist</i> dan tidak terdapat kerusakan pada <i>Static Probe</i> | <i>Static Probe is in good condition</i> |

Repair yang dilakukan pada *static pressure lines* setelah *Visual Inspection* yaitu dengan melakukan *flushing* yang dapat dilihat pada gambar 4. 16. Berikut adalah *tool* yang diperlukan untuk melakukan *Flushing Static Pressure Lines* yang dapat dilihat pada tabel 4. 10 dan gambar 4. 15.

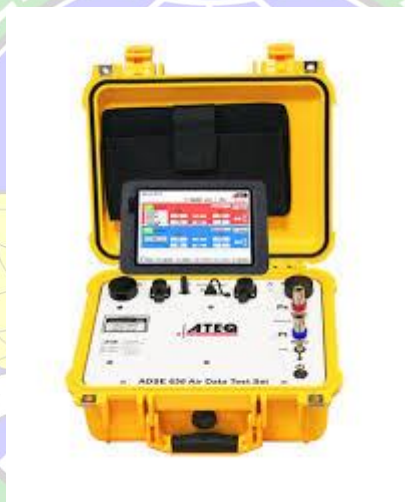
Gambar 4. 17 ADSE 650

Setelah pelaksanaan *Repair* maka dilakukan *Functional Test ADM Accuracy* dengan menggunakan ADSE 650 yang dapat dilihat pada gambar 4. 17.
