**LAPORAN *ON THE JOB TRAINING*  
DI FL TECHNICS INDONESIA – HANGGAR BALI**

**01 April 2024 – 30 Juni 2024**

**MADE ANGGA REDITYA  
NIT 30421014**

**PROGRAM STUDI DIPLOMA 3 TEKNIK PESAWAT UDARA  
POLITEKNIK PENERBANGAN SURABAYA  
2024**

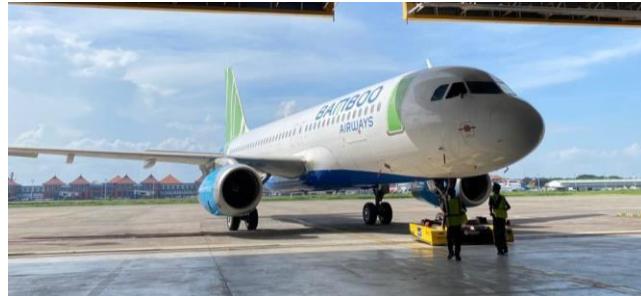
Gambar 3 1 Airbus A320

Airbus A320 adalah pesawat penumpang komersial jarak dekat sampai menengah yang diproduksi oleh Airbus. A320 merupakan pesawat penumpang pertama dengan sebuah sistem kendali *fly-by-wire* digital, di mana pilot mengendalikan penerbangan melalui penggunaan sinyal elektronik dan bukan secara mekanik dengan *handle* dan sistem *hydraulic*. Kelompok pesawat A320 (yang termasuk A318, A319, A320, dan A321, serta pesawat jet bisnis ACJ) adalah satu-satunya kelompok pesawat berbadan sempit (*narrow-body*) yang diproduksi Airbus yang dapat dilihat pada gambar 3.1.

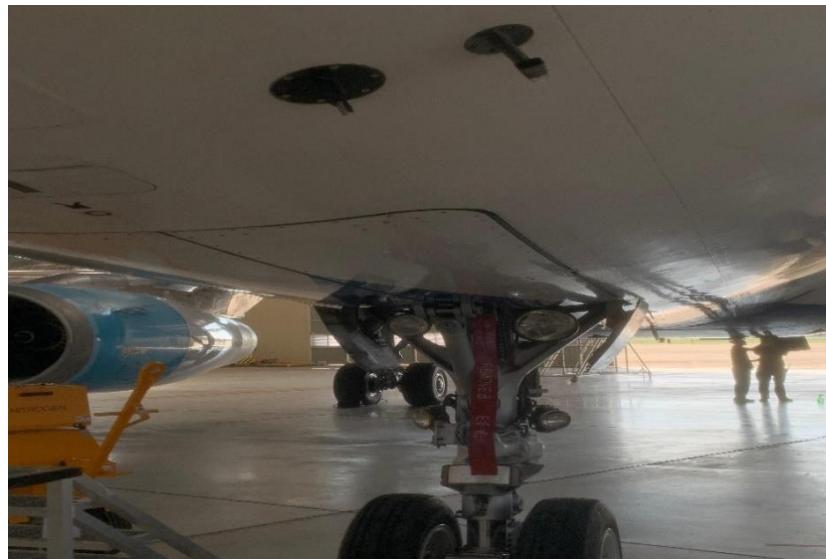
Gambar 3 5 Taxi Light

*Taxi Light* adalah lampu dengan intensitas sedang yang dipasang pada *nose landing gear* yang dapat dilihat pada gambar 3.5. *Taxi light* menghasilkan cahaya yang terang, sering kali berwarna putih atau kekuningan. Intensitas cahayanya dirancang sedemikian rupa agar dapat membedakan pesawat dari latar belakang dan objek di sekitarnya dengan jelas. Lampu ini digunakan untuk memberikan penerangan pada taxiway selama operasi di darat, seperti saat *taxiing* (pergerakan di landasan bandara), *takeoff* (lepas landas), dan *landing* (mendarat). Fungsi utama dari *taxi light* adalah untuk meningkatkan visibilitas pesawat di sekitar area bandara dan landasan, serta untuk memberikan peringatan kepada kendaraan dan pejalan kaki lainnya yang berada di sekitar pesawat. Lampu ini selalu mengikuti putaran *nose gear wheel*, dikontrol dengan switch dapat di set ON/OFF. Lampu dapat menyala secara otomatis, Ketika *nose gear* pada posisi *extended*.

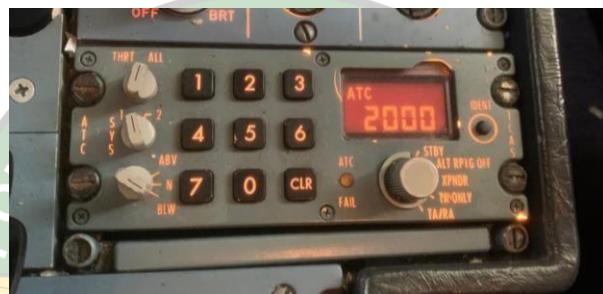
Gambar 3.6 TCAS

Pada sistem kokpit modern yang ada di pesawat udara, layar TCAS memiliki kemungkinan untuk digabungkan dengan layar Navigasi (*Navigation Display/ND*) atau pada layar EHSI (*Electronic Horizontal Situation*).

TCAS melibatkan komunikasi antara seluruh pesawat udara yang dilengkapi dengan penerima sinyal (*transponder*) yang telah diaktifkan. Tiap-tiap instrumen TCAS akan mendeteksi sinyal instrument TCAS lain dalam jarak yang telah ditentukan (via frekuensi radio 1,030 MHz) dan pesawat udara yang lain (yang pada saat itu berada dalam jarak jangkauan instrumen TCAS) akan menjawab panggilan tersebut (via frekuensi radio 1,090 MHz).

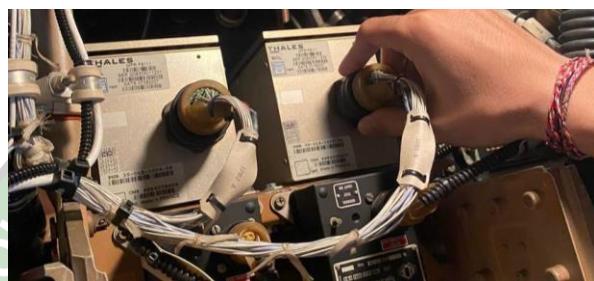
Gambar 3 7 Battery Charge limiter

BCL menggunakan sensor tegangan untuk memantau tegangan baterai saat pengisian. Sensor ini memberikan informasi yang diperlukan untuk mengatur arus masuk sesuai dengan kebutuhan. BCL terintegrasi dalam sistem manajemen daya pesawat yang lebih besar. Ini mencakup hubungannya dengan generator utama pesawat, sistem distribusi listrik, dan panel kontrol yang memungkinkan pilot atau sistem otomatis untuk memantau dan mengatur operasinya

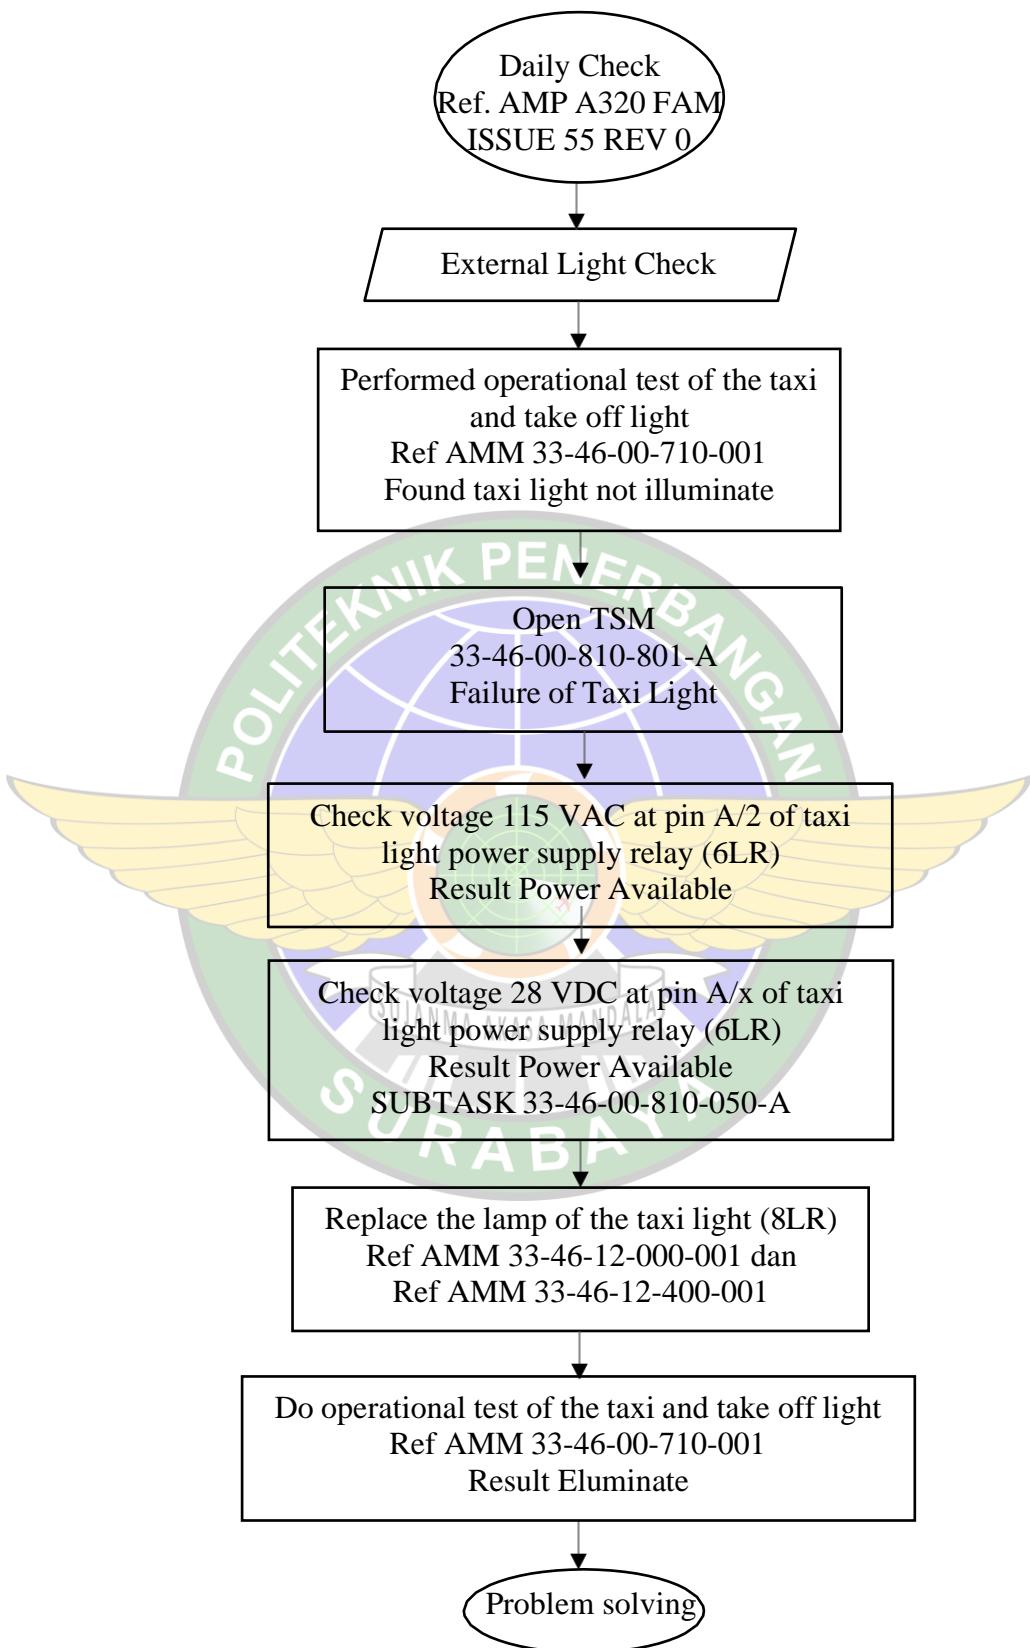
Bagan 4.1 Flowchart Troubleshooting Taxi Light

Pada pesawat Airbus A320 dengan registrasi LY – NVJ ditemukan pada saat pelaksanaan *On The Job Training* maka harus diberikan beberapa penanganan masalah pada gambar flowchart 4.1 sebagai berikut:

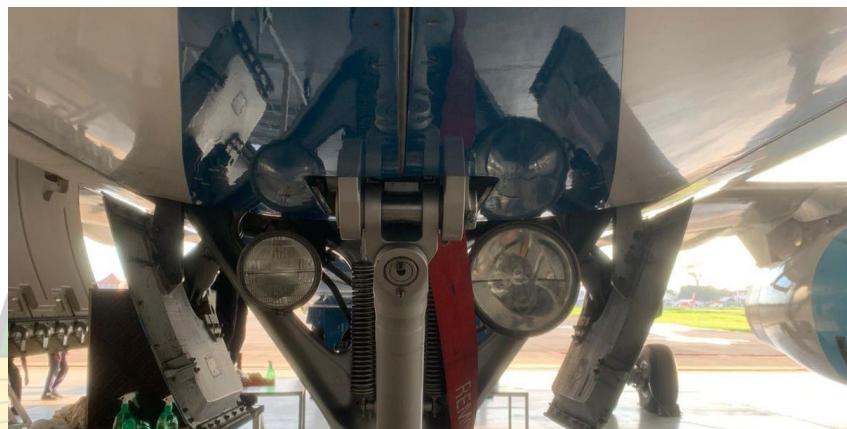
Gambar 4. 1 *Troubleshooting Manual Taxi Light*

*Troubleshooting Taxi Light* dikarenakan terdapat temuan bahwa pada saat *daily Check light* pada *taxi Light* tidak berfungsi yang dapat dilihat pada gambar 4.1. Dengan hal ini *engineer* mengambil keputusan untuk melakukan *troubleshooting* untuk dapat mengetahui permasalahan yang terjadi pada *system* sehingga dapat melakukan *maintenance* sesuai dengan pedoman *Troubleshooting Manual* (TSM).

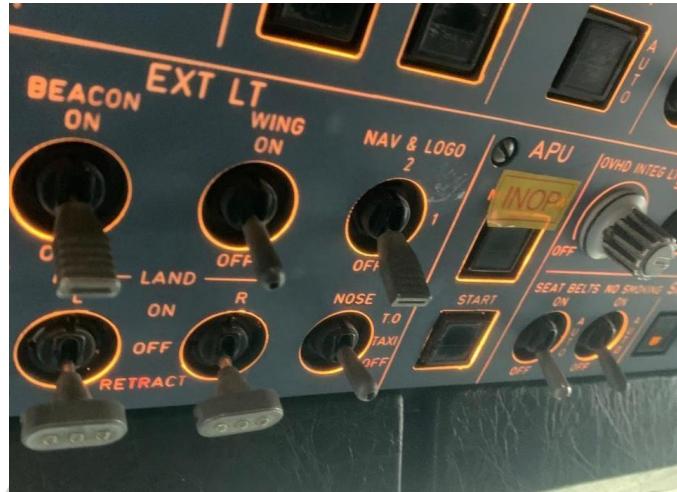
Gambar 4. 2 *Operational Test Taxi Light*

Lakukan *operational test* pada *taxi light* dengan Ref AMM 33-46-00-710-001. Di *section 25VU overhead panel* pastikan *selector switch* pada posisi *taxi* yang dapat dilihat pada gambar 4.2

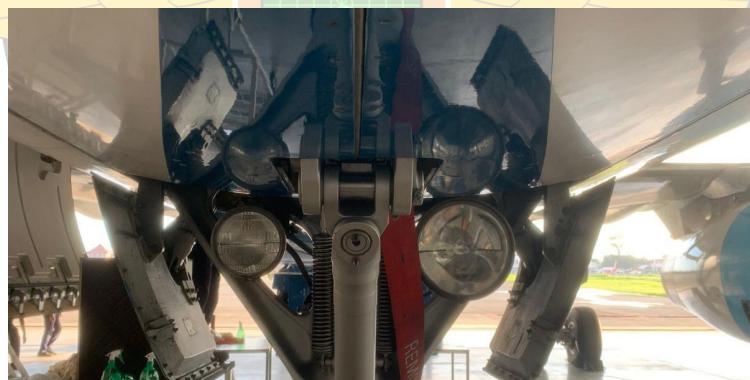
Gambar 4. 3 *Taxi Light Tidak Menyala*

Setelah melakukan *operational test* hasil yang didapat yaitu *Taxi Light* tidak menyala yang terlihat pada gambar 4.3

Setelah dilakukan *operational test* maka sesuai TSM 33-46-00-810-801-A yaitu dilakukan pengukuran tegangan pada *connector Taxi Light* agar mengetahui adanya power supply yang masuk yang dapat dilihat pada gambar 4.4. Pengukuran menggunakan alat yang bernama Multimeter, hasil dari pengukuran menunjukkan 115VAC pada pin A/2 dan 28 VDC pada pin A/X. Maka sesuai dengan ref *TSM 33-46-00-810-801-A* mengharuskan teknisi melakukan *replacement* pada *taxi light*.

Setelah melakukan pengukuran dan mendapatkan hasil yang sesuai dengan Ref TSM 33-46-00-810-801-A sehingga dilakukan *replacement* *Taxi Light* sesuai dengan Ref AMM 33-46-12-000-001 dan Ref AMM 33-46-12-400-001.

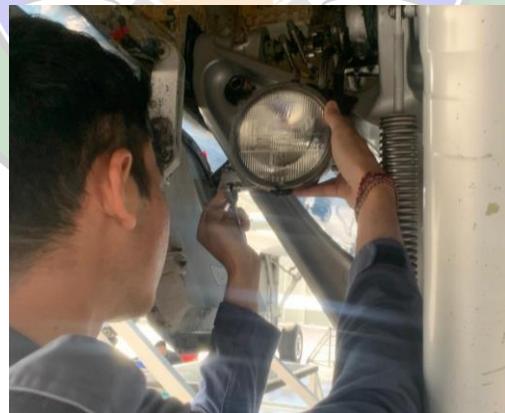
Gambar 4. 5 Pergantian Taxi Light

Setelah melakukan konfigurasi maka dilakukan *remove and install* yang dapat dilihat pada gambar 4.5

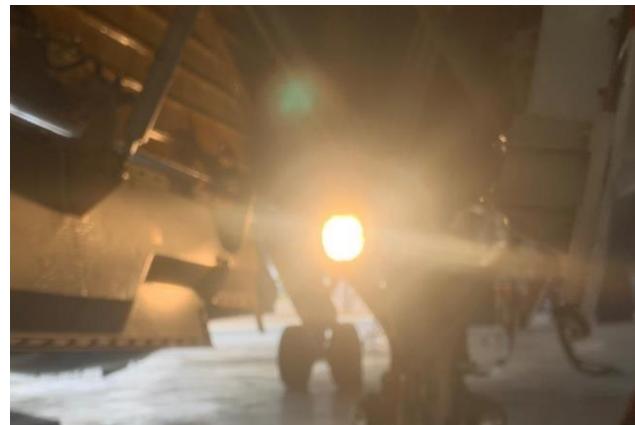
Gambar 4. 6 Functional Test Taxi Light

*panel* yang dimana menandakan *taxis light* berfungsi kembali secara normal yang dapat dilihat pada gambar 4.6

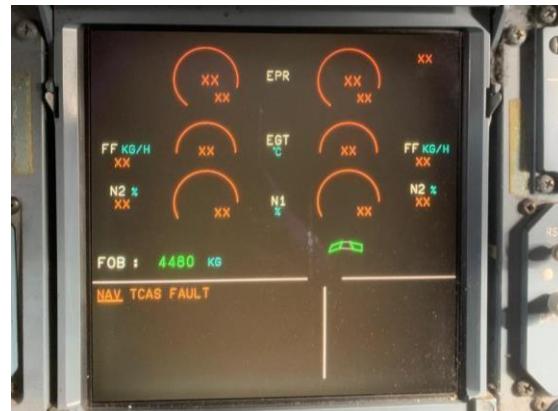
Gambar 4. 7 Fault Message Appear on Upper ECAM

Pada pesawat Airbus A320 dengan registrasi LY - NVJ terdapat *pilot report* yang menyatakan bahwa ditemukan permasalahan pada *TCAS*. Maka harus dilakukan perbaikan dengan alur yang dapat dilihat pada flowchart 4.2 sebagai berikut :

Teknisi memastikan *circuit breaker* dalam keadaan *closed* kemudian pada *ECAM message* tertulis *NAV TCAS FAULT* maka dilakukan *replacement transceiver TCAS*.sesuai dengan ref AMM 34-43-34-000-0001 dan ref AMM 34-43-34-400-001.

Setelah dilakukan *rectification*, teknisi melakukan *replacement* TCAS sesuai dengan *Ref AMM 34-43-34-000-005* dan *Ref Amm 34-43-34-400-005* yang dapat dilihat pada gambar 4.8.

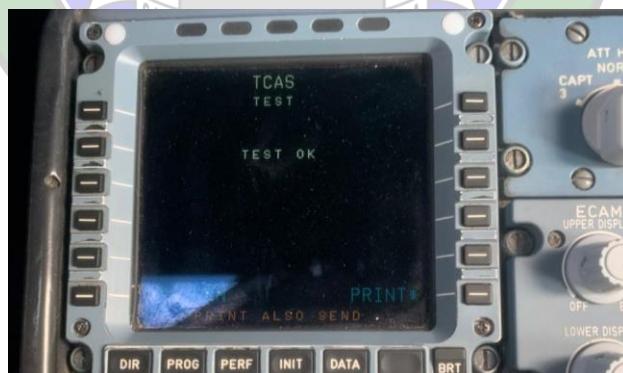
Gambar 4. 9 Functional Test TCAS

Setelah pergantian TCAS maka dilakukan *functional test* berdasarkan *Ref AMM 34-43-00-740-006* dengan MCDU (*Multifunction Centralized Display Unit*) guna memastikan TCAS benar benar berfungsi secara normal yang dapat dilihat pada gambar 4.9.

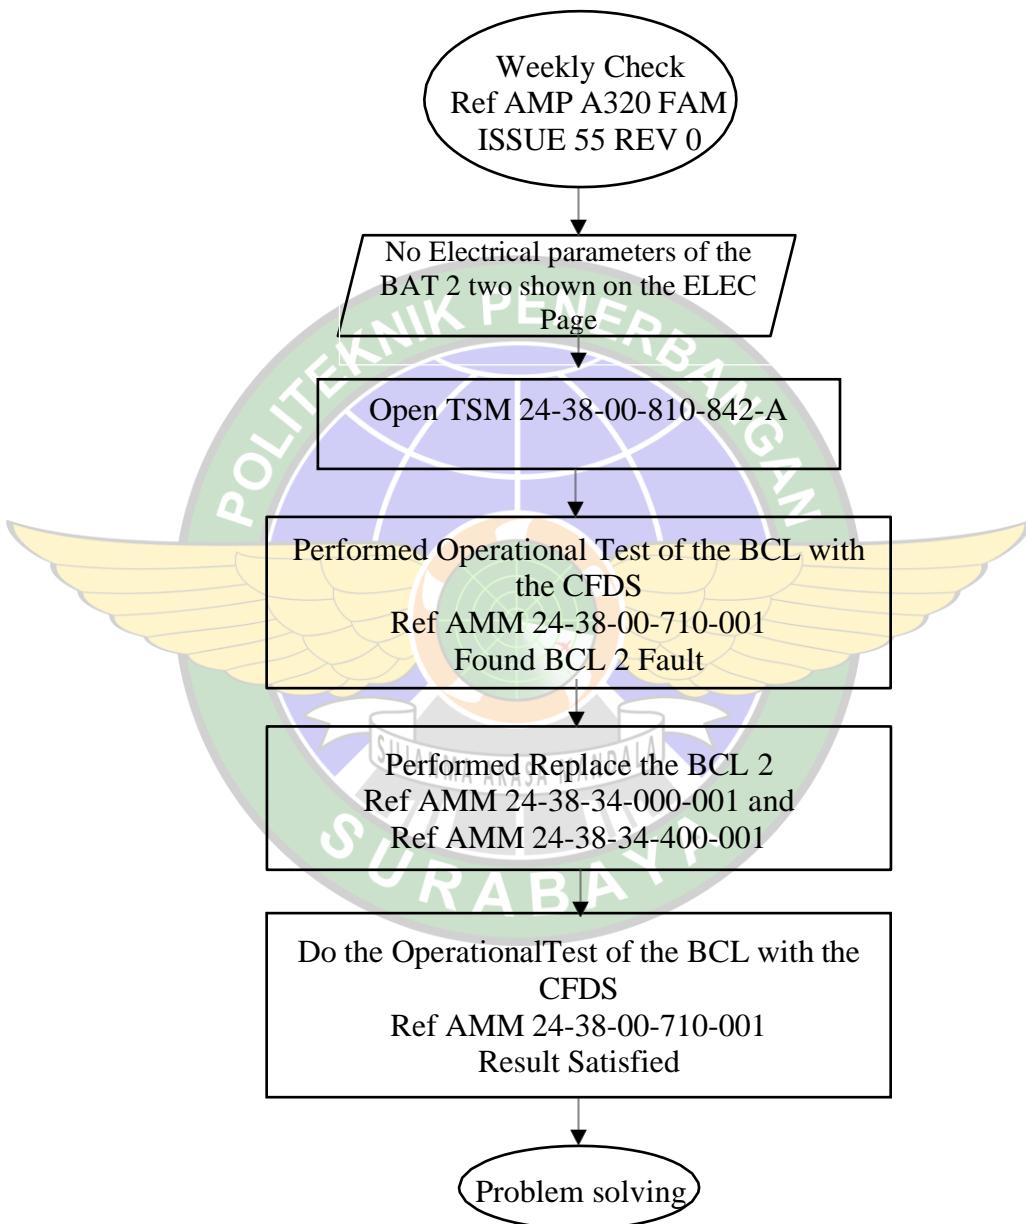
Bagan 4.3 Flowchart Troubleshooting Battery Charger Limiter

Pada pesawat Airbus A320 dengan registrasi LY – NVJ pada saat *weekly check* ditemukan permasalahan pada *battery charge limiter* maka harus dilakukan perbaikan dengan alur yang dapat dilihat pada *flowchart* 4.3 dengan alur sebagai berikut:

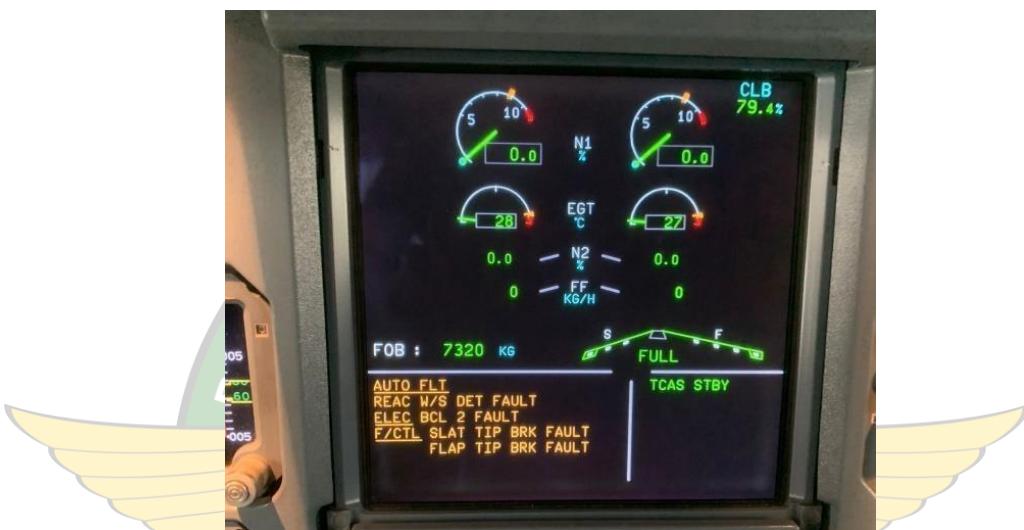
Gambar 4. 10 *Upper ECAM Show Message*

Troubleshooting *Battery Charger Limiter* dikarenakan terdapat temuan bahwa pada saat *weekly Check indicator BCL* pada *upper ECAM*. Ternyata didapat *message* seperti pada gambar 4.10 yang menyatakan bahwa *battery charge limiter* membutuhkan *troubleshooting*. Setelah diketahui, dibuatlah *non routine work card* untuk perbaikan lebih lanjut. Perbaikan selesai pada tanggal 15 Mei 2024

Teknisi melakukan *operational test* terhadap *Battery Charge Limiter* dengan CFDS ref. AMM 24-38-00-710-001. Setelah dilakukan test didapatkan hasil bahwa *ELEC BCL 2 Fault* maka harus dilakukan *replace* pada *BCL 2*. Sehingga, langkah selanjutnya yakni *replace BCL 2* sesuai dengan ref AMM 24-38-34-000-001 dan ref AMM 24-38-34-400-001

Setelah dilakukan *operational test BCL 2* dan mendapatkan hasil *BCL 2 Fault* maka sesuai dengan *Troubleshooting manual* yaitu harus melakukan pergantian *BCL* sesuai dengan Ref AMM 24-38-34-000-001 dan Ref AMM 24-38-34-400-001 yang dapat dilihat pada gambar 4.12

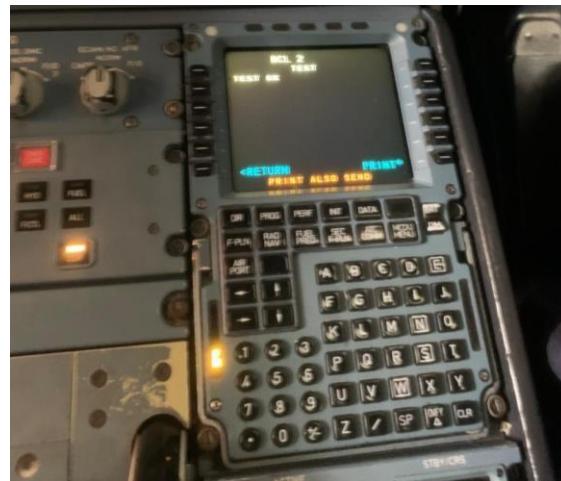
Gambar 4. 12 *Indicator CFDS*

Setelah dialakukan pergantian *BCL 2* maka dilakukan *operational test* sesuai dengan ref AMM 24-38-00-710-001 dan didapatkan hasil *test ok* pada *MCDU* yang menunjukan bahwa *BCL 2* telah kembali berfungsi normal yang dapat dilihat pada gambar 4.12
