LAPORAN ON THE JOB TRAINING
DI AKADEMI PENERBANGAN INDONESIA BANYUWANGI
01 APRIL 2024 - 28 JUNI 2024

PROGRAM STUDI DIPLOMA 3 TEKNIK PESAWAT UDARA
POLITEKNIK PENERBANGAN SURABAYA
2024

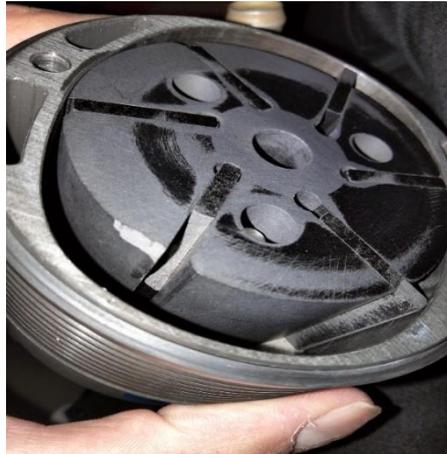
Gambar 4. 5 Komponen *vacuum pump*

Inspection dilakukan untuk mengetahui permasalahan yang ada di *vacuum pump*. Pada saat inspeksi ditemukan bahwa *brush* yang ada di dalam *vacuum pump* sudah aus yang disebabkan karena *friction*, bahkan ditemukan salah 1 *brush* mengalami patah seperti pada gambar 4. 5 dan gambar 4. 6.

Setelah mengetahui permasalahan pada *vacuum pump* yakni terjadi aus dan patah pada *brush* maka engineer memutuskan untuk dilakukan tindakan *replace* pada *vacuum pump*.

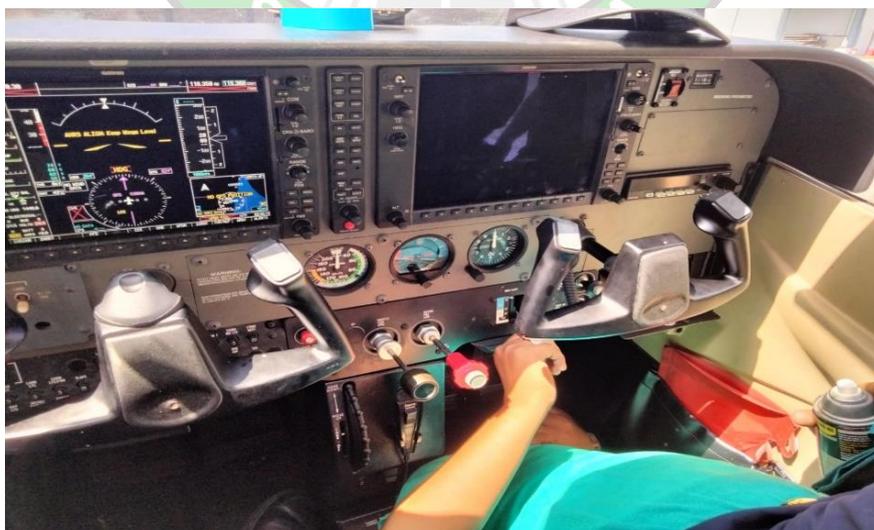
Gambar 4. 8 Servicing pada switch flaps

Setelah diidentifikasi masalah *engineer* melakukan *servicing* dengan memberikan *contact cleaner* guna untuk membersihkan komponen elektronik khususnya pada *switch* seperti pada gambar 4. 8.

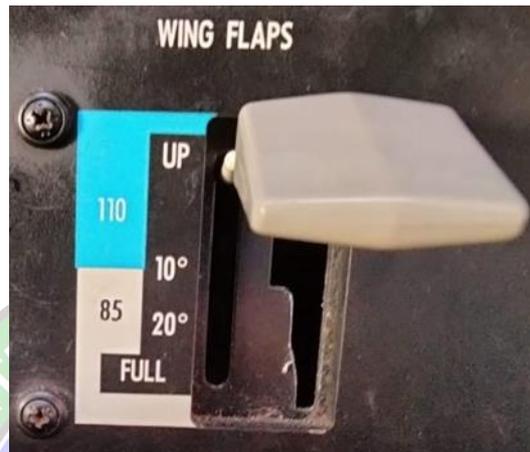
Gambar 4. 9 Lever flaps

Setelah dilakukan *cleaner* pada *switch flap* kemudian dilakukan *operational check* sesuai AMM 27-50-00 page 209 seperti pada *flaps* dari *full up position* sampai *full down position* guna memastikan apakah sudah normal atau belum seperti pada gambar 4. 9.

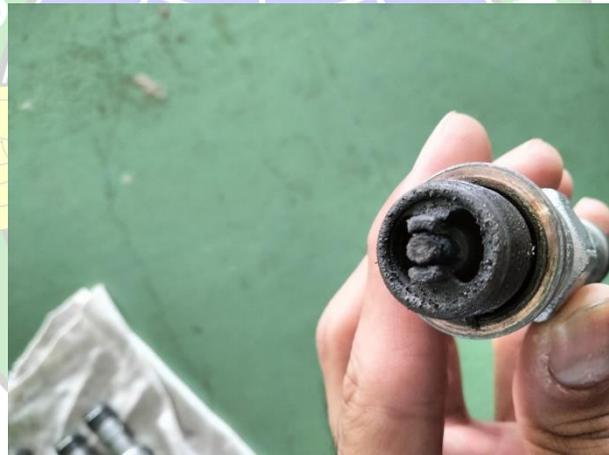
Gambar 4. 15 *Spark plug* penuh dengan *carbon*

Langkah inspeksi dilakukan untuk mengetahui apakah terdapat *defect* pada komponen serta memastikan komponen tersebut masih layak digunakan, pada saat melepas *spark plug* ditemukan *gap* pada *spark plug* hampir tertutup oleh karbon seperti pada gambar 4. 15., itulah salah satu penyebab *magneto drop* melebihi limitnya. *Spark plug* tersebut di bersihkan dan diberi *Loctite LB 8150*

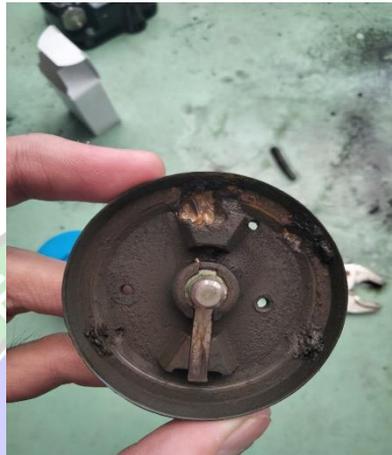
Gambar 4. 17 *Magneto casing distributor burn*

Setelah melakukan inspeksi pada *spark plug* dan membersikannya kemudian dilakukan inspeksi pada *magneto*, pada saat melakukan inspeksi pada *magneto* kanan *engine* kiri ditemukan banyak *defect* di dalamnya diantaranya : banyak karbon, *cam* dan *rasio small gear* timing aus, *magneto casing distributor burn*, *bolt corrosion*. Seperti pada gambar 4. 17 dan gambar 4. 18.

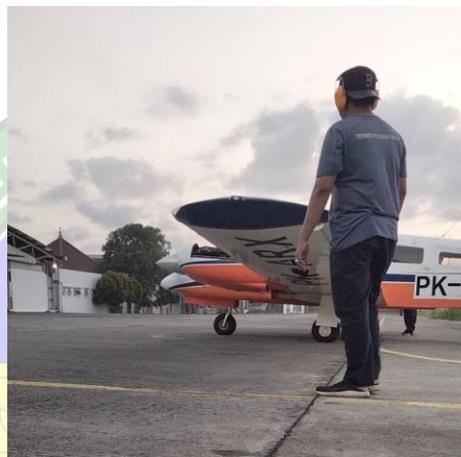
Gambar 4. 19 *Functional test*

Setelah dilakukan *reassembly* kemudian melakukan *engine ground run* guna memastikan engine sudah layak digunakan seperti pada gambar 4. 19.

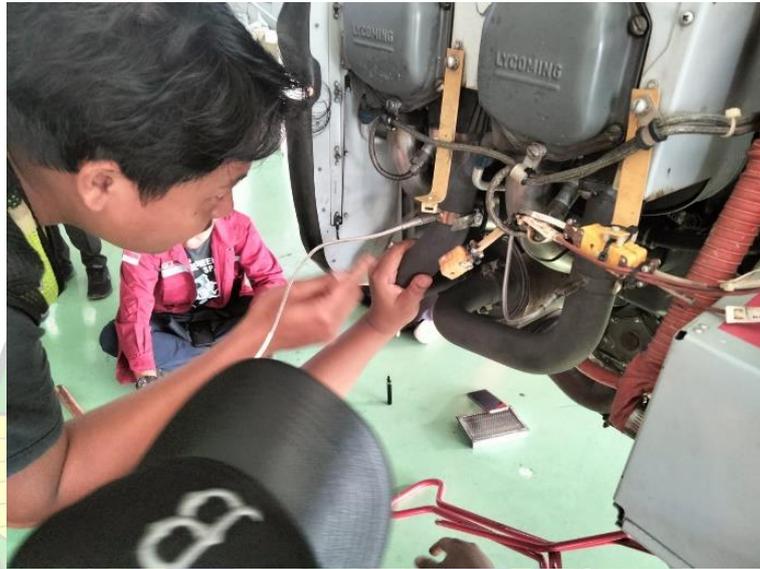
Gambar 4. 20 Inspeksi sensor *CHT* dan *EGT*

Inspeksi dilakukan oleh engineer guna memeriksa sensor *CHT* dan *EGT* dengan cara melepas sensor tersebut sesuai dengan *AMM 77-20-00 page 201-204* seperti pada lampiran 8, setelah melepas sensor tersebut *engineer* melakukan inspeksi dan ditemukan *defect burn* pada sensor akibat kabel tis terputus sehingga *wire CHT* dan *EGT* yang menghubungkan ke *GEA 71* menempel pada *intake* dan *exhaust*. Seperti pada gambar 4. 21.

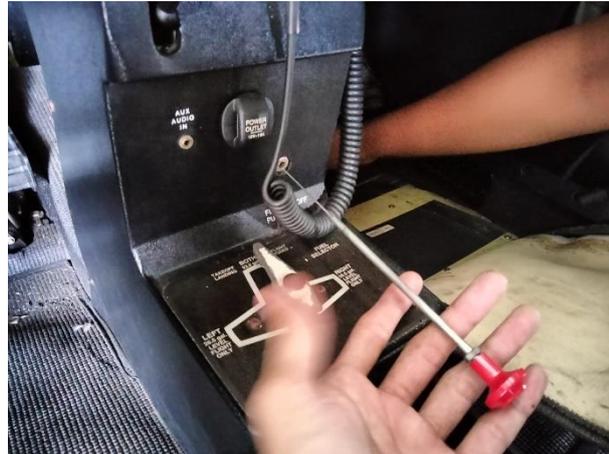
Gambar 4. 24 *Fuel shutoff valve control cable* terputus

Setelah *screw* dan *lock nut* terlepas selanjutnya dilakukan inspeksi pada gambar 4.24 ternyata *shutoff valve cable* nya putus dikarenakan pilot terlalu kencang saat menarik.

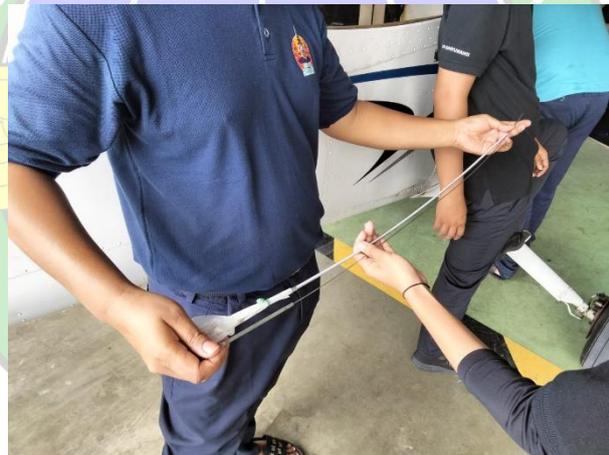
Gambar 4. 25 *Replace pada fuel shutoff valve control cable* sesuai part Number S1533-9

Pada gambar 4.25 setelah dilakukan inspection kemudian engineer memutuskan untuk melakukan *replace* pada *fuel shutoff valve control cable* dengan yang baru sesuai dengan part number yaitu S1533-9

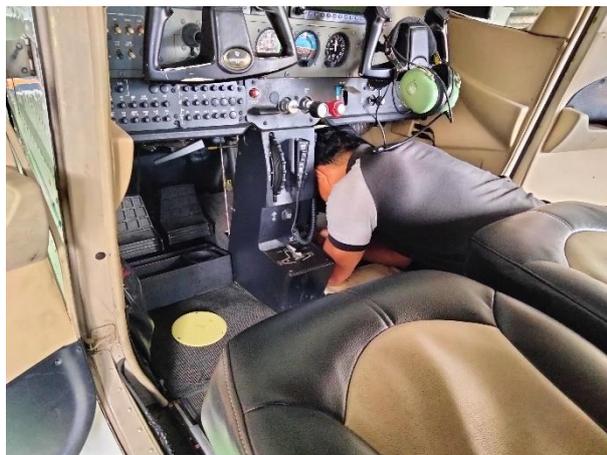
Gambar 4. 26 *Installation fuel shutoff valve control cable* sesuai AMMCessna 172S Skyhawk.

Setelah dilakukan *replace* pada *fuel shutoff valve control cable* dengan yang baru kemudian pada gambar 4. 26 *engineer* melakukan *installation* pada komponen sesuai dengan AMM ata chapter 28-20-00 page 215, pasang *lock nut* lalu kencangkan hingga minimum 15 inch/pouds dan pastikan *control arm* bergerak dengan lancar . Setelah itu kencangkan *screw* dan pasang kembali *copilot's rudder pedal shields*.

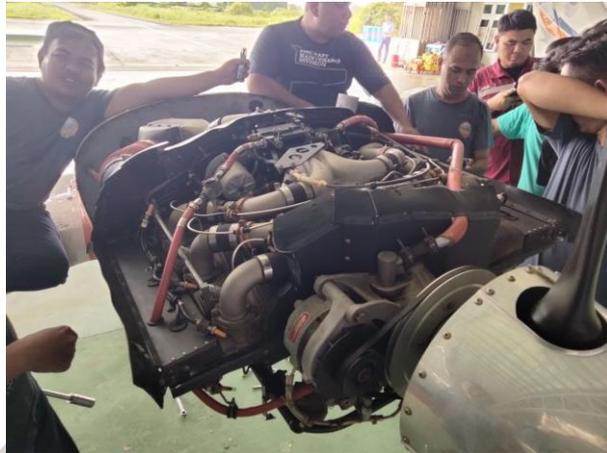
Gambar 4. 28 *Disassembly engine cowling*

Sebelum melakukan inspeksi terlebih dahulu *engineer* melakukan *removal* yaitu melepas *cowling engine* seperti pada gambar 4. 28.

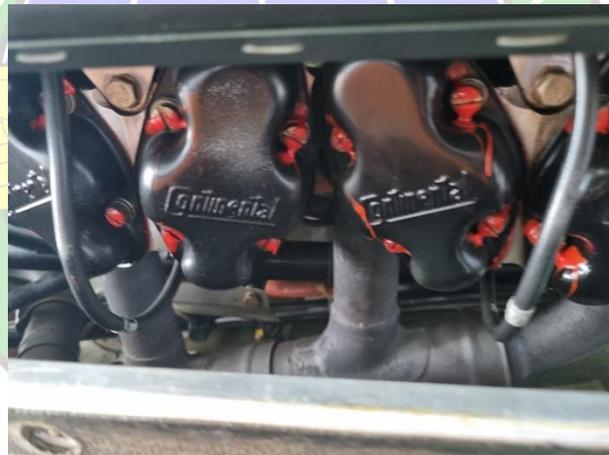
Gambar 4. 31 *Installation pada head rockerbox*

Setelah melakukan *replace* kemudian *engineer* melakukan *installation* yang ditunjukkan pada gambar 4. 31 dengan memasang *head rockerbox* kembali

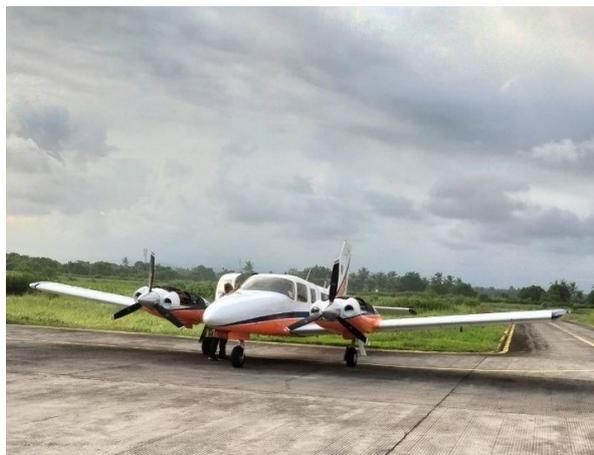
Gambar 4. 32 Engine ground run Seneca V

Setelah memasang kembali *head rockerbox* kemudian dilakukan *functional test* guna untuk memastikan apakah *oil* sudah tidak *leak* lagi dengan cara *engine ground run* seperti pada gambar 4. 32.

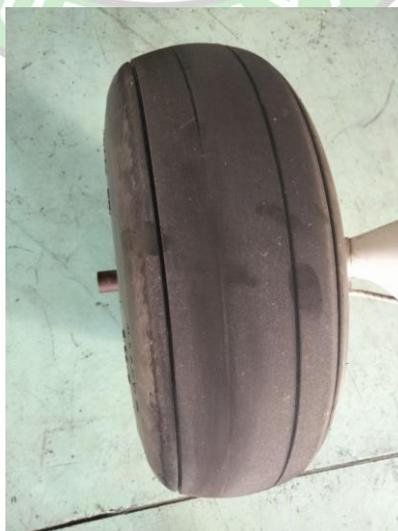
Gambar 4. 33 Left main wheel spot

Pada tanggal 25 juni 2024 *engineer* menemukan *defect* pada saat inspeksi preflight secara visual pagi hari, ditemukan bahwa *left main wheel* pada pesawat PK-BYS mengalami *spot* atau aus seperti pada gambar 4. 33, sehingga *engineer* memutuskan untuk membawa pesawat tersebut ke hanggar c untuk dilakukan *replace* pada *left main wheel*.

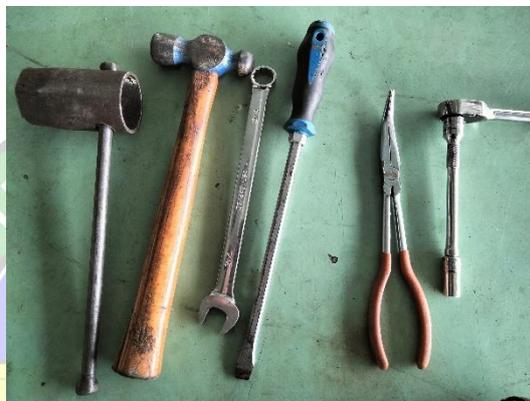
Gambar 4. 34 Tool yang digunakan untuk melepas left main wheel

Dilakukan removal sesuai AMM ata chapter 32-40-00 seperti pada lampiran 10 di mulai dengan memberi *jack* pada *strut left main wheel* pesawat setelah itu melepas *cotter pin* dengan *cutting plier*, lalu lepas *nut* menggunakan *special tool* seperti pada gambar 4. 34, lalu melepas *bolt* yang terpasang pada *back plate assembly* dan *pressure plate assembly* lalu melepas backing plate lalu menarik *wheel* dari *axle* lalu membuka *tire* seperti pada gambar 4. 35.

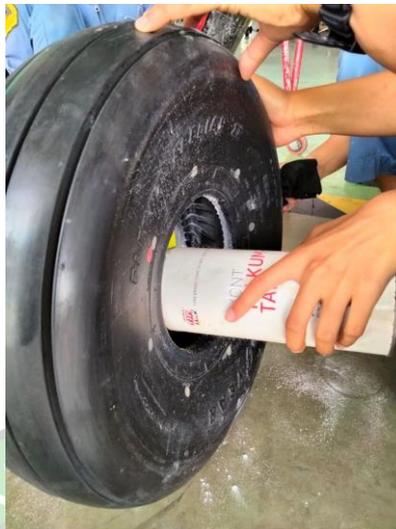
Gambar 4. 36 Memberi *mont talkum talc* pada *wheel*

Setelah *removal* kemudian langkah selanjutnya memberi *mont talkum talc* pada *main wheel* yang berfungsi menyerap kadar air didalam *wheel* seperti

pada gambar 4. 36. setelah itu dilakukan pemasangan *main wheel* dengan yang baru seperti pada gambar 4. 36. Kemudian diberi tekanan 42 *psi*

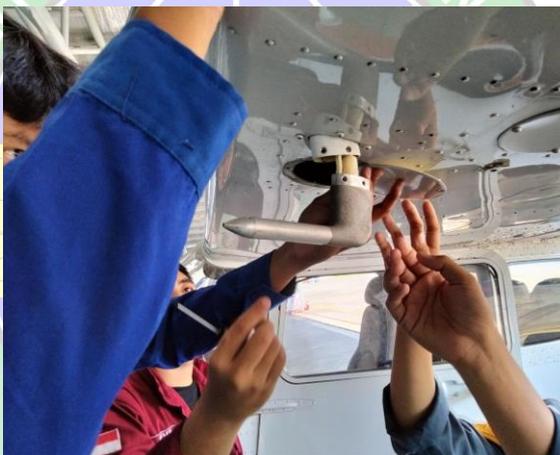
Gambar 4. 38 Removal pitot tube

Setelah pesawat dimasukkan di hanggar kemudian *engineer* melakukan *removal* dengan cara melepas *pitot* menggunakan *screwdriver philip* sesuai dengan *AMM* ata *chapter 34-11-00 page 201* seperti pada gambar 4.38.

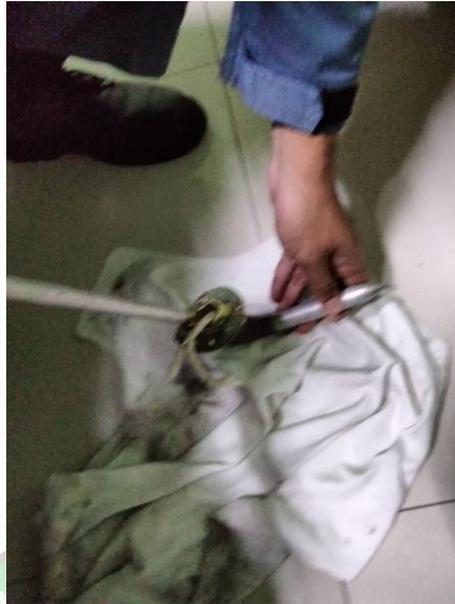
Gambar 4. 39 Membersihkan *pitot* menggunakan *compressor*

Servicing dilakukan dengan cara membersihkan *pitot tube* dengan menggunakan *compressor* seperti pada gambar 4. 39, kemudian *engineer* memastikan *pitot line* terhubung ke *standby instrument airspeed indicator* dan *GDC (Garmin Data Computer)* seperti pada gambar 4. 40. Setelah dilakukan *cleaning* pada *pitot tube* ditemukan batu kecil seperti pada gambar 4. 41 yang menyebabkan tertutupnya *pitot* sehingga *pitot* tidak terbaca pada *standby instrument airspeed indicator* dan monitor *garmin*.

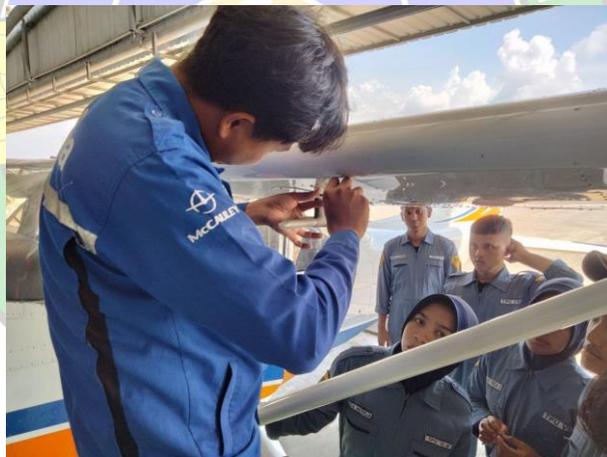
Gambar 4. 42 *Installation pitot tube*

Setelah dilakukan *servicing* pada *pitot* kemudian *engineer* melakukan *installation* pada *pitot* dan memasang kembali *standby instrument* seperti pada gambar 4. 42.

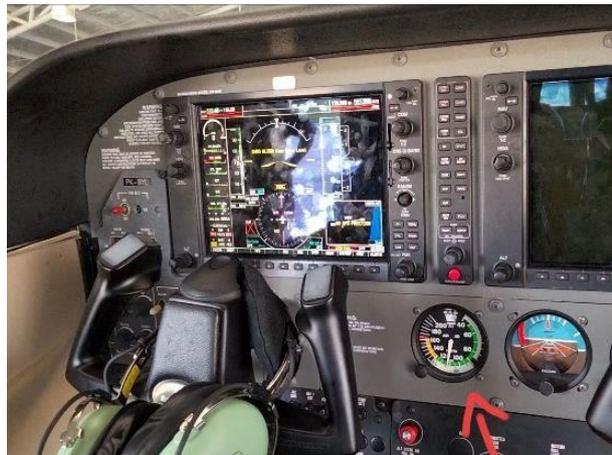
Gambar 4. 43 *Functional test* pada *pitot tube*

Selanjutnya *engineer* melakukan *functional test* dengan mengarahkan peserta *OJT* meniup *pitot tube* tersebut dan hasilnya *pitot* bekerja dengan baik dengan melihat *standby instrument airspeed indicator* dan monitor *garmin* seperti pada gambar 4. 43

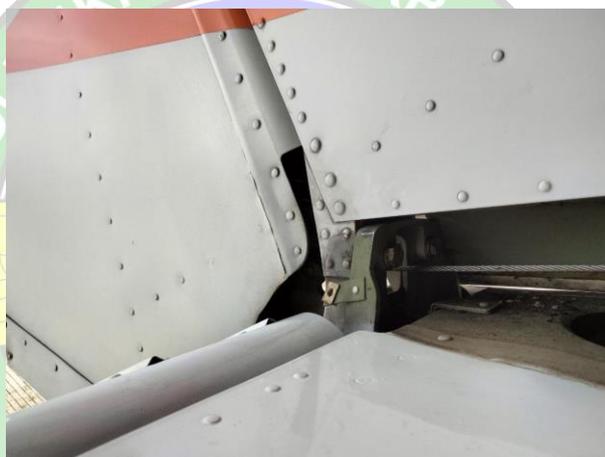
Gambar 4. 44 *Inspection flight control rudder cable*

Penulis melakukan inspeksi bersama seluruh *engineer shift* pagi. beberapa komponen yang diinspeksi seperti *flight control cable* dan *spark plug*. penulis menginspeksi *flight control cable* dengan majun guna memastikan apakah ada *wire* pada *flight control cable* terputus serta memastikan pergerakan *flight control* sesuai operation sesuai dengan referensi AMM 05-20-01 page 5-6 seperti pada gambar 4. 44.

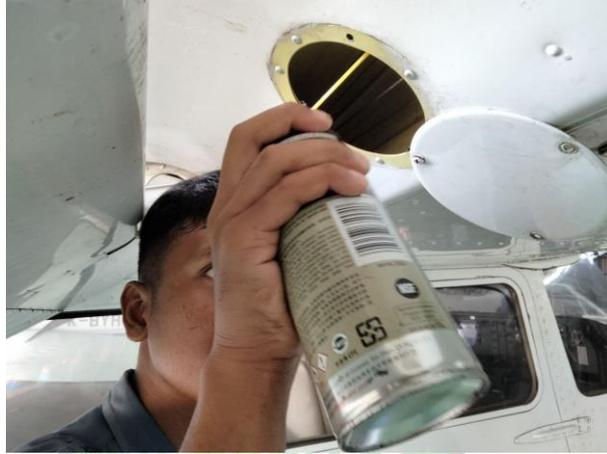
Gambar 4. 45 *Lubrication* pada *pulley flight control*

Setelah melakukan inspeksi pada *flight control cable* dan *spark plug* kemudian dilakukan *servicing*, ada beberapa *servicing* yang dilakukan penulis diantaranya adalah: memberikan *lubricant* pada *pulley flight control* seperti pada gambar 4. 45, kemudian *engine oil change*, *clean spark plug*, *clean air filter*. *Engine oil change* adalah pergantian oil pada pesawat dengan cara membuka drain pada oil sump menggunakan wrench 3/4 seperti pada gambar 4. 46. *Engine oil change* dilakukan sesuai dengan AMM 12-14-02 page 301-303. Setelah *engine oil change* kemudian *refill oil* yang baru dengan SAE J1966 dilakukan kemudian penulis melakukan *cleaning* pada *air filter* dengan *compressor* sesuai dengan referensi ata *chapter 12-*

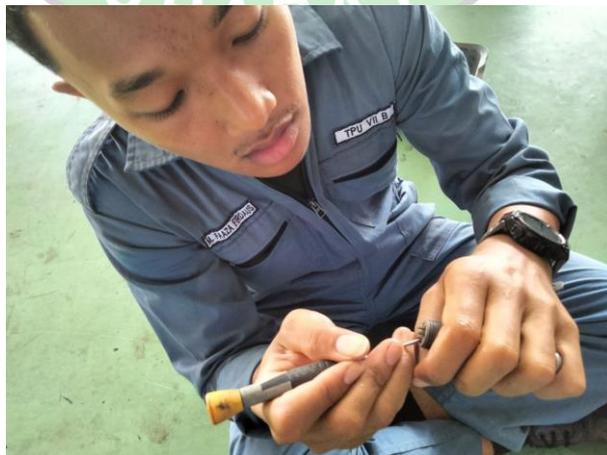
Gambar 4. 47 *Cleaning spark plug*

15-00 page 301-303. Setelah itu penulis melakukan *cleaning* pada *spark plug* yang ditunjukkan pada gambar 4. 47

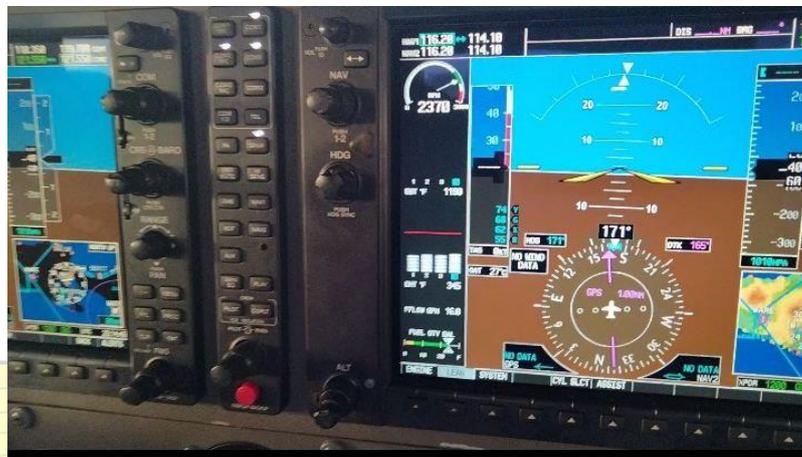
Gambar 4. 48 *Engine ground run after inspection 50 PK-APK.*

Setelah *installation* dilakukan kemudian *engineer* dan penulis melakukan *functional test* dengan cara *engine ground run* seperti pada gambar 4. 48.

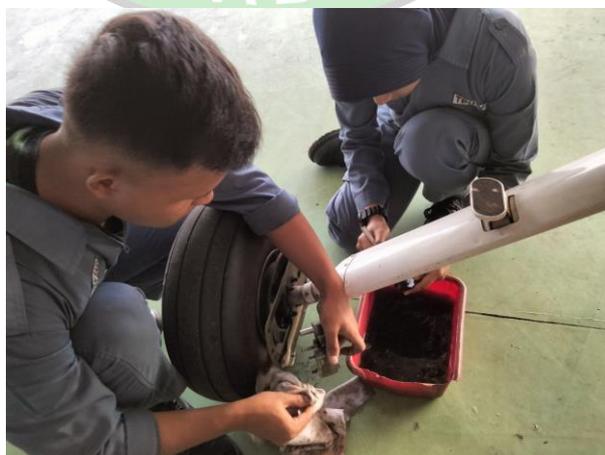
Gambar 4. 50 *Removal main wheel*

Pertama yang dilakukan adalah membuka *engine cowling* dengan *screwdriver philip* sesuai *AMM chapter 71*. Kemudian melepas *fuel strainer* dengan menggunakan *wrench 7/16* sesuai *AMM 28-20-00 page 220* seperti pada gambar 4. 48. Setelah itu juga melepas *main wheel* dengan menggunakan beberapa tool seperti *wrench 7/16* sesuai dengan *AMM 32-40-00 page 203* seperti pada gambar 4. 49.

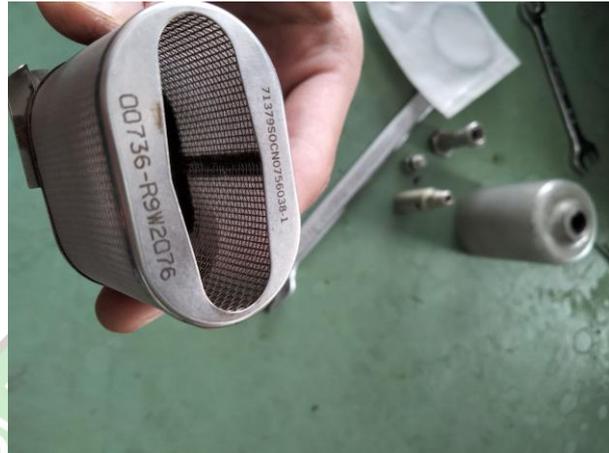
Gambar 4. 51 *Inspection fuel strainer*

Setelah melakukan *removal* kemudian melakukan inspeksi sesuai dengan *100 hours inspection task card*. Dengan adanya inspeksi kita bisa memastikan apakah komponen tersebut masih layak atau tidak. Seperti pada gambar 4. 51 dan gambar 4. 52

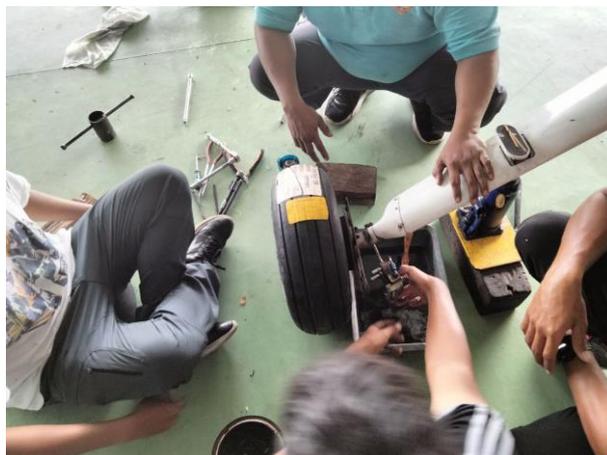
Gambar 4. 53 Intallation main wheel

Kemudian melakukan tahap ke empat yaitu *installation* yaitu memasang semua komponen yang sudah diinspeksi dan di *servicing* seperti pada gambar 4. 53.

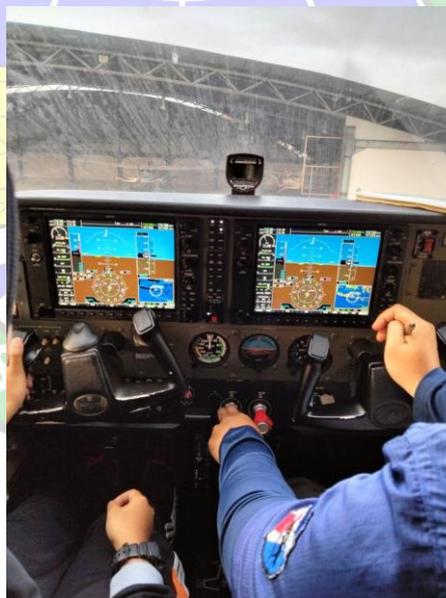
Gambar 4. 54 *Functional test*

Setelah melakukan *installation* kemudian *engineer* melakukan *functional test* dengan *engine ground run* guna untuk mengecek apakah *engine* sudah beroperasi dengan baik atau belum seperti pada gambar 4. 54
