**LAPORAN *ON THE JOB TRAINING***  
**DI AKADEMI PENERBANGAN INDONESIA BANYUWANGI**  
**01 APRIL 2024 – 28 JUNI 2024**

**PROGRAM STUDI DIPLOMA 3 TEKNIK PESAWAT UDARA**  
**POLITEKNIK PENERBANGAN SURABAYA**  
**2024**

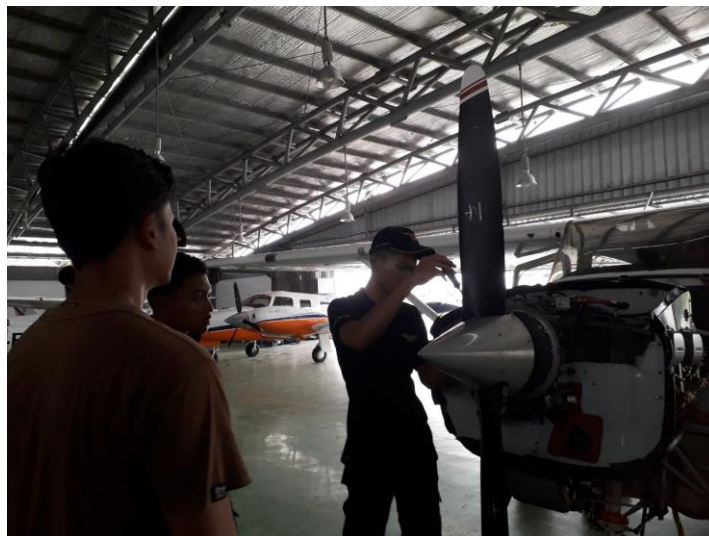
Gambar 3. 2 Maintenance Cessna 172S

Tujuan lain daripada perawatan pesawat udara seperti yang di tunjukan pada gambar 3.2 adalah untuk mempertahankan pesawat dalam kondisi terbaik pada saat dioperasikan oleh pengguna. Untuk dapat melakukan perawatan dengan benar, maka setiap pesawat udara diharuskan memiliki Program Perawatan (*maintenance program*) yang berisi informasi detail tentang apa, kapan dan bagaimana perawatan sebuah pesawat udara.

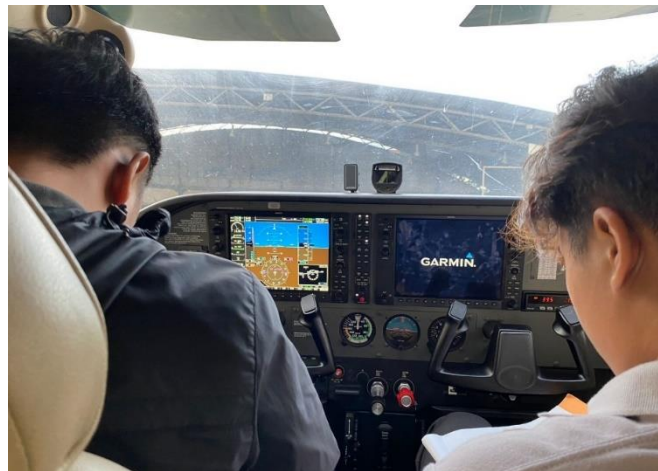
Gambar 3. 5 Kegiatan *Engine Ground Run*

*Engine ground run* dilakukan setelah *pre-flight* guna untuk memastikan *engine* dalam keadaan yang layak yang mencakup untuk melihat kondisi *oil pressure*, *oil temperature*, *fuel flow*, *exhaust gas temperature*, *cylinder head temperature*, *amps battery*, dan *vacuum* pada pesawat yang akan dipakai untuk terbang. Berikut ini contoh kegiatan pada *engine ground run*.

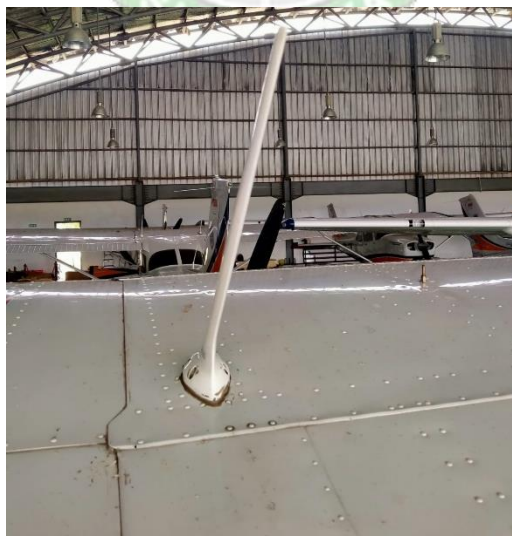
Gambar 4.7 Reassembly GPS Antenna

Setelah antenna diganti dengan yang baru maka dipasang kembali *connector* kemudian pasang dan kencangkan *screw* menggunakan *philip screwdriver*, pada tahap ini pastikan dengan benar 4 *screw* terpasang dengan benar dan kencang sesuai dengan *aircraft maintenance manual chapter 34 navigation*.

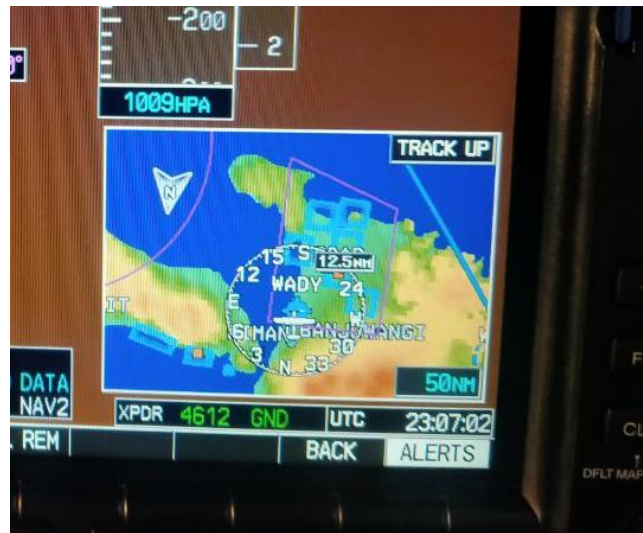
Gambar 4.8 *Functional Test* GPS

*Functional Test* dilakukan setelah *GPS antenna* terpasang dengan mengoperasikan pesawat dan mengamati *Garmin Display Unit* dengan hasil yang didapatkan GPS sudah terbaca pada PFD seperti yang ditunjukkan pada gambar 4.7.

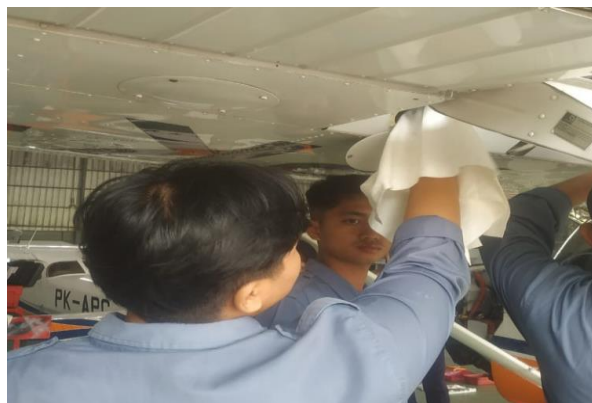
Gambar 4.4 *Inspection Flight Control Panel*

Setelah *screw* terlepas dan panel terbuka, tahap selanjutnya adalah melaksanakan inspeksi secara visual dan fisik dengan memegang kabel menggunakan kain, dengan tujuan untuk memastikan tidak ada kerusakan pada *wire* atau *cable defect* dalam *flight control cable*, setelah itu juga di lakukan pengukuran tegangan kabel menggunakan *cable tension*.

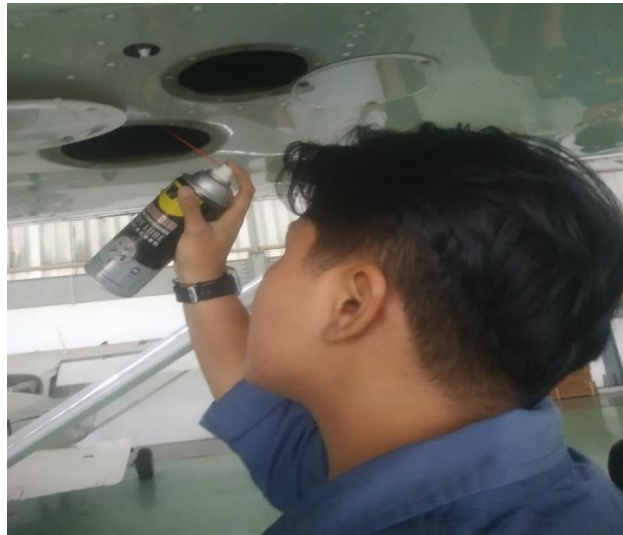
Gambar 4.5 *Servicing Flight Control Cable*

anti karat dengan cara di semprotkan dan menggunakan kain yang di berikan *oil*. *Cable control inspection* merupakan maintenance rutin guna mengetahui kondisi kabel setelah di gunakan selama interval waktu tertentu sesuai dengan *aircraft maintenance manual chapter 12 servicing*

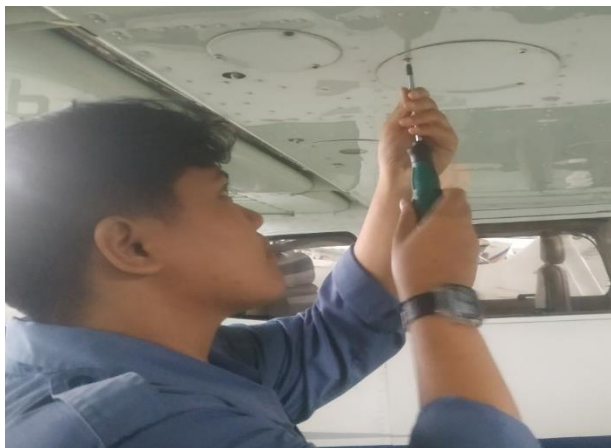
Gambar 4.6 *Installation panel*

Setelah inspeksi dan lubrikasi selesai, dilanjutkan dengan menutup kembali *acces panel* yang ada dibagian *lower wing* kiri dan kanan, dan *acces panel* pada *fuselage* bagian belakang kanan dengan menggunakan *phillips head screwdriver* seperti yang ditunjukkan pada gambar 4.18, sesuai dengan *aircraft maintenance manual chapter 12 servicing* lampiran 2.

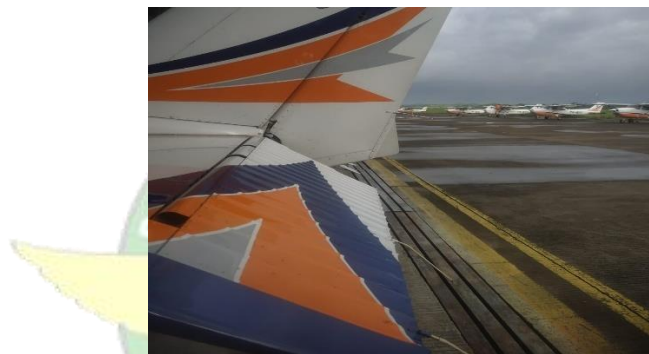
Gambar 4.7 Return To Service Flight Control Cable

Setelah dilakukan *functional test* dan hasil yang diperoleh adalah *flight control* tersebut telah beroperasi secara normal dan tidak di temukan *wire* yang terputus, maka pesawat Cessna 172-S PK-BYC dinyatakan layak terbang dan dapat dioperasikan kembali dalam kegiatan penerbangan.

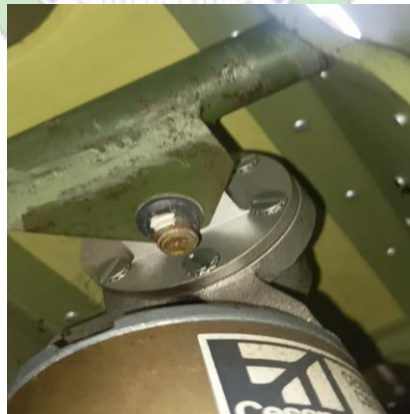
Gambar 4.19 *Flap Motor*

*Flap Motor Stuck / Failed* terdapat bahwa pada pengecekan flap saat pengoprasian yang di lakukan kegiatan *ground run flap extend* tidak dapat dapat berfungsi. Dapat disimpulkan bahwa *flap motor* terjadi kerusakan, dan di lakukan proses maintenance dengan mengganti flap motor, dengan flap motor yang baru sesuai *AMM Chapter 27 27-50-00 Page 201 Rev 26*.

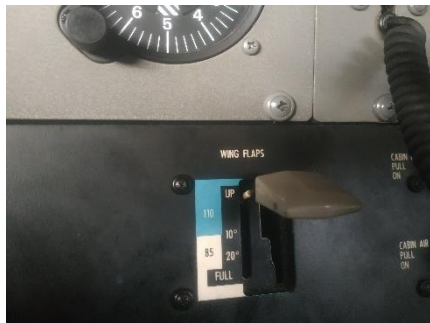
Gambar 4.8 *Operation Test Flap*

Setelah proses *replace* selesai maka dilanjutkan dengan *operation test* dengan menggunakan *power GPU* untuk menghidupkan *ectrical* pada pesawat setelah itu *operation test* dilakukan dengan menggunakan *selector flap* yg berada pada *cockpit*

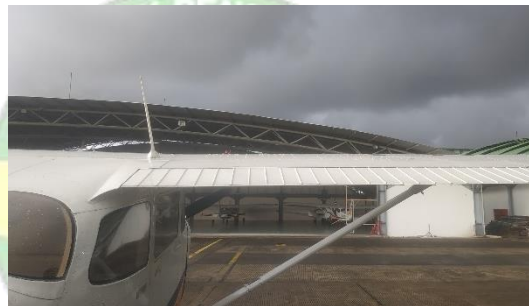
Gambar 4.9 *Return to Service Flap*

Setelah dilakukan *operation test* dan hasil yang diperoleh adalah *flap* tersebut telah beroperasi secara normal dan tidak di temukan kendala lainnya, maka pesawat Cessna 172-S PK-BYD dinyatakan layak terbang dan dapat dioperasikan kembali dalam kegiatan penerbangan.

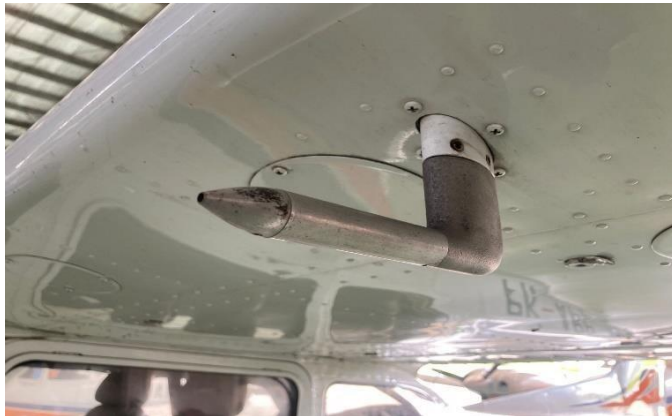
Gambar 4.10 Penyumbatan pada *Pitot Tube*

Pada tanggal 13 mei 2024 Cessna 172S dengan registrasi PK-BYC yang telah lama tidak beroperasi akan di operasian kembali dalam penerbangan, maka dari itu akan dilakukanya *maintenance* sesuai dengan *task temporary storage return to service*, pada saat melakukan pengecekan *standby airspeed indicator* dengan cara mencoba meniup *pitot tube* ternyata *indicator* tersebut mengalami *stuck*

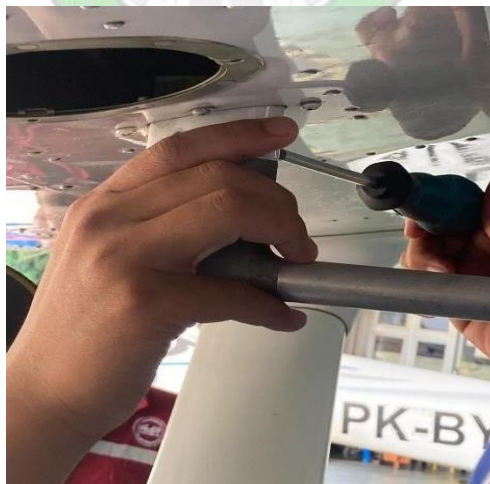
Gambar 4.11 *Disassembly Pitot Tube*

Sebelum melakukan tindakan ke tahap selanjutnya hal yang harus dilakukan yaitu disassembly dengan melakukan prosedur sesuai *Aircraft Maintenance Manual* (AMM) yang dimulai dengan melepas screw yang mengaitkan tabung *pitot* ke *wing* seperti ditunjukkan pada gambar 4.26, lalu lepaskan *pitot tube*, selanjutnya lepaskan *ram air tube* dari *pitot* berdasarkan *aircraft maintenance manual chapter 34 navigation*

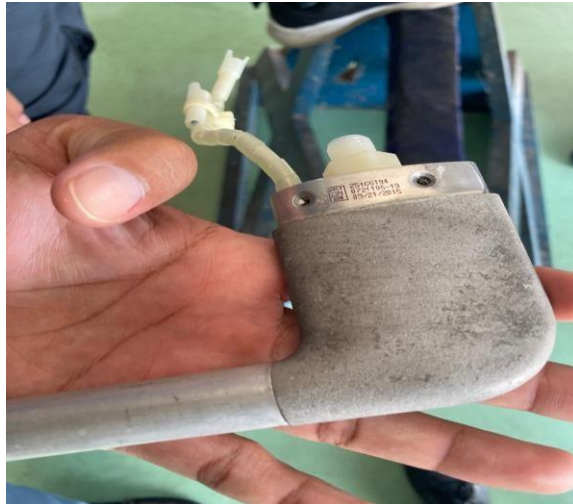
Gambar 4.12 *Inspection Pitot Tube*

permasalahan pada pitot system. Dilakukanya pengecekan pitot tube secara visual dengan melihat bagian lobang *pitot tube* dimana ditemukan penyebab permasalahan ini terjadinya penyumbatan pada lubang pitot tube sehingga tidak terbacanya *standby* indikator yaitu *air speed indicator*.

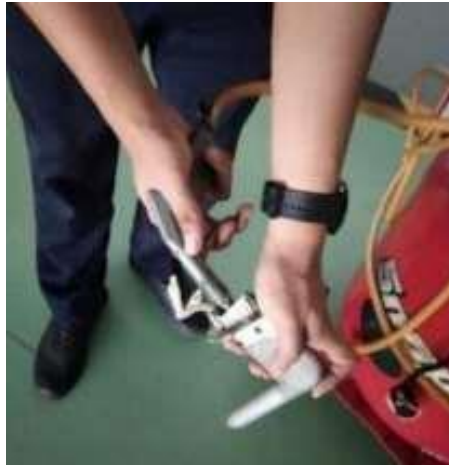
Gambar 4.13 *Servicing Pitot*

Setelah melaksanakan inspeksi, langkah selanjutnya yaitu melakukan cleaning pada *pitot tube* dengan cara membersihkan bagian lobang *pitot tube* yang disemprotkan dengan menggunakan alat yaitu kompresor sehingga kotoran penyumbat yang ada didalam *pitot tube* dapat keluar berdasarkan *aircraft maintenance manual* (Reff. AMM Chapter 12).

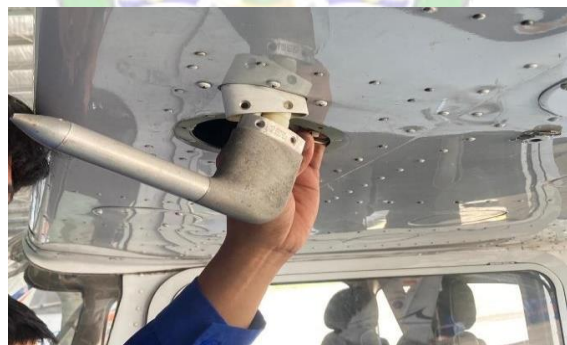
Gambar 4.14 *Installation Pitot*

Langkah-langkah pekerjaan installation pitot sesuai dengan *Maintenance Manual Cessna 172S*. Secara garis besar tahap ini meliputi pemasangan pitot tube dengan memasang ram *air tube* ke pitot, lalu pasang electrical connector ke *pitot heater* dan *pitot heat ground*. Pastikan komponen *pitot tube* dalam keadaan bersih, bebas dari penyumbatan, dan kebocoran untuk pengompresian yang benar sesuai dengan *aircraft maintenance manual chapter 34 navigation*.

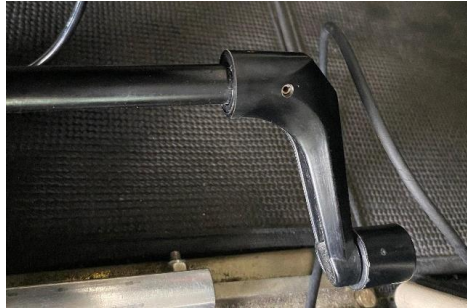
Gambar 4.32 *Pin adjustable rod*

Setelah di lakukan langkah removal pada *height adjustable seat*, langkah selanjutnya adalah dengan *Replace pin* pada *adjustable rod* sesuai dengan *aircraft maintenance manual*.
