**LAPORAN ON *THE JOB TRAINING* (OJT)  
PESAWAT BOEING 737-800  
DEVISI ENGINE APU MAINTENANCE  
PT. BATAM AERO TECHNIC**

**PROGRAM STUDI D3 TEKNIK PESAWAT UDARA  
POLITEKNIK PENERBANGAN SURABAYA  
2026**

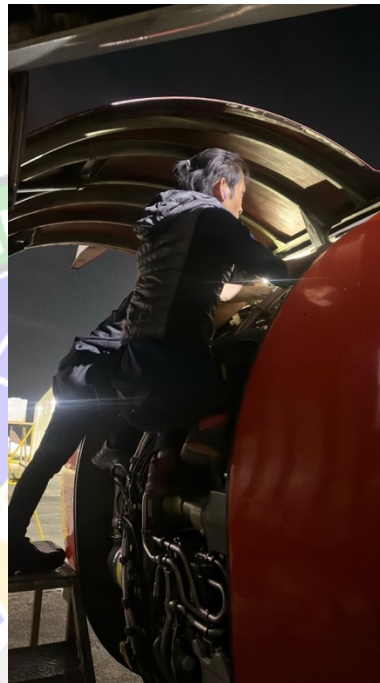
Gambar 3. 8 Proses Pengerjaan ( Sumber: Dokumentasi Pribadi)

Sebelum dilakukan proses *preservation* pada *engine*, maka diperlukan tahapan inspection awal untuk memastikan kondisi *engine* dalam keadaan siap dilakukan prosedur *preservation* serta tidak terdapat kerusakan atau kontaminasi yang dapat mempengaruhi proses tersebut.

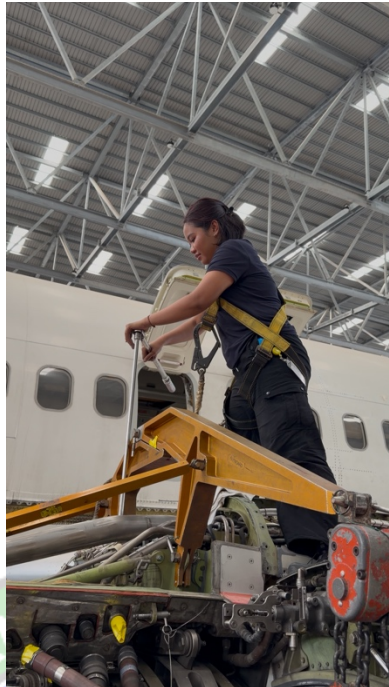
2. Gambar 3. 9 Proses Remove Engine (Sumber: Dokumen Pribadi)

Proses ini meliputi pelepasan *engine* yang terpasang pada pesawat (*engine removal*) dan penggantian dengan *engine* lain yang telah memenuhi persyaratan kelayakan operasional (*serviceable engine*). Pekerjaan ini merupakan salah satu pekerjaan berat (*heavy maintenance*) yang memerlukan koordinasi tim, penggunaan *special tools*, serta mengacu secara ketat pada prosedur *Aircraft Maintenance Manual* (AMM). Pekerjaan ini dilakukan pada tanggal 9-11 Februari 2026 (*Aircraft Maintenance Manual (AMM) TASK 71-00-02-000-801-F00. REMOVAL OF POWER PLANT*, 2024).
