**LAPORAN ON THE JOB TRAINING
DI GMF AEROASIA - HANGAR TANGERANG
05 MEI 2025 – 25 JULI 2025**

**PROGRAM STUDI DIPLOMA 3 TEKNIK PESAWAT UDARA
POLITEKNIK PENERBANGAN SURABAYA
2025**

Pesawat Airbus A320 dengan registrasi VT – IFP harus dilakukan perbaikan dengan alur bagan 4. 1 karena terjadi permasalahan *Failure of Overpressure Valve*.

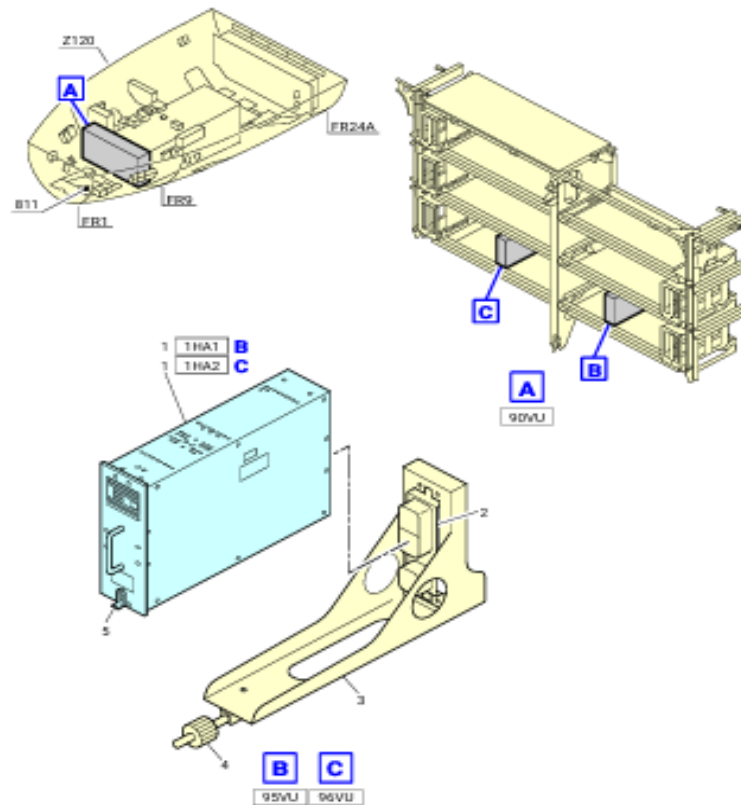
Gambar 4. 17 Removal BMC #1

OPS. No.	DISCREPANCIES FOUND DURING INSPECTION(Use reverse side if necessary):	Insp
0020	- ENG 1 VIB NI 1.5 UNIT AT 75% NI : 805602064. - ENG 2 VIB NI 2.15 UNIT AT 85% NI : 805602065. - DURINGER FOUND BMC #1 FAULT : 80556353	I.A7898 04 JUN 2025

Setelah mengetahui pasti penyebab *trouble* selanjutnya *engineer* dan mekanik melakukan *replacement* BMC #1 berdasarkan *reference* AMM Removal TASK 36-11-34-000-001-A dan AMM Installation TASK 36-11-34-400-001-A. Sesuai dengan TSM langkah selanjutnya yaitu melakukan *replacement* BMC #1. Sebelum melakukan AMM removal TASK 36-11-34-000-001-A dibutuhkan *tools* yaitu ACCESS PLATFORM 2M (6 FT), CAP-BLANKING, dan SAFETY CLIP-CIRCUIT BREAKER.

- a. **Removal Bleed Monitoring Computer 1**
 1. Loosen the nut (4).
 2. Lower the nut (4).
 3. Pull the BMC (1) on its rack (3) to disconnect the electrical connectors (2).
 4. Remove the BMC (1) from its rack (3).
 5. Put CAP - BLANKING on the disconnected electrical connectors.
